DOWNTOWN TOPEKA

HISTORIC DISTRICT

DESIGN GUIDELINES

City of Topeka, Kansas

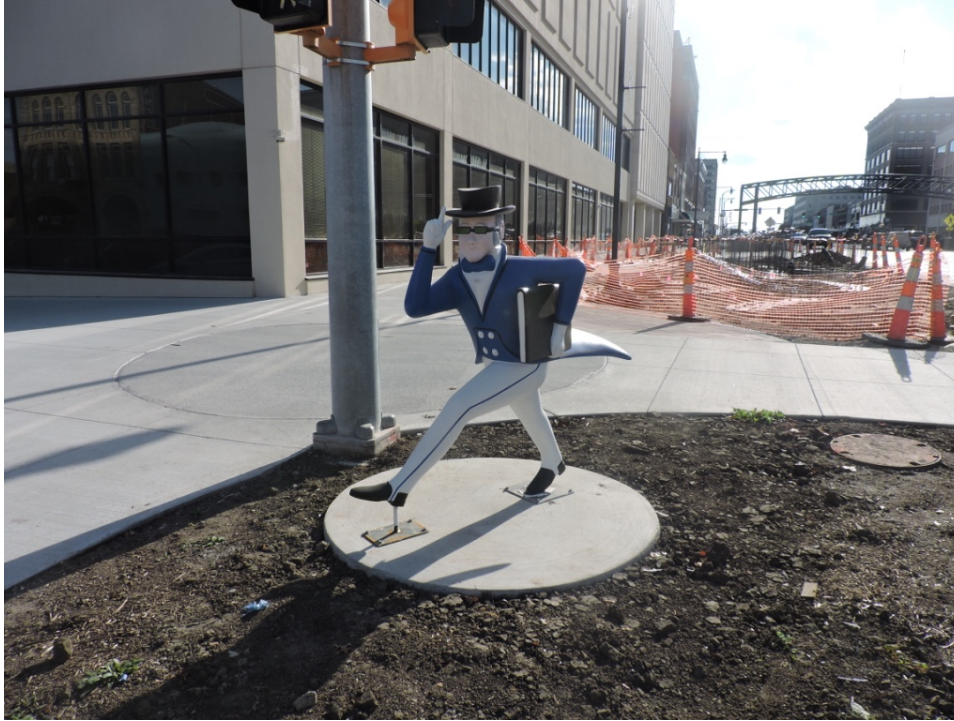
Streetscape improvements under construction, November 2015

The South Kansas Avenue Project is a public/private partnership in which the City of Topeka is constructing road and utility improvements while private partners are providing funding for public enhancements. The City's portion of the work has included a new water main, water and gas services to properties along the street, storm water infrastructure, street paving, curbs, and sidewalks with a cost of approximately \$5 million.

Over \$2 million in private investment has been provided for streetscape amenities, pocket parks, and aesthetics. Focal points of the design are mid-block crossing points, two of which feature large metal truss arches that frame the street and provide stage backdrops for public events.

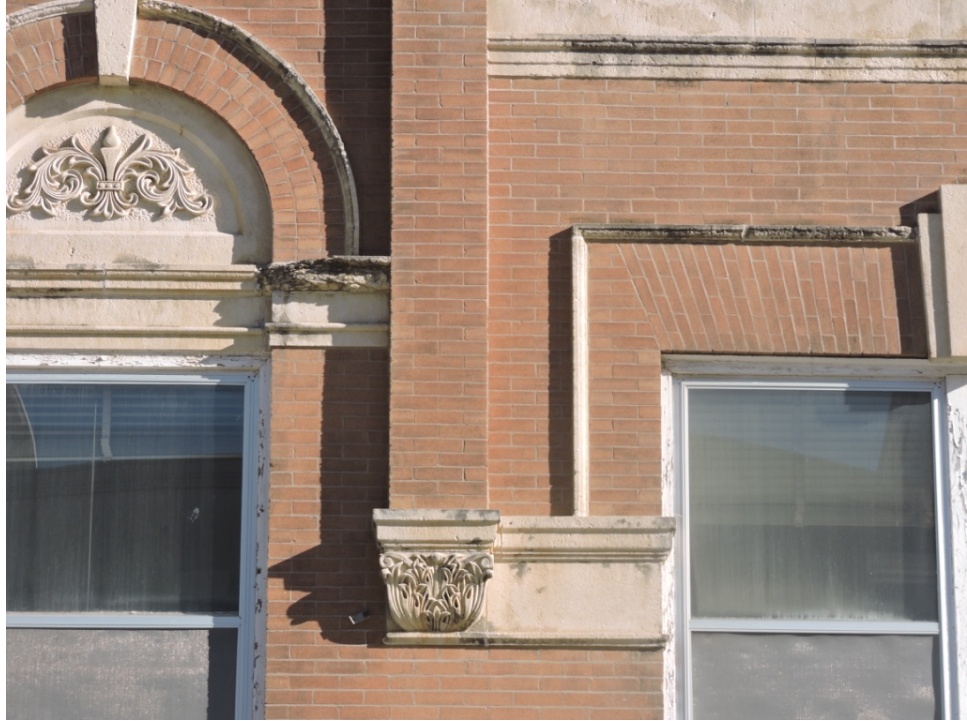
Interesting decorative historic building fabric, including masonry conservation issues, typical of the historic districts.

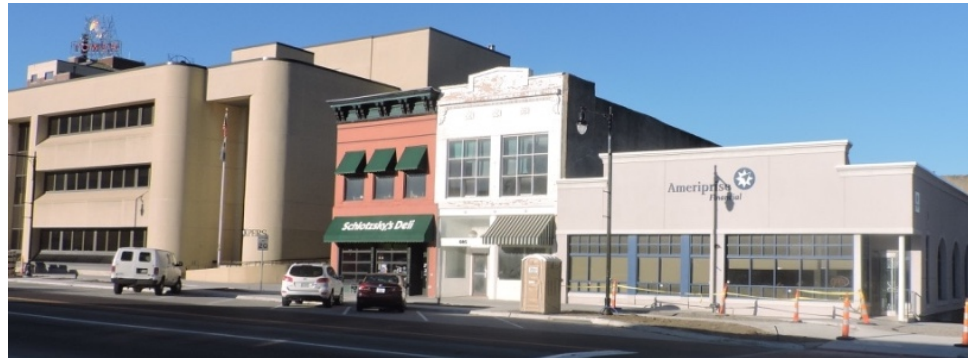
607 (left) and 605 (right) South Kansas Avenue today. The façade of 607 was modified c.1888 and the façade of 605 was modified in 1911.

Topeka experienced a significant amount of new construction during the first decades of the new century. Several **substantial and well designed new buildings** were constructed. The Elks Club and IOOF, pictured above, are examples. **Façade alterations** were performed on many earlier nineteenth century commercial street-fronts. In general, the new facades were designed with simpler brick fronts, larger windows, more restrained and sophisticated ornament. The façade of 605 South Kansas Avenue, pictured above in the previous section, was modified in 1911 and is an example.

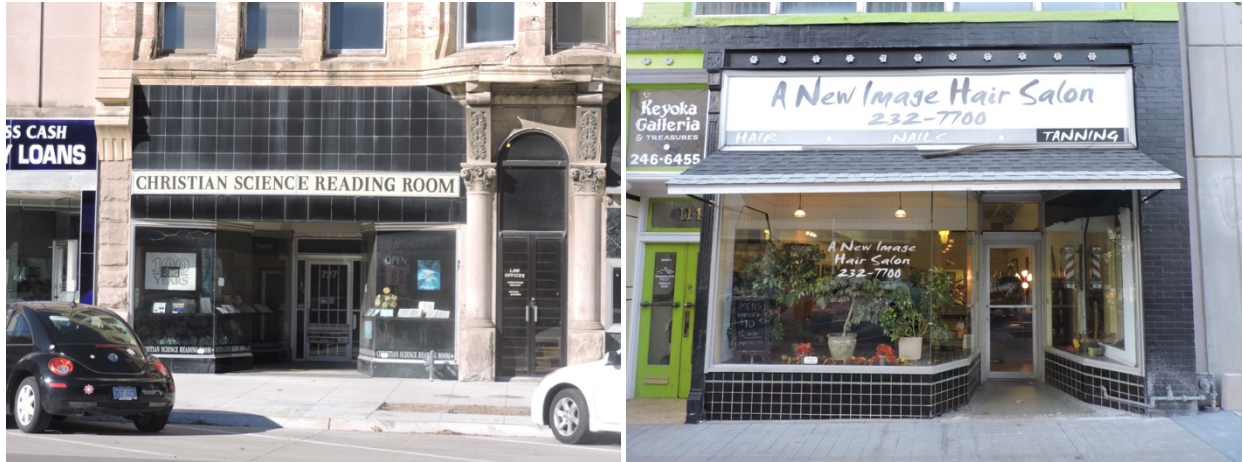
Storefronts of two late-nineteenth century buildings modified with 1950s/60s designs, 727 South Kansas Avenue (left) and 114 SW 8th Avenue (right)

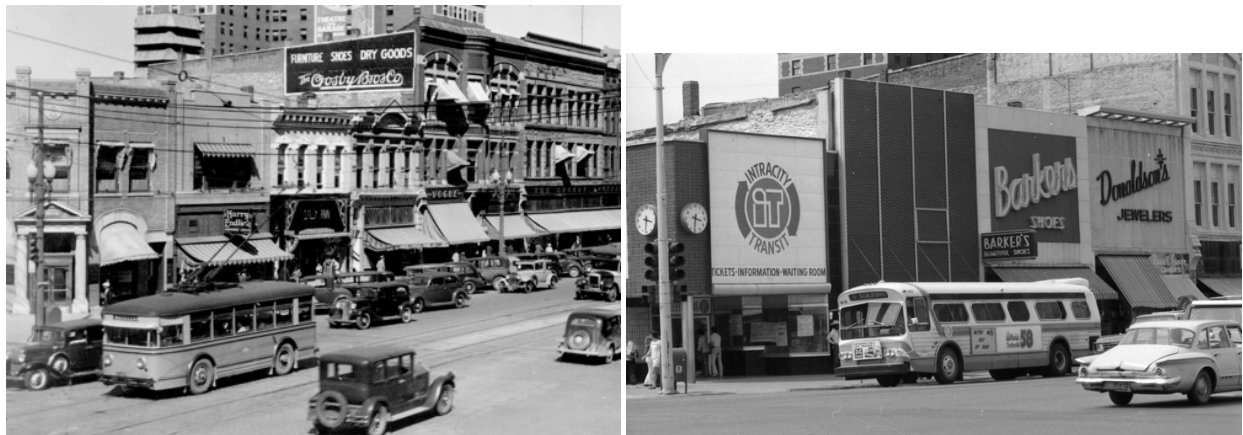
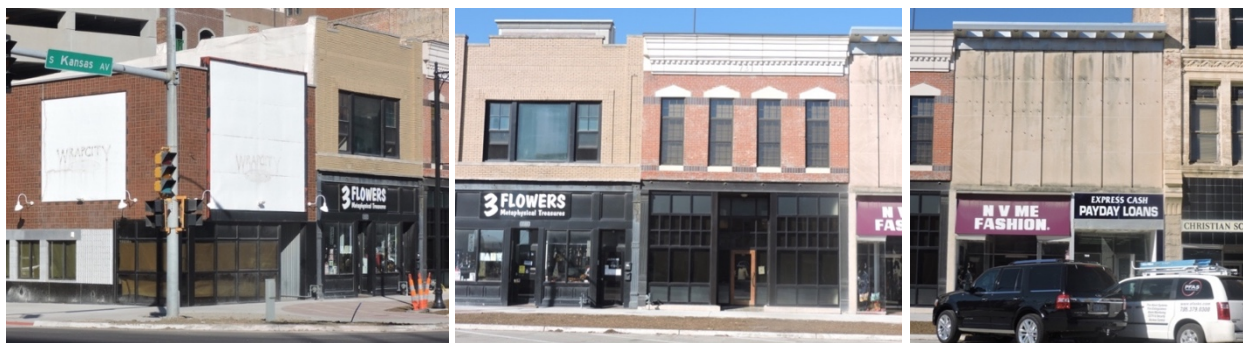
Façade alterations to 735, 733, 731, & 729 South Kansas Avenue between 1935 (left) and 1980 (right). (KHS Kansas Memory)

Today, the façade coverings have been removed from two of the buildings (731 and 733) and their upper level historic facades restored. Historic detailing has been lost from 731, however. The sign letters have been removed from the two others (729 and 735).

The four two-story buildings at 729-735 South Kansas Avenue, shown below, exemplify this modern development. In the photograph from 1935, the four buildings can be seen retaining their late nineteenth (729, 731, and 735) and early twentieth century (733) character. In the photograph from 1980, 735 at the corner of 8th and South Kansas Avenue has been demolished and a new building constructed with a two-story façade sign. The other three historic buildings have been covered with modern materials effectively making them two-story signs as well. Their storefronts at the street level have also been fully modernized.

Today, the façade coverings at 733 and 731 have been removed.

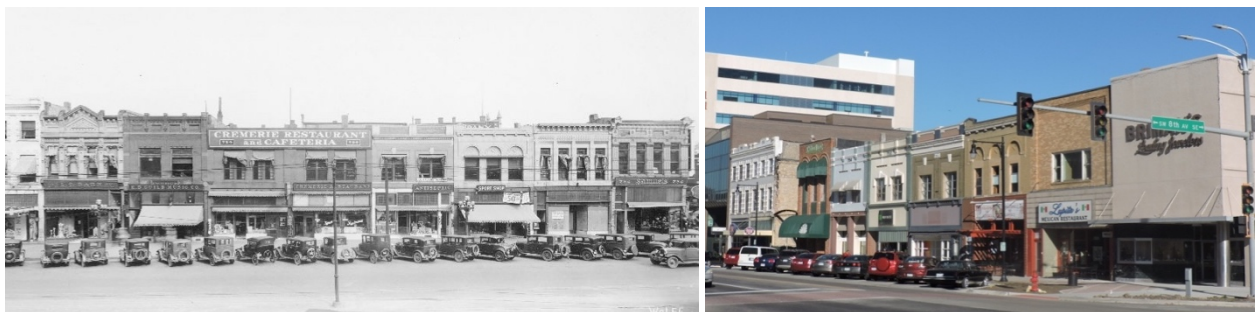
Façade rhythm of the historic streetscape – c.1930 and today – east side of the 700 block

- Retain features and characteristics of the historic streetscape, especially the rhythm of early facades and lot lines. Preserve buildings that reflect this rhythm.
- Minimize the combining of lots.
- Use the historic rhythm of facades as a possible design feature in new construction, helping new buildings to reflect the historic pattern of the streetscape.
- Identify and preserve historic materials and features from earlier periods of a building's evolution, especially exterior limestone walls.

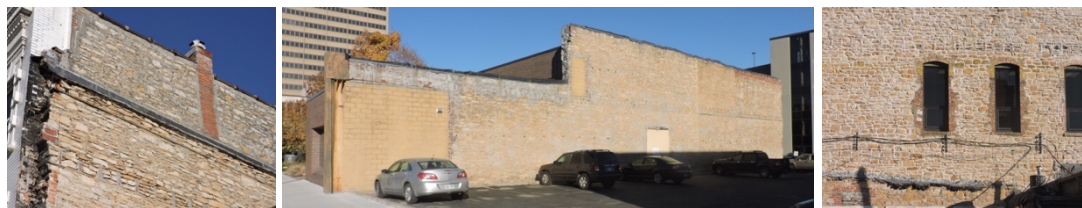
Remnant nineteenth century limestone walls

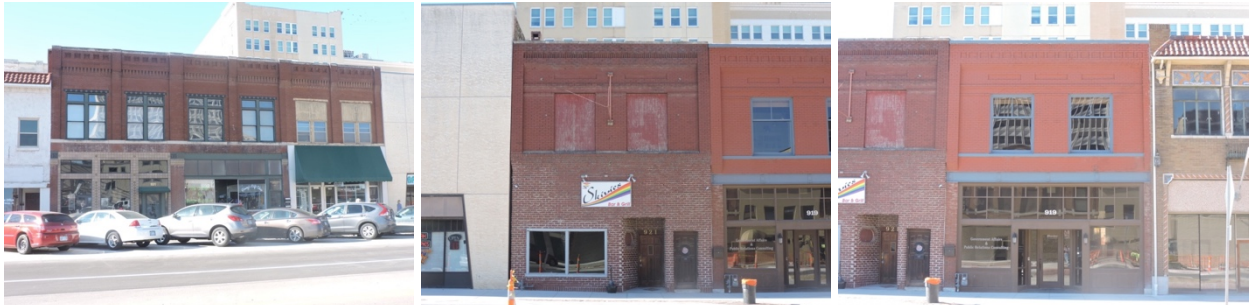
Three buildings in the 900 block of South Kansas Avenue that retain their overall nineteenth century character though their storefronts are later changes. The storefront of 921 South Kansas Avenue (center) is inappropriate and should be removed and a new, more appropriate storefront designed.

- Preserve character-defining features and historic building fabric remaining in smaller late nineteenth century buildings within the historic district. Primarily, these features and fabric are present on the upper story portions of streetscape facades as well as in the surrounds of later storefronts.
- Preserve and rehabilitate storefronts from later periods that have been installed and are themselves significant building elements.
- Remove storefronts that are inappropriate to the building and do not contribute to the streetscape. Install new contemporary storefronts that are compatible with the overall character of the building.

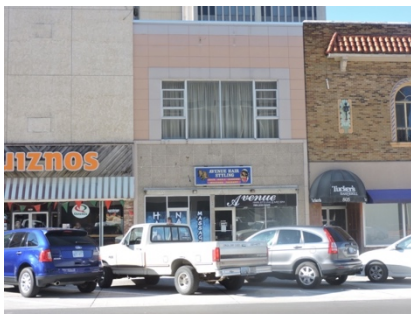
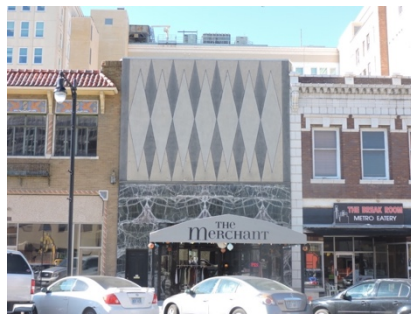
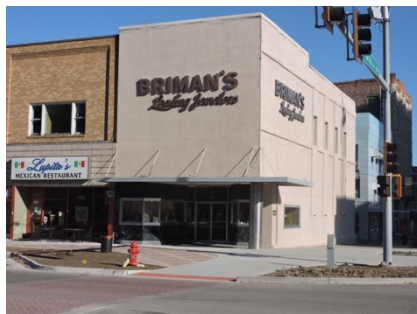
807 South Kansas Avenue (alt. c1950), 913 South Kansas Avenue (alt. c1960), 734 South Kansas Avenue (alt. 1964)

- **Determine whether mid-century façade alterations contribute to the character of the streetscape and should be preserved.**
- **Should it be desired to remove a façade covering, first determine the condition of the older façade beneath it and whether the older façade can be repaired.**
- **Appropriately treat façade materials – some mid-century facades used unique materials that are difficult to repair or replace.**
- **Encourage the use of state rehabilitation tax credits for retail modifications.**

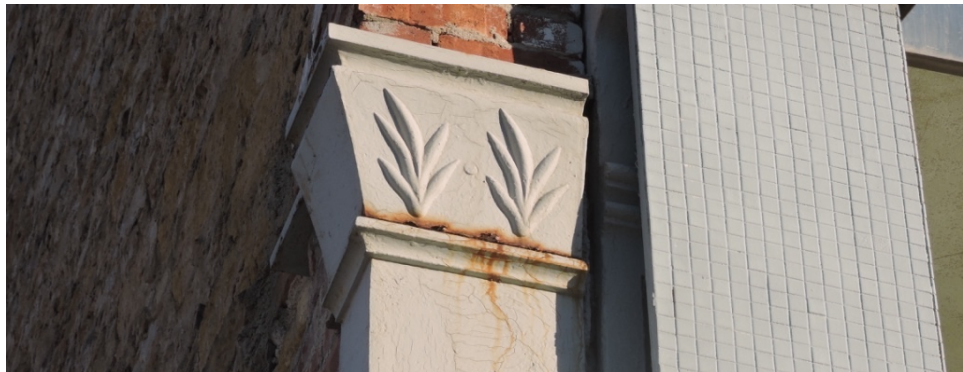
Remnant nineteenth century cast iron column encased by a later 1960s facade

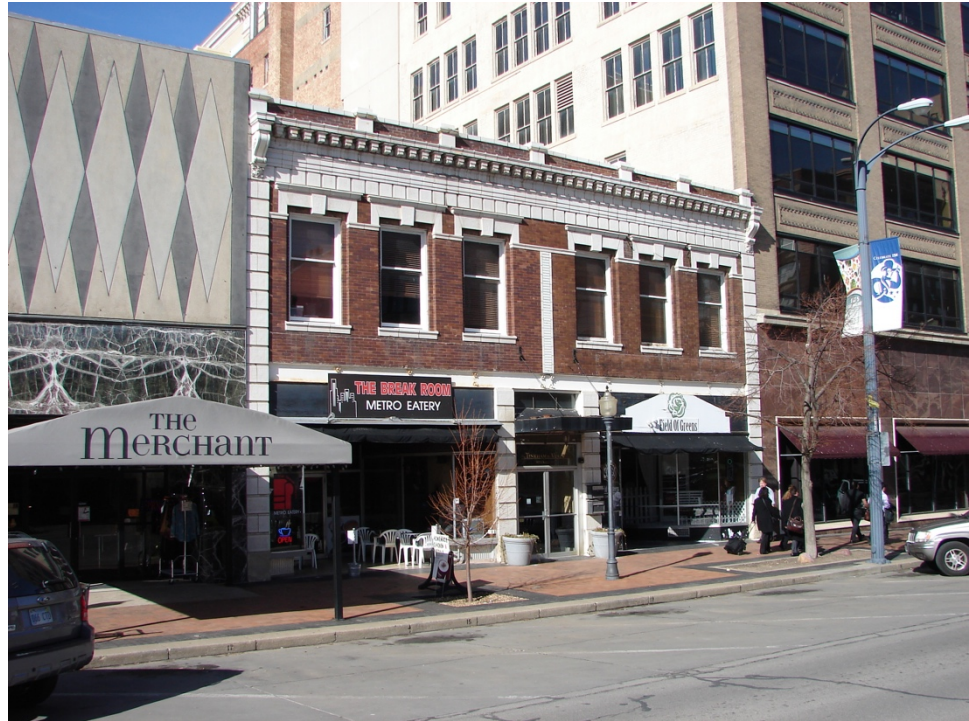
The Veale Building (909-911 South Kansas Avenue) was rehabilitated in 2003 using the Secretary of the Interior's Standards.

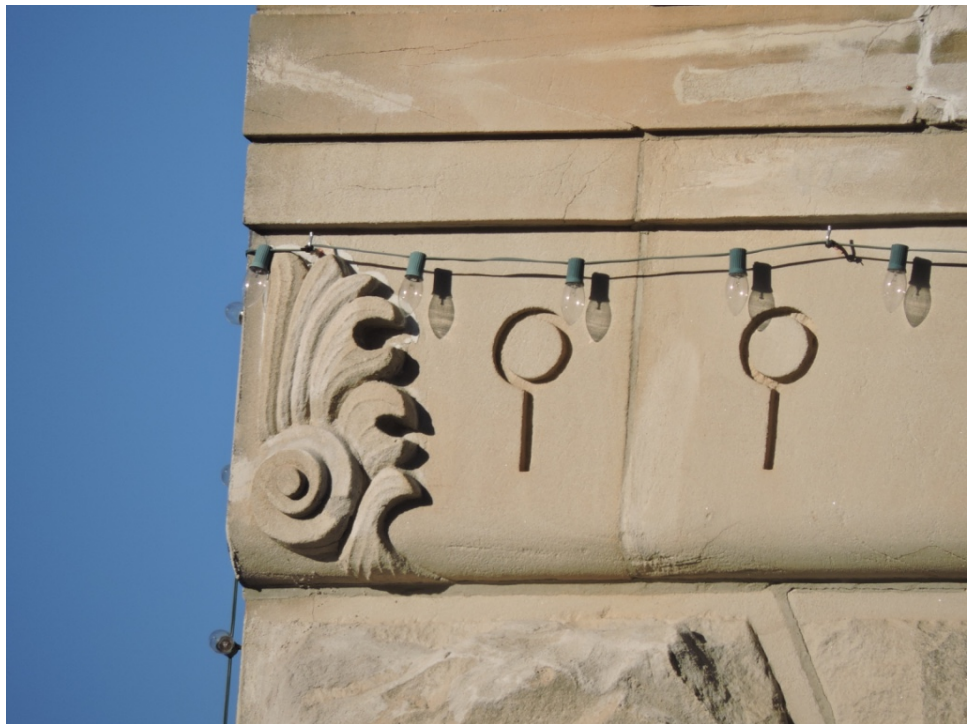
High-quality nineteenth century stonework that has undergone repair

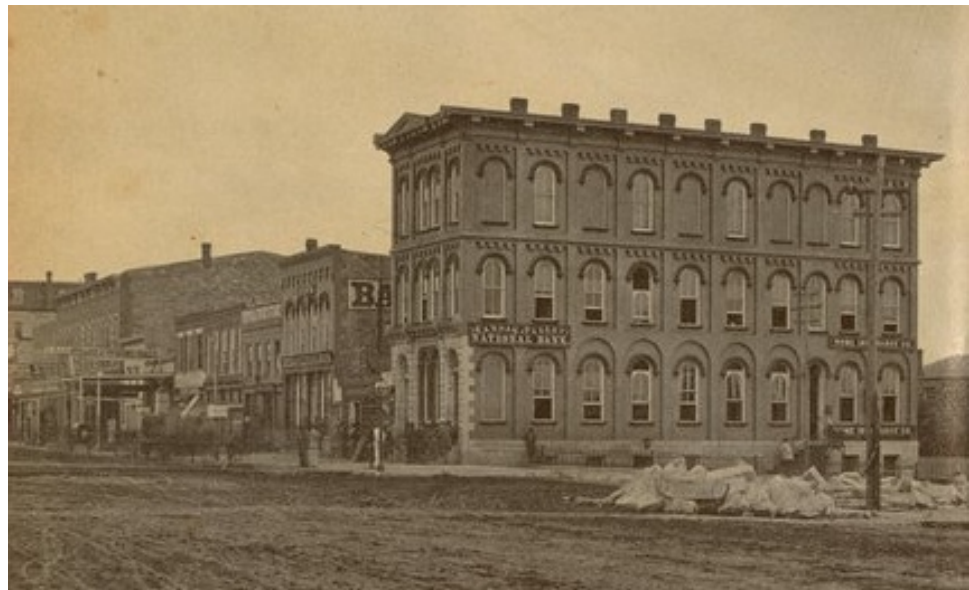
Detail of a 1870-75 photograph of the southwest corner of Kansas Avenue and 6th Street (KHS Kansas Memory)

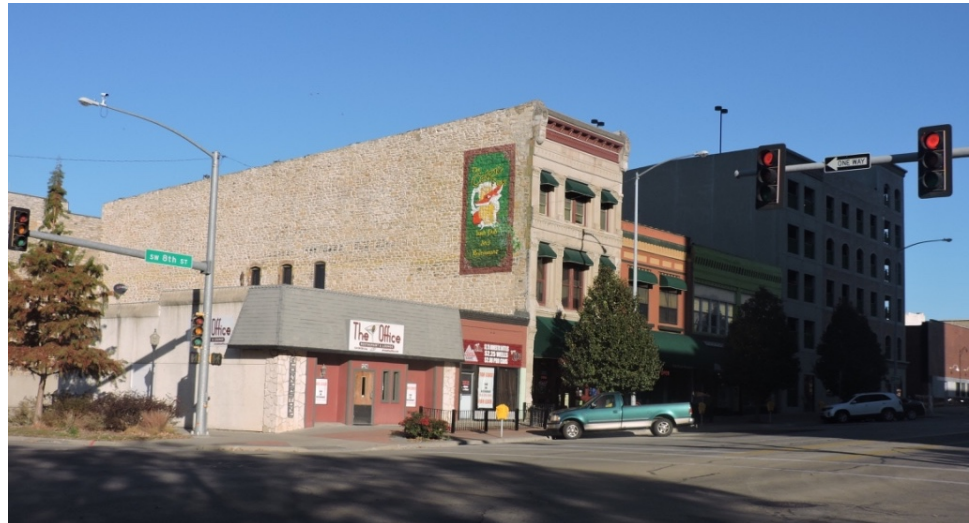
The roofs of most early historic commercial buildings in Downtown Topeka slope from front to back.

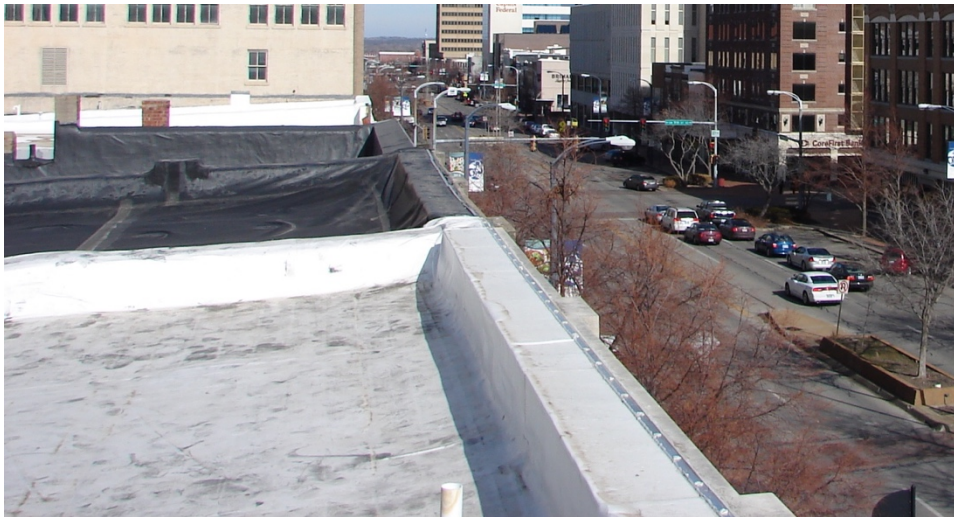
Rubber membrane is the most common form of contemporary roofing for flat or gently sloping roofs not visible from the street. The membrane adapts to the form of the roof and is secured to the top of the parapet wall with a metal bar and waterproof seal.

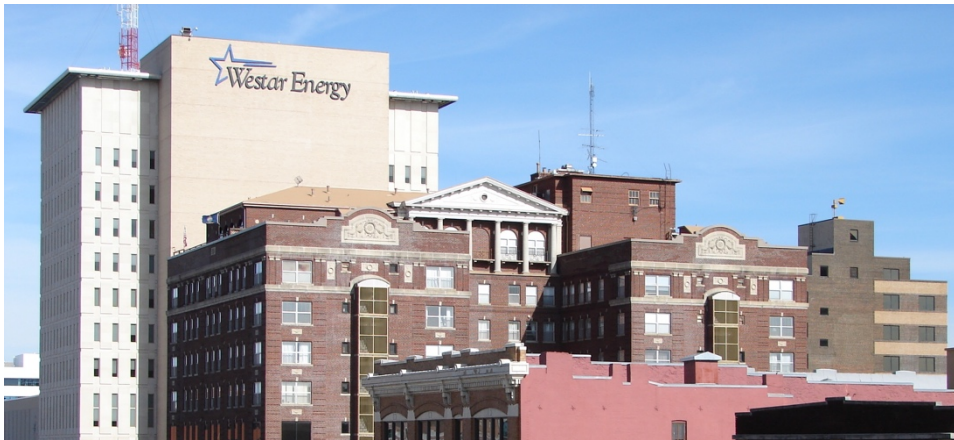
Rooftop structures and attachments are visible on several of Topeka's taller buildings.

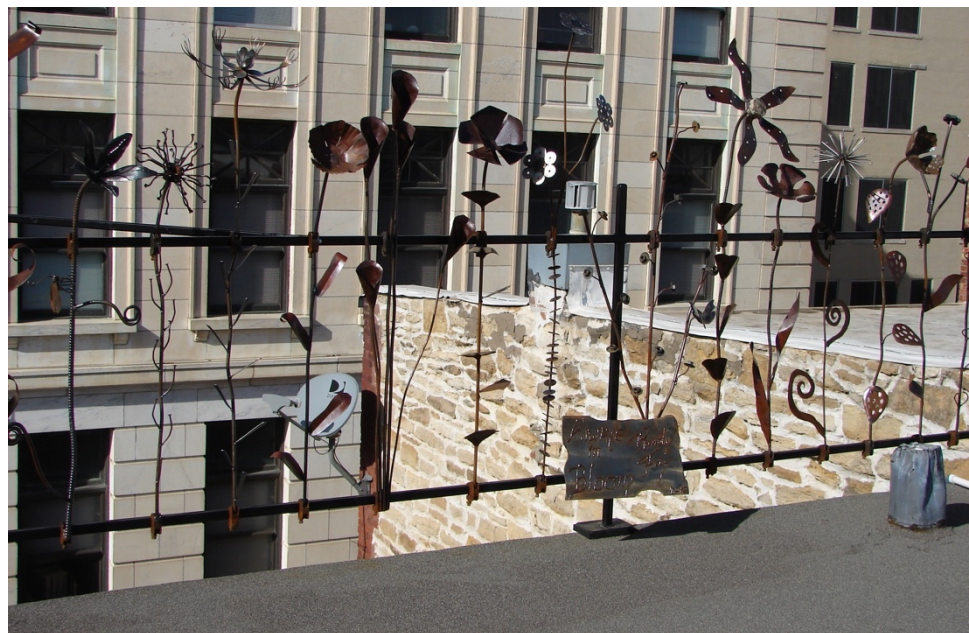
Artistic railing installed along the rear edge of a roof used as a terrace.

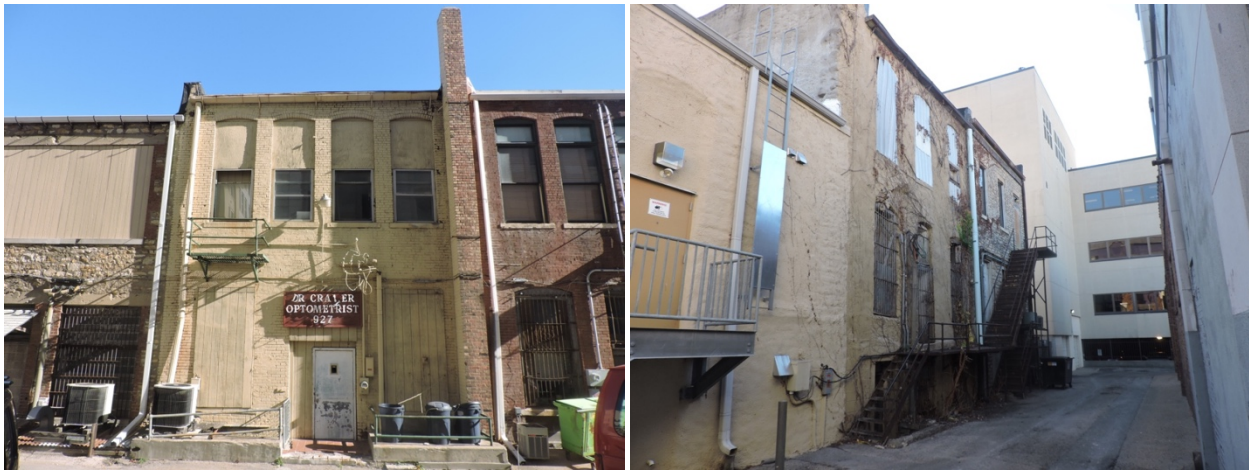
Exterior gutters and downspouts on the rear facades of historic buildings.

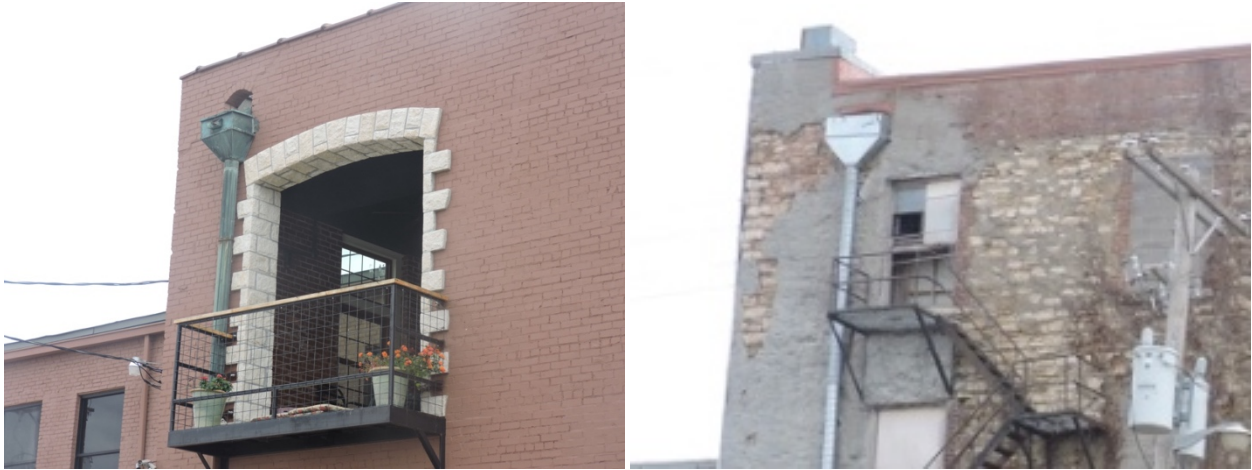
Through-wall metal scuppers and downspouts at the rear of two larger buildings. The decorative copper scupper on the left is a contributing historic feature. The rough modern metal scupper on the right is not; its downspout is probably undersized for the area of the roof it serves.

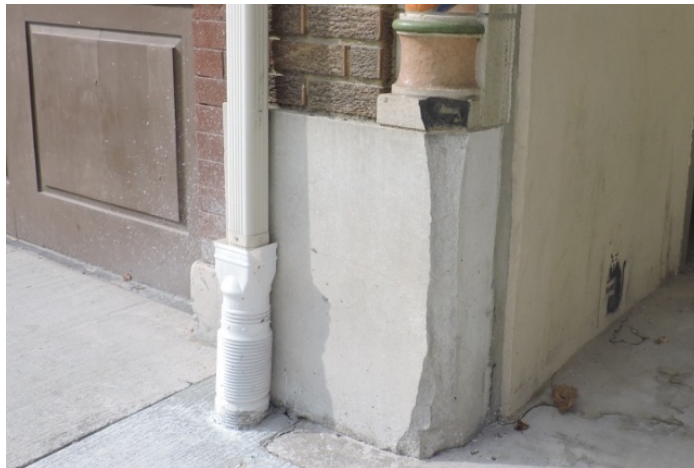
Gutters and downspouts are rare on the front, primary facades of Downtown Topeka buildings. This one collects water from a pent roof projecting out from the top of the wall. The material choices should have been of higher quality. The downspout should match the color of the brick. The boot should be cast iron, not PVC.

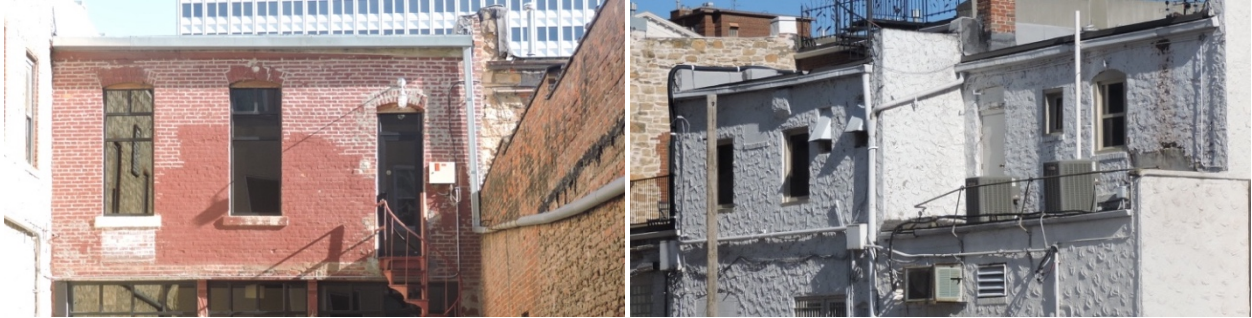
Complex configurations of gutters, downspouts, and roof structures in Topeka's alleyways

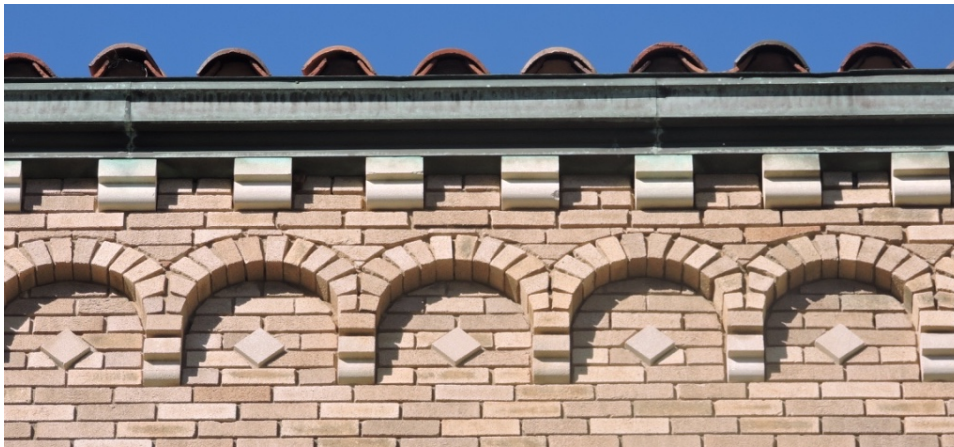
Decorative roof edge with copper gutter

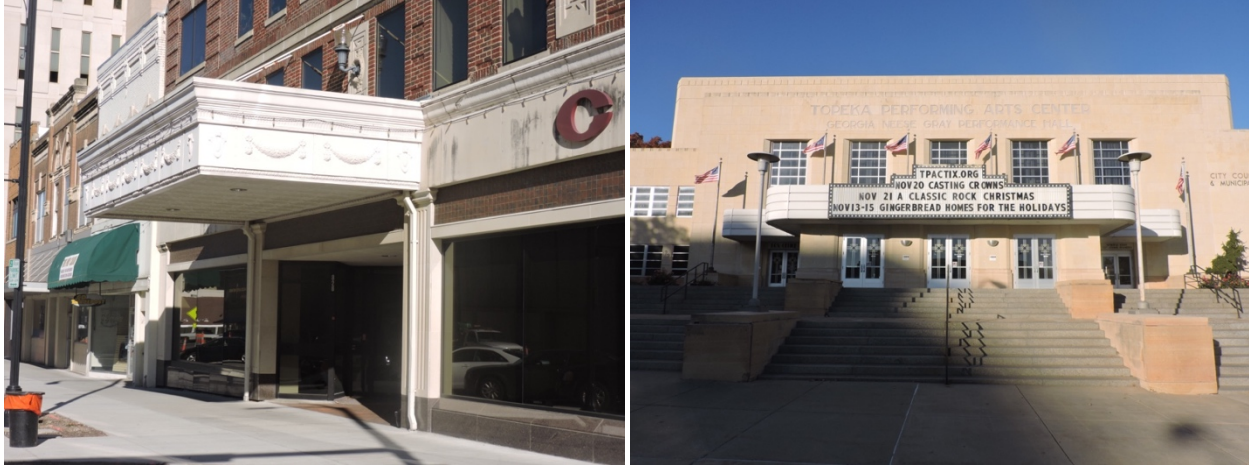
Canopy at the Hotel Kansan; marquee at the Topeka Performing Arts Center

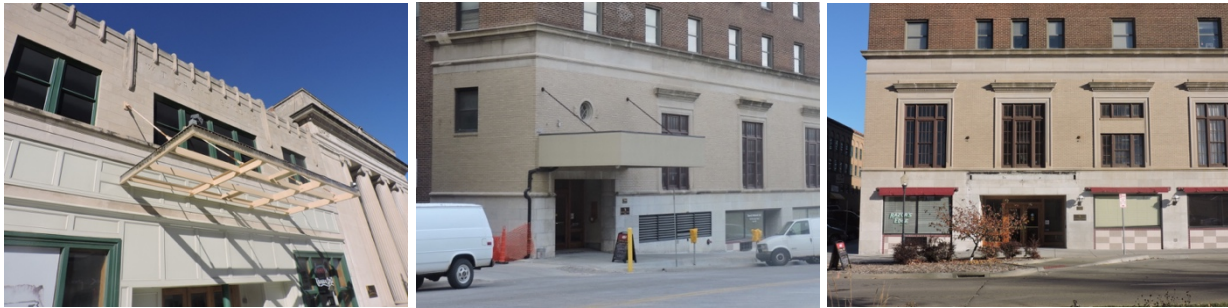
Metal frame of a canopy on Kansas Avenue; modified and missing canopies at the Jayhawk Hotel

Public Safety – Inspect and verify that the structural design and structural components of the canopy are adequate to support its weight and potential snow loads. Assess their structural condition. Pay close attention to the anchors where the canopy supports anchor into the building facade.

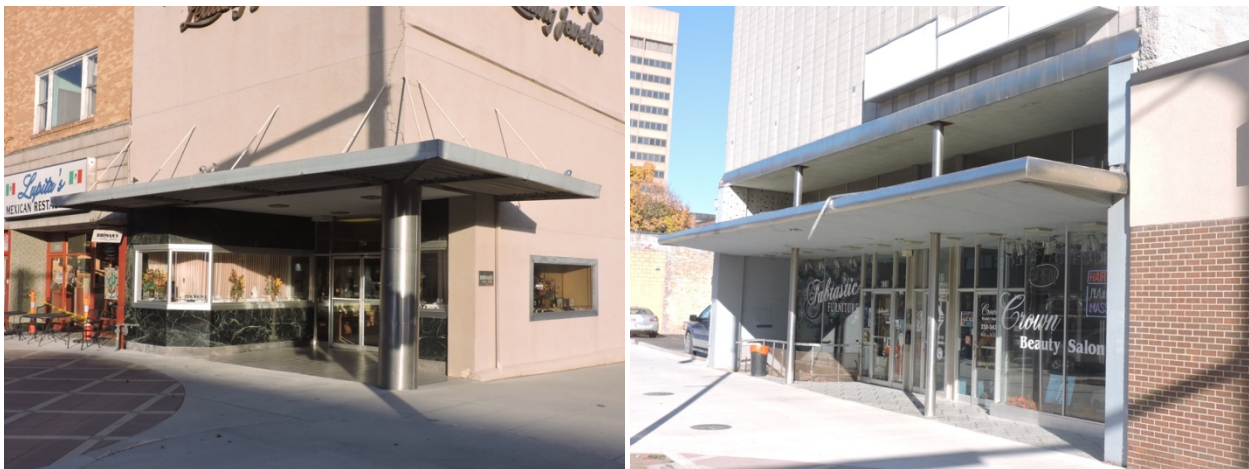
Mid-century Modern aluminum canopies on the east side of Kansas Avenue

- Corrugated **aluminum canopies** from the 1960s have no additional roofing material and should not be re-roofed.
- Ensure that any **water collected** on the roof of the canopy is carried to the street level. Water should not be allowed to overflow onto pedestrians or wash down the façade of the building. Be cognizant of the possibility of unsafe winter ice conditions for pedestrians from downspouts that empty at grade.

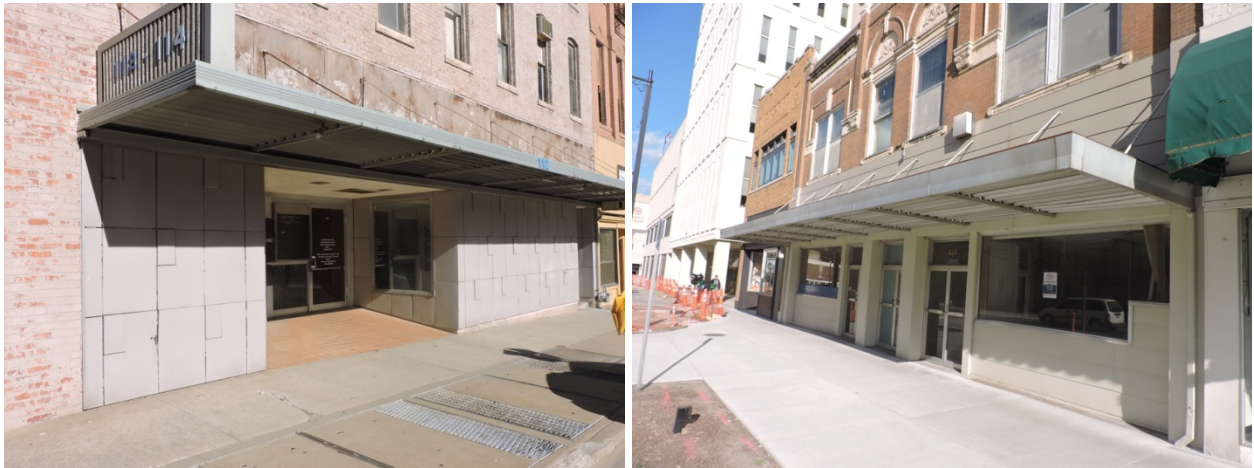
Other Mid-century Modern aluminum canopies

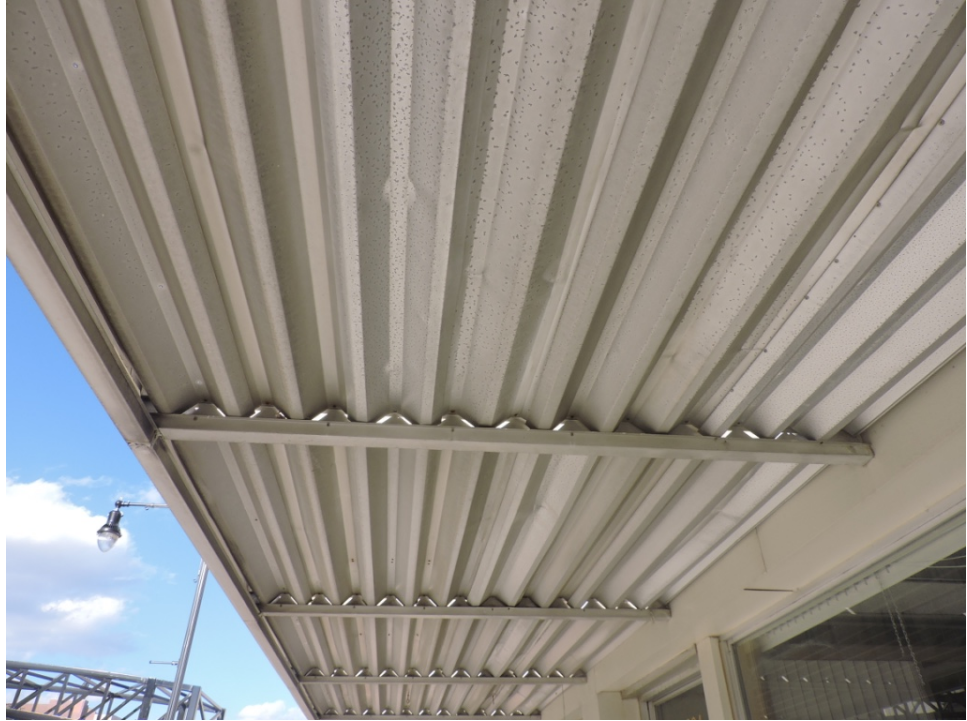
Topeka's corrugated aluminum canopies are of similar design. The corrugated roof directs water to perpendicular channels, which then convey water to the U-shaped gutter along the outer edge. The gutters connect to downspouts on the face of the building at each end. The system has limited capacity and is known to overflow, but the canopies are unique and significant contributing features.

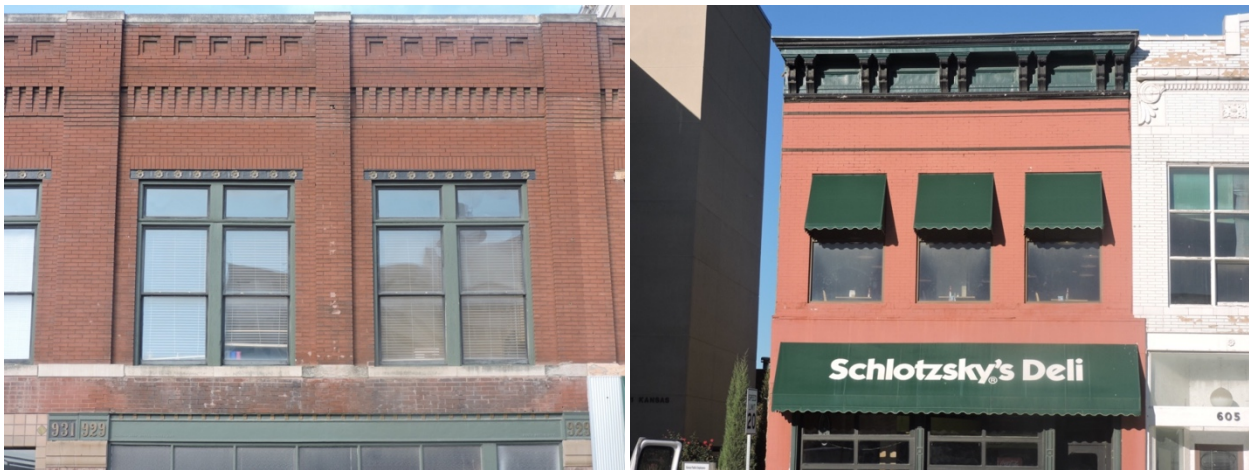
Nineteenth century brick walls used common brick in patterns created largely by variations in surface relief. The overall quality of the brick used was good, with few apparent problems in the deterioration of brick units.

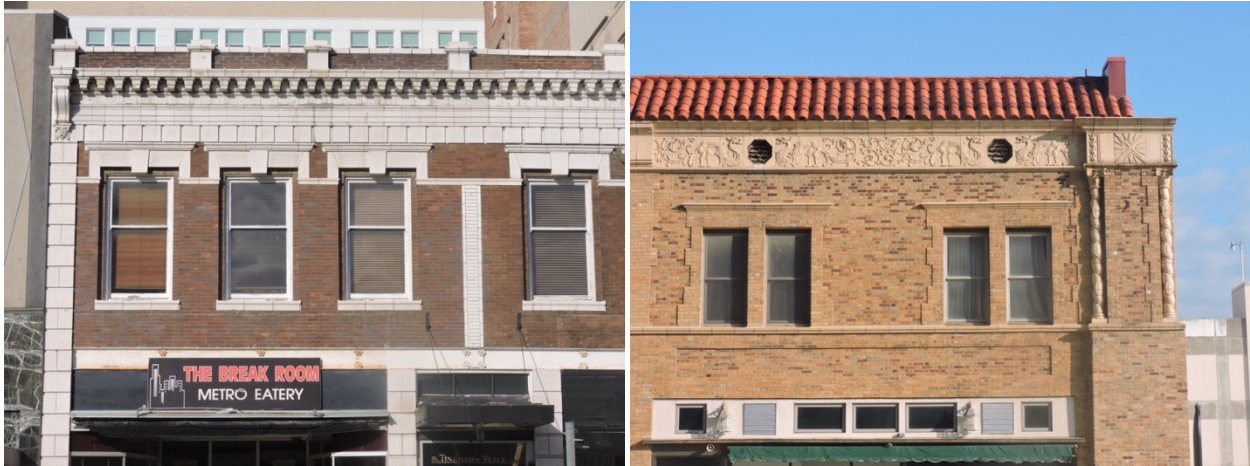
Early twentieth century brick masonry walls introduced more complex combinations of materials, more sophisticated design, and a higher level of technical execution.

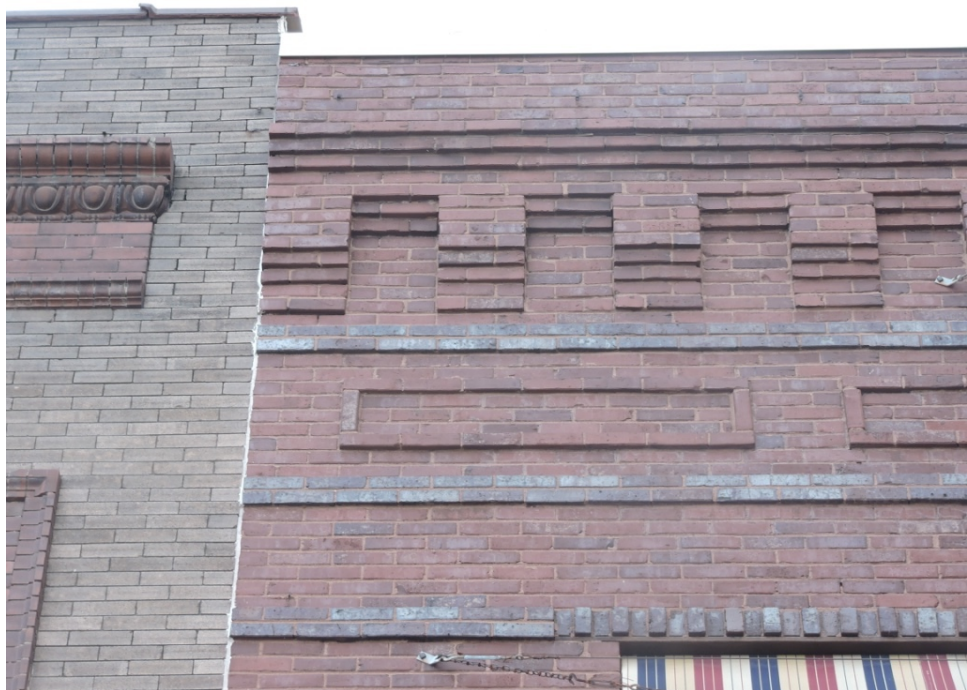
Brickwork in Downtown Topeka buildings is in good overall condition despite conditions such as raised brickwork and projections that could cause problems.

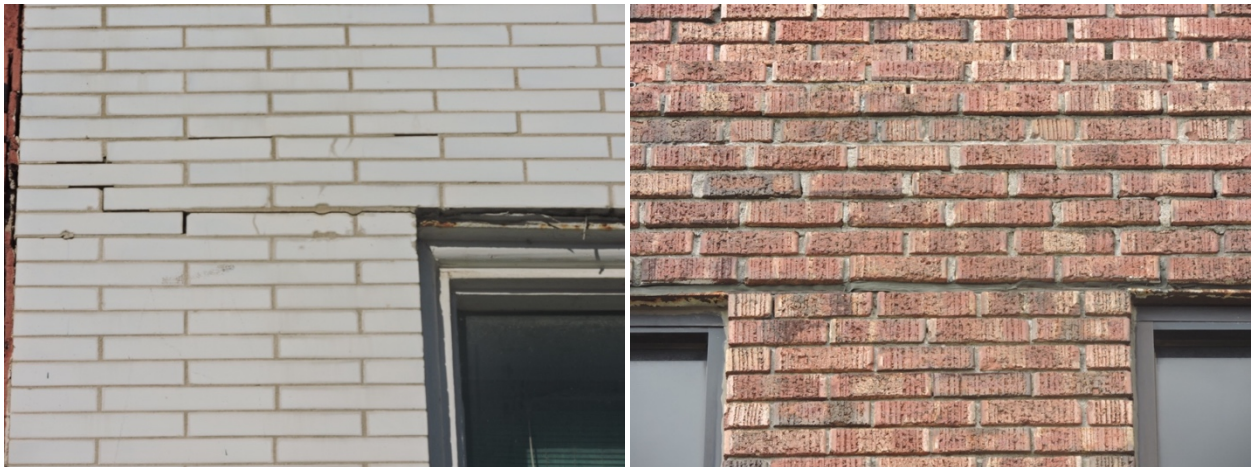
The jacking of rusted steel lintels is a common masonry problem. A significant crack due to jacking can be seen extending from the corner of the window in the picture on the left. On the right, the entire joint between the two windows has widened due to rusting and has been filled with sealant, which only traps the water in the wall.

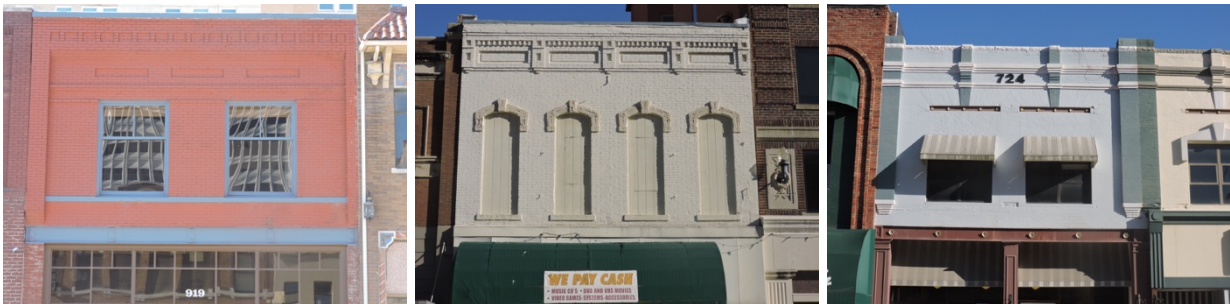
Brickwork should not be painted unless there are deficiencies in the quality of the bricks that are causing them to deteriorate, and a painted coating is needed for their protection.

Painted Coatings – Do not apply painted coatings or stucco to masonry buildings as a substitute for repointing and general maintenance. Such treatments may ultimately trap moisture within the walls and should be used only as a last resort in instances where maintenance and masonry repairs have not succeeded in limiting water penetration.

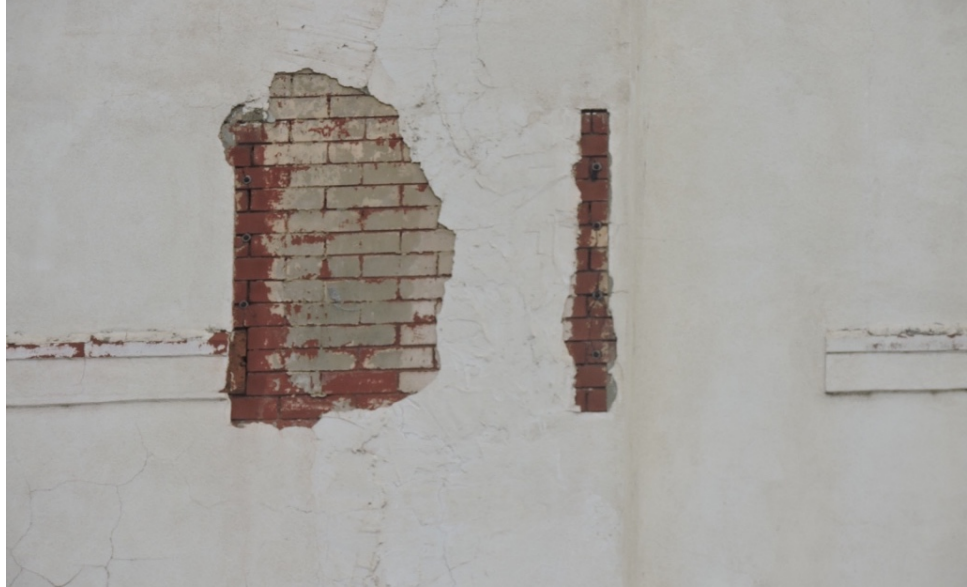
This brick wall was coated in paint and then a thin layer of parging/stucco, both of which are now failing due to the moisture trapped in the wall beneath which is causing them to peel off.

- Do not apply **waterproof materials, synthetic stuccos, or insulation** to exterior masonry walls. The walls of masonry buildings must be allowed to breathe by allowing water vapor from the building interior to migrate through the wall and evaporate to the exterior.
- Masonry walls can only be insulated from the **interior** with proper vapor barriers as in new construction (see below).

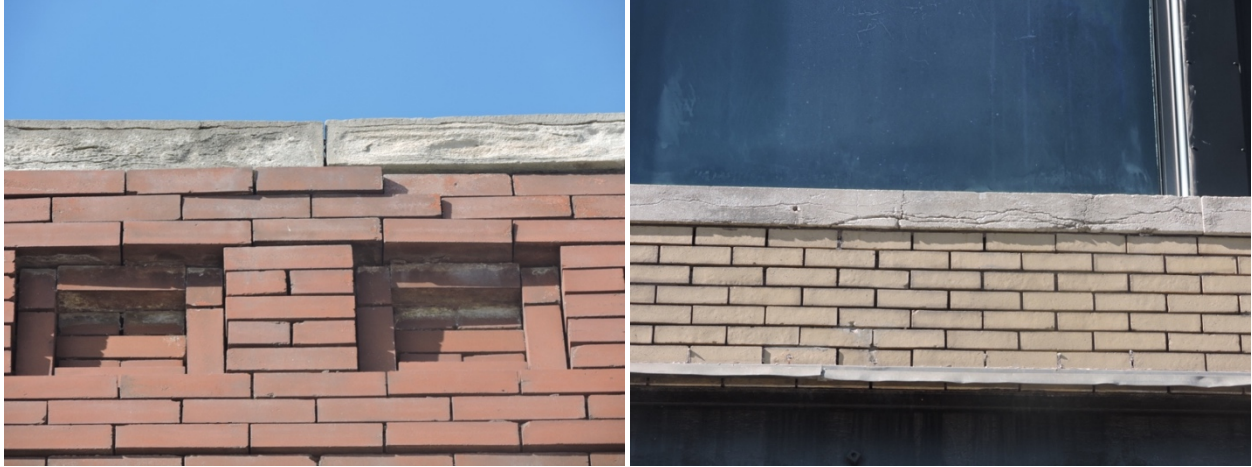
Open joints, dislocated bricks, and deteriorated stone in the walls of two Topeka buildings. The wall on the left is a building parapet; parapets are particularly vulnerable because of their exposure and difficulty to observe.

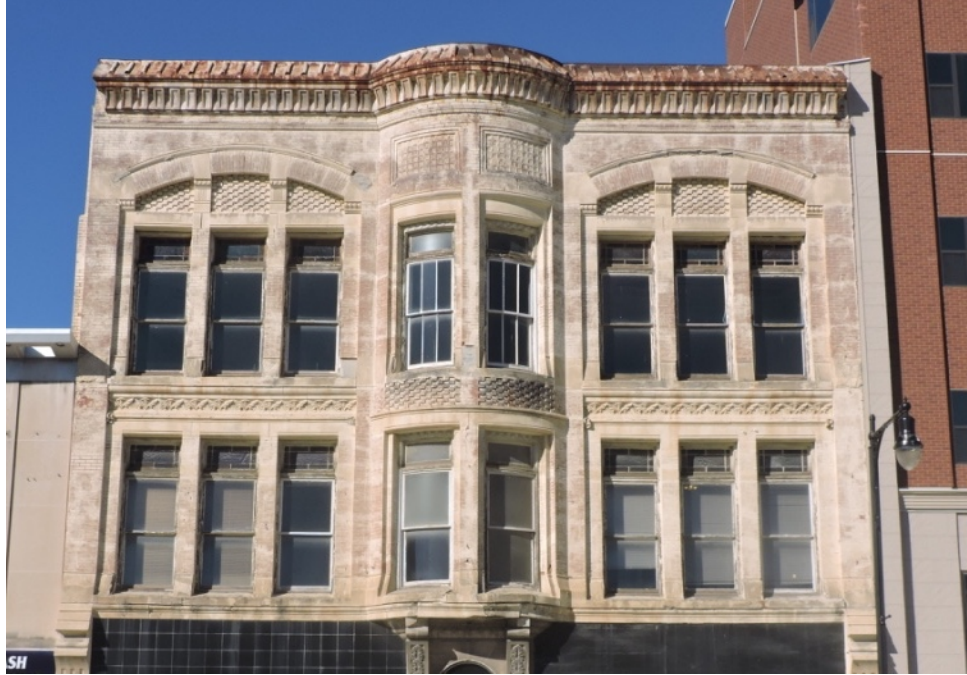
Topeka's late-nineteenth century buildings are particularly significant and vulnerable. The Davies Building, shown here, combines both brick and stone masonry with complex detailing. The bearing wall construction quality of the period was in transition.

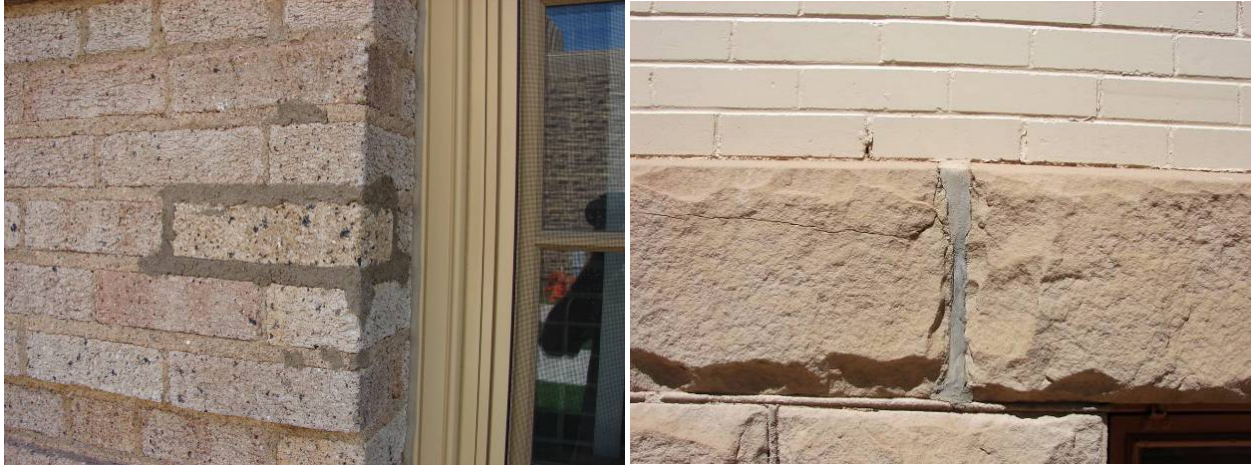
Inappropriate modern mortar used for pointing both brick and stone walls. In addition to not matching the historic mortar joints visually, the hard modern mortar can physically damage the brick or stone.

- Match repointing mortar to the **strength of the existing mortar** of the historic building.
- For nineteenth and early twentieth century historic buildings, use a soft mortar with a **high lime and sand content**.

- If possible, have a **mortar analysis** undertaken of a sample of the historic mortar to determine its composition. Such an analysis can be performed by a building conservator for a modest cost. Use the mortar analysis to prepare a custom specification for the new mortar matching the materials and mix proportions of the historic mortar.
