DOWNTOWN TOPEKA

HISTORIC DISTRICT

DESIGN GUIDELINES

City of Topeka, Kansas

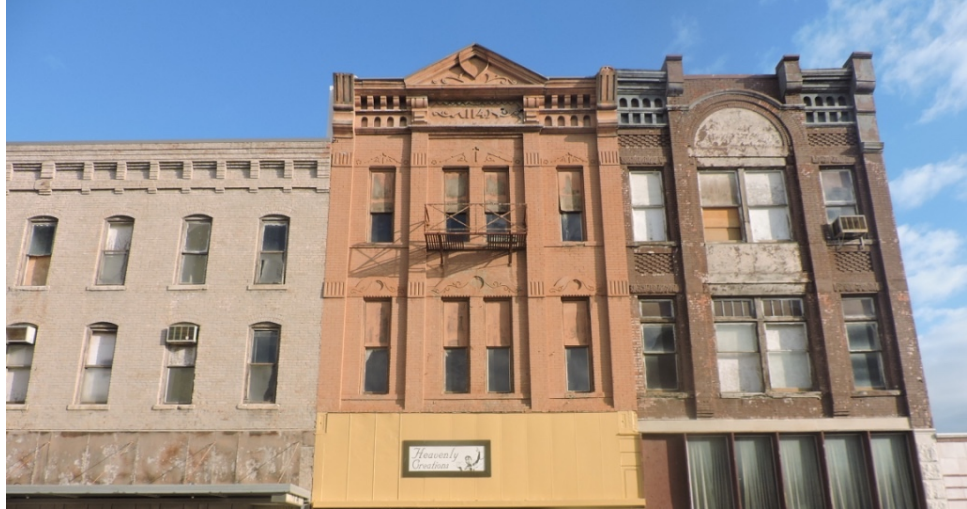
These three late-nineteenth century brick buildings on SE 7th Street are similarly significant and vulnerable. All three have been painted, which is inappropriate but may have helped preserve their brickwork. Proper maintenance would have been better.

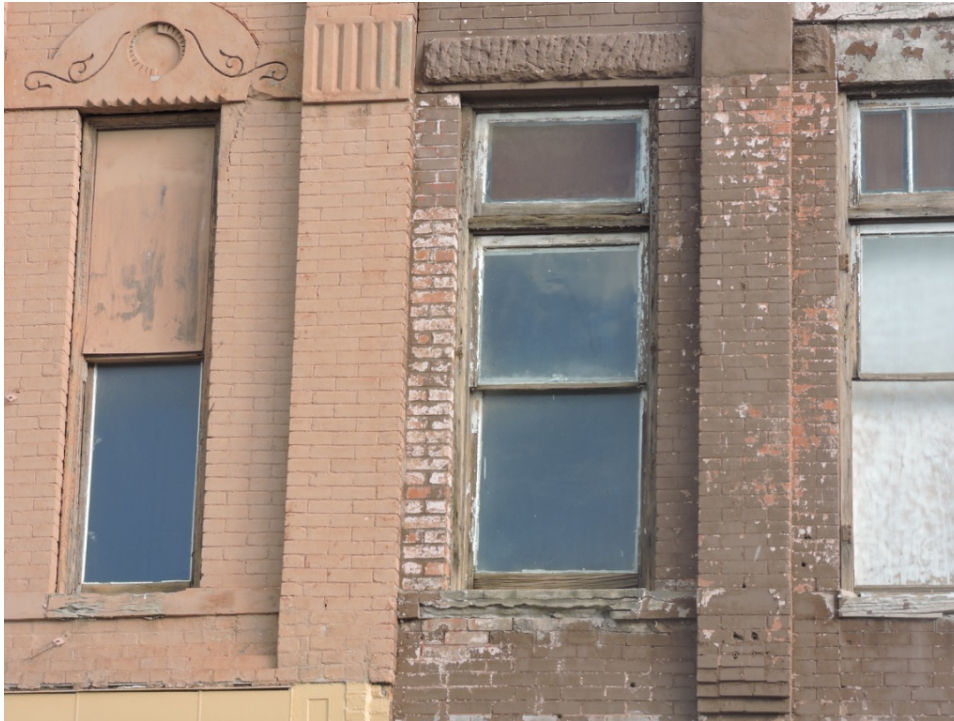
Detail of buildings pictured on the previous page. The brickwork appears to be in relatively good condition despite paint delamination and joint deterioration. Paint will need to be removed and repointing performed, even if they are to be repainted.

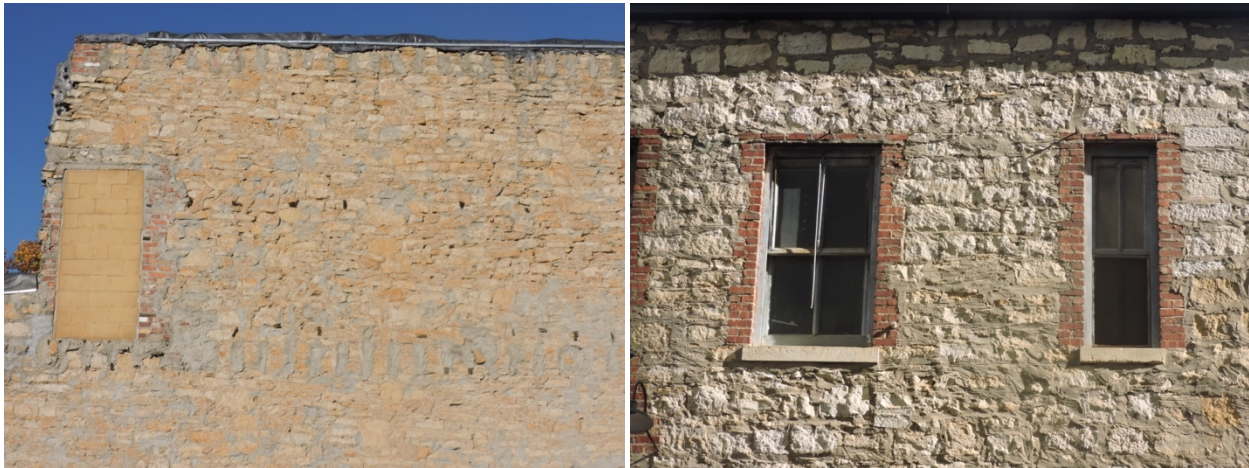
Many of Downtown Topeka's exposed limestone rubble side and rear walls have open joints and have been dashed with modern mortar. The side walls were not meant to be exposed, but are rich in character. The modern mortar is not appropriate in texture or color and may be excessively hard and inflexible.

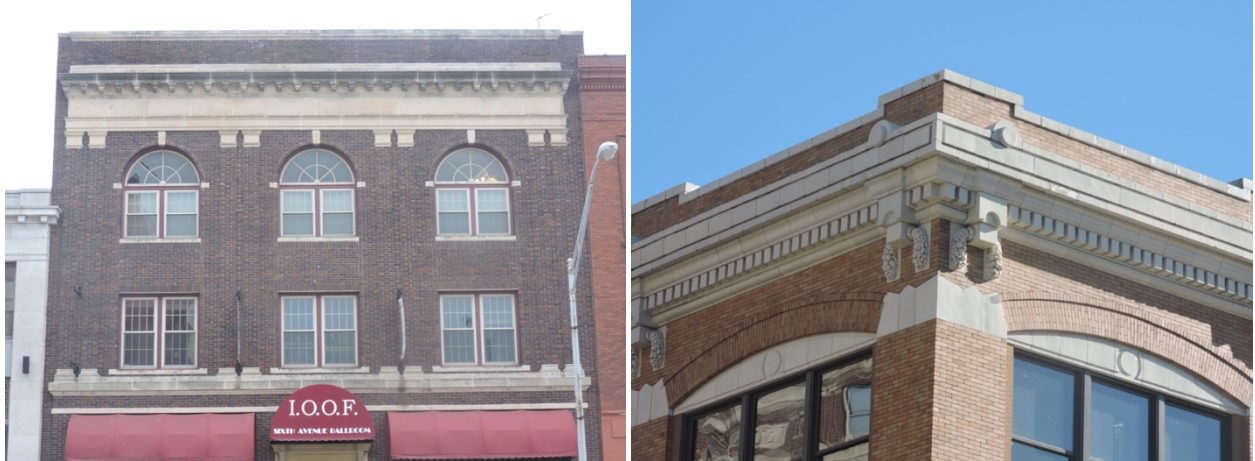
The early twentieth century saw the use of high quality stone detailing.

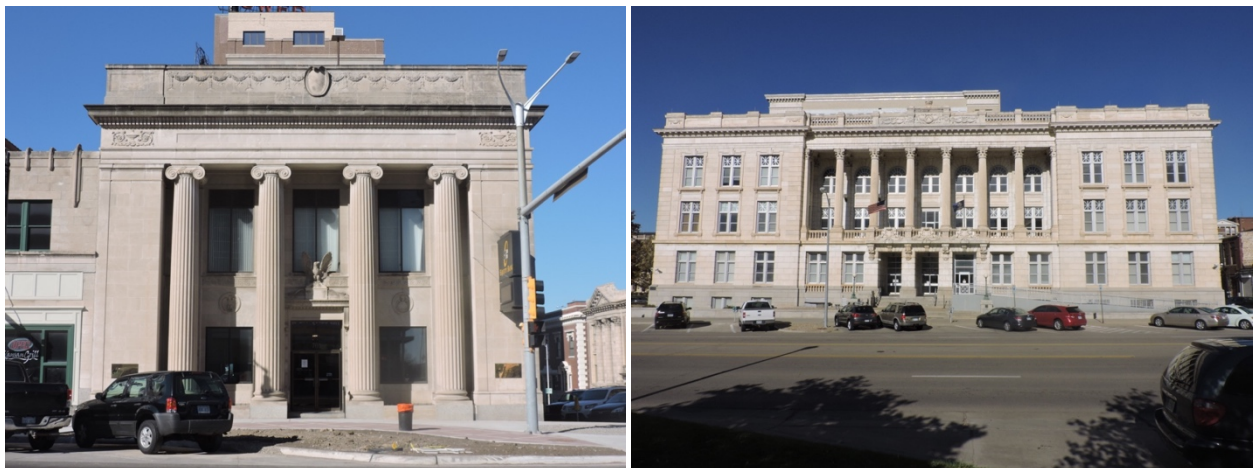
High quality stone veneer was used for several of Topeka's most prominent downtown buildings.

It is important to note that many later buildings that appear to be constructed of stone actually have only a thin veneer of stone that is supported by an interior masonry wall or steel frame. Individual stones are secured to the underlying wall with metal crimps and held in place with vertical pins, instead of being held together by their own weight and the strength of the mortar between them. In this type of construction, the mortar that is visible is merely intended to solidify the wall and prevent water from penetrating the exterior. Even a well-constructed wall is susceptible to water damage, however, because stone is a porous material. Techniques for addressing this damage and other common problems are outlined below.

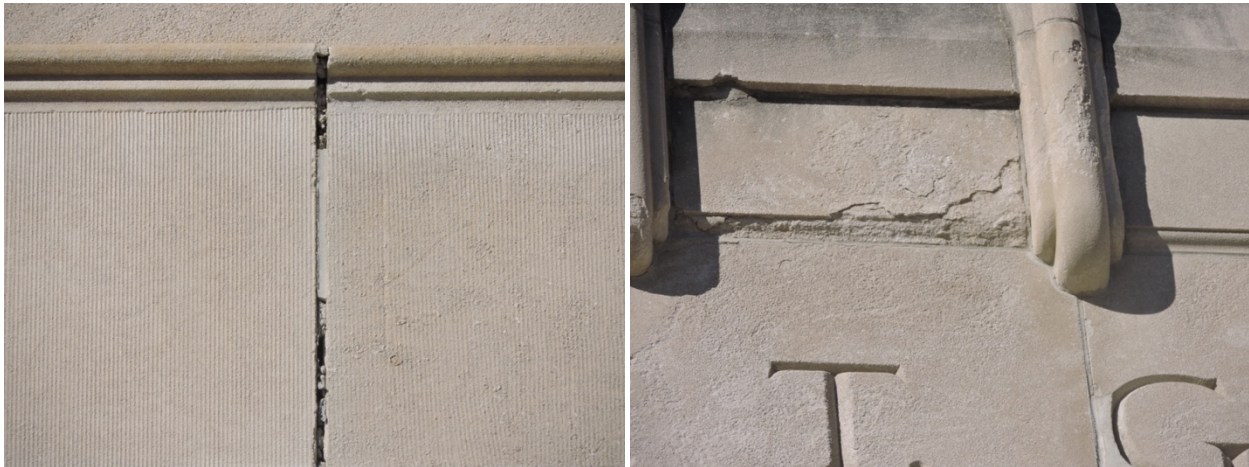
Open mortar joint and surface delamination in stone veneer walls. The open joint should be repointed. The surface delamination may not warrant repair.

Open Joints – When mortar joints fail in a stone wall, they allow water to flow into the wall, creating a chain of events that can weaken the entire wall. Variations in pressure caused by water and ice can cause individual stones to move. Cracking along the mortar joints is one indication that the stones are in motion. In veneer walls, rust stains may indicate that the pins and crimps used to hold the stones together have begun to deteriorate.

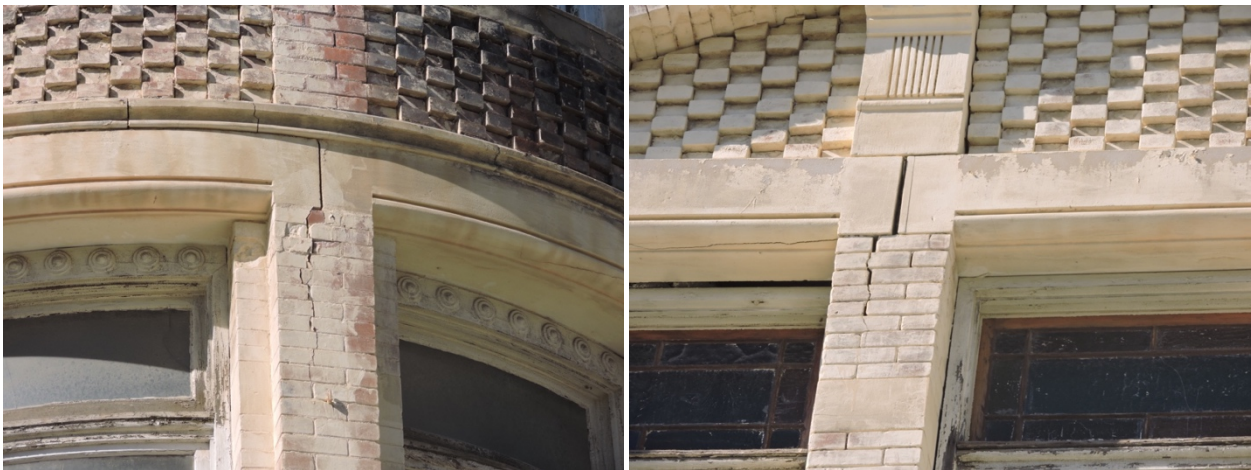
Deep masonry cracks in stone and brick piers at the Davies Building.

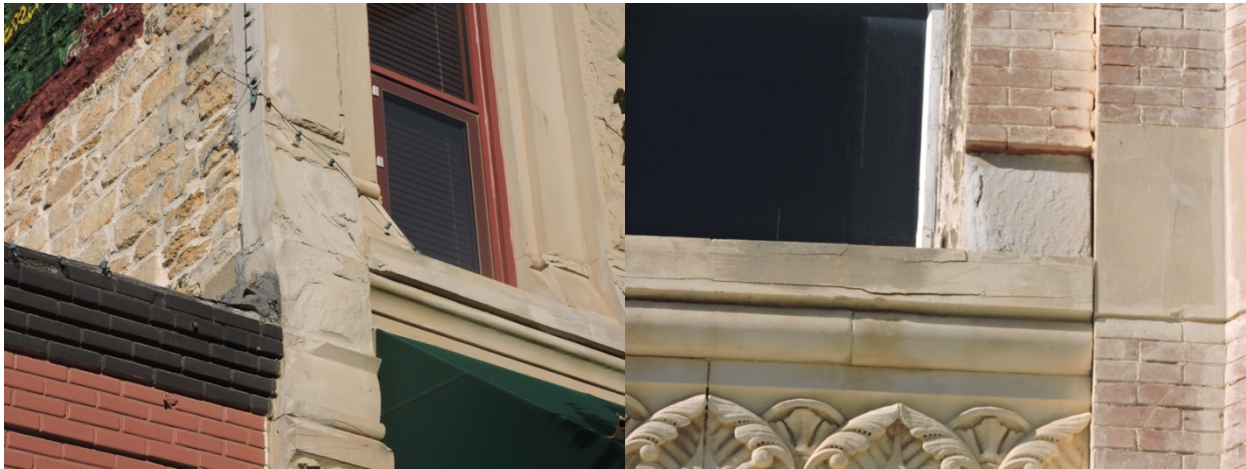
Delamination of a stone pilaster at left; spalling of a stone window detail at right.

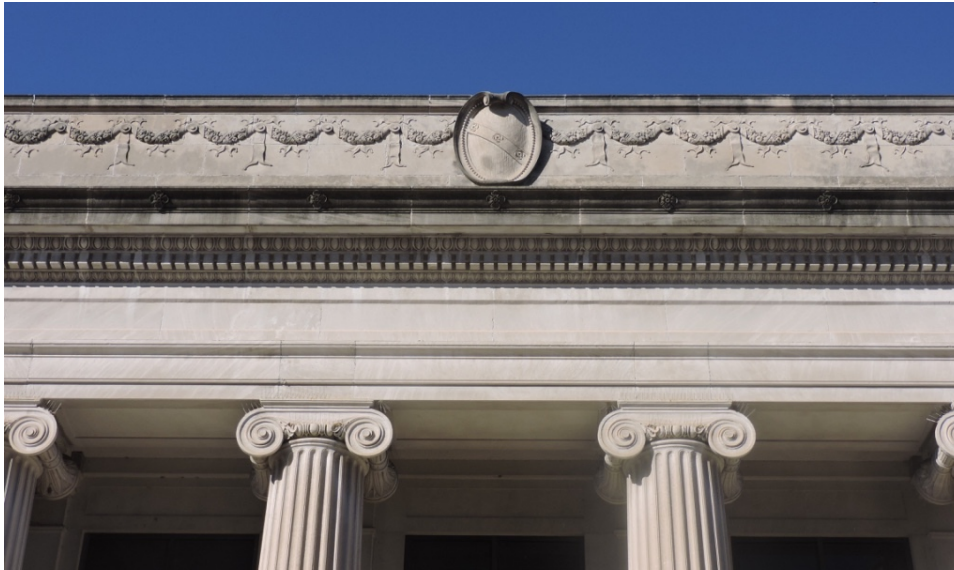
Joints in parapet and the wash surfaces of cornices, watertables, and other stone detailing are particularly vulnerable to water penetration. This cornice is the type of surface that might be subject to cleaning.

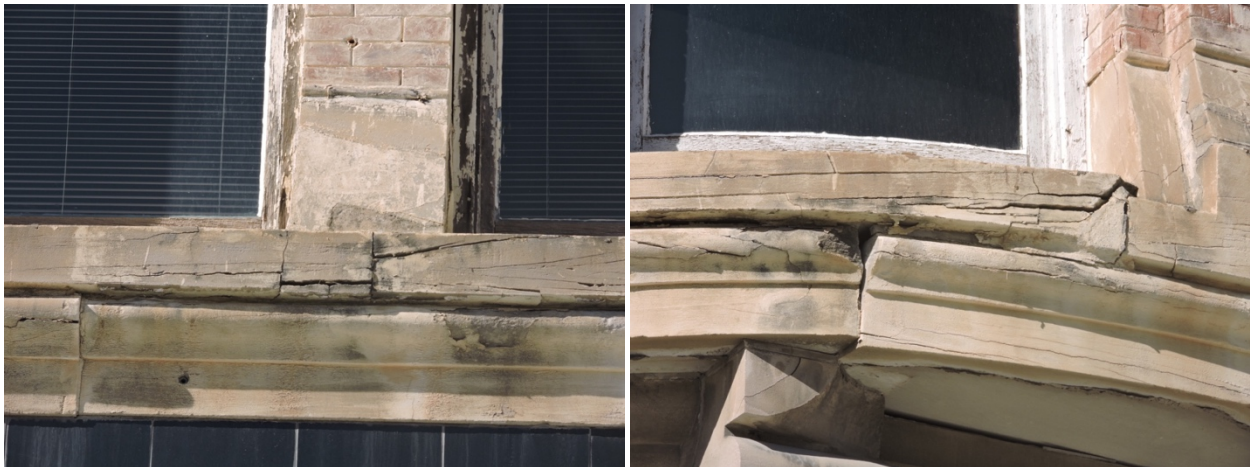
Severe horizontal cracking of stone window sills. These stones may require replacement.

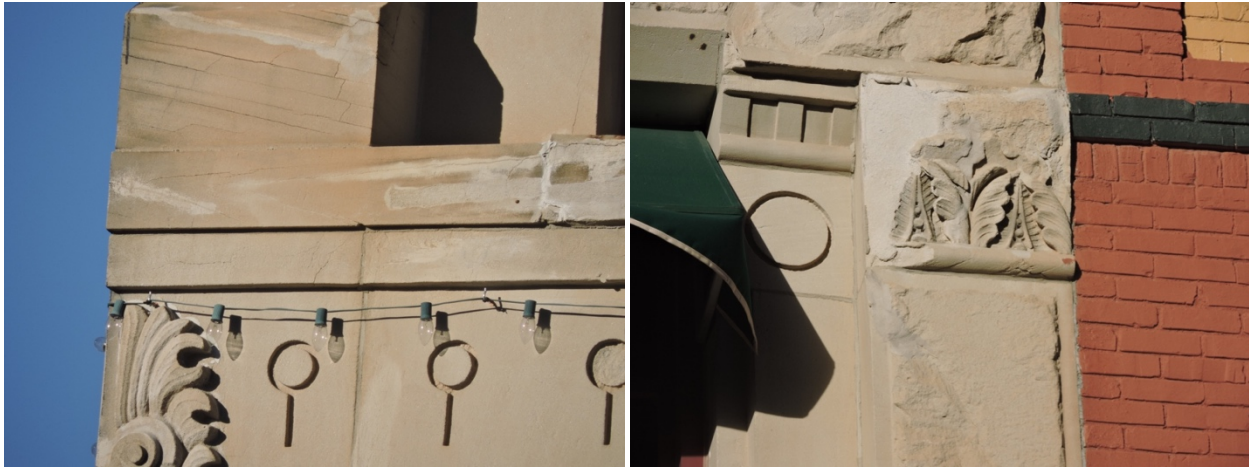
Consolidant used over horizontal cracks in stone at left and roughly over deteriorating stone detailing at right to simply prevent further disintegration.

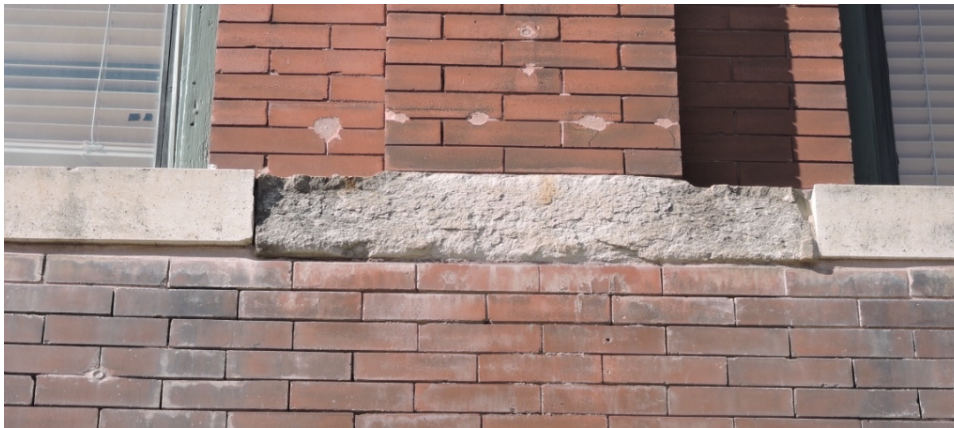
Stone sill that will require replacement.

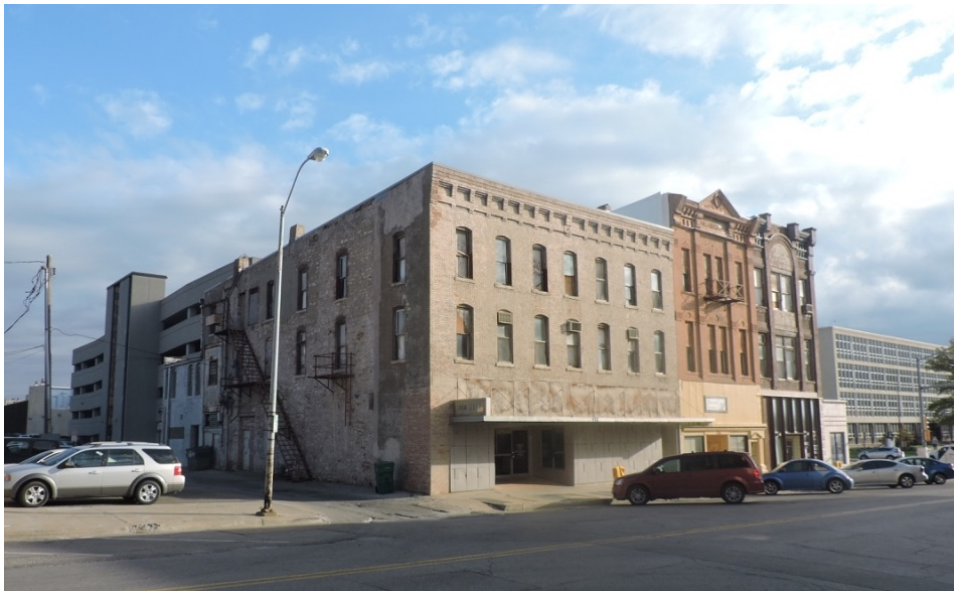
Wood is the primary interior structural materials for Downtown Topeka's nineteenth and early twentieth century buildings.

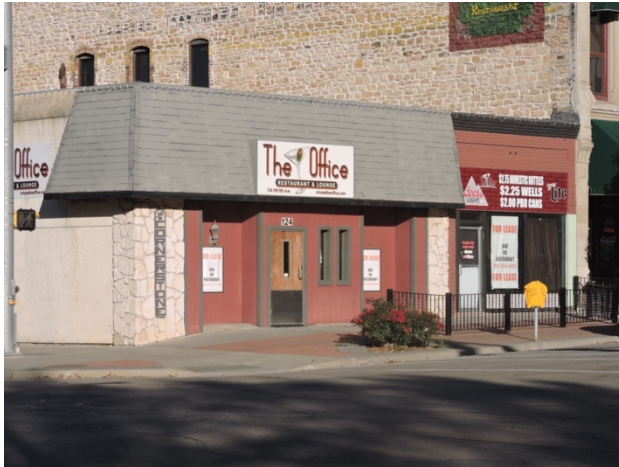
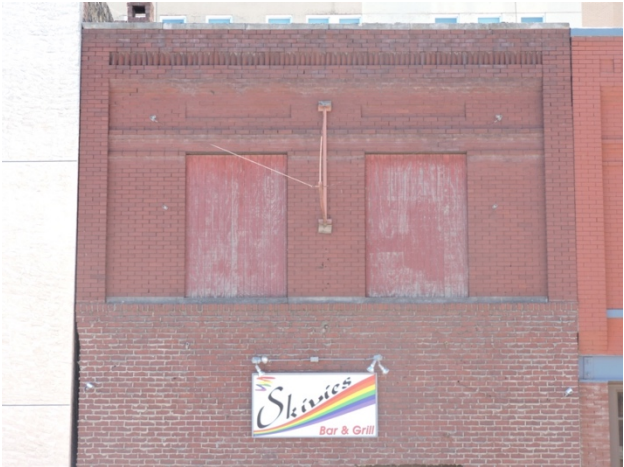
Wood has been used for numerous inappropriate purposes, such as this façade and the closure of windows and storefront transoms.

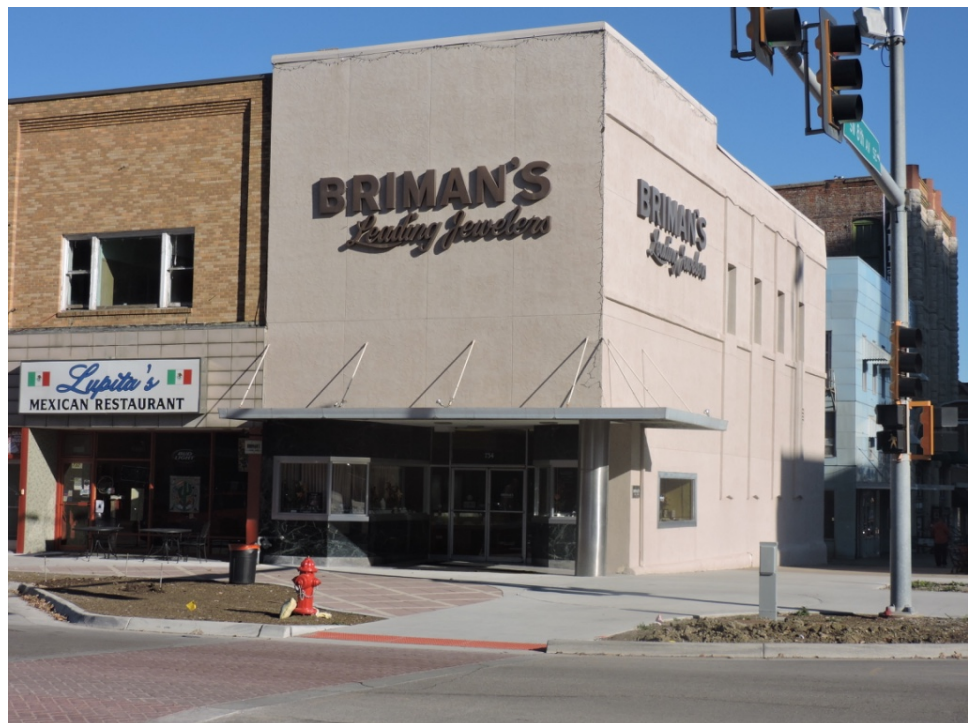
Stucco is a prominent material in several of Downtown Topeka's 1960s renovations.

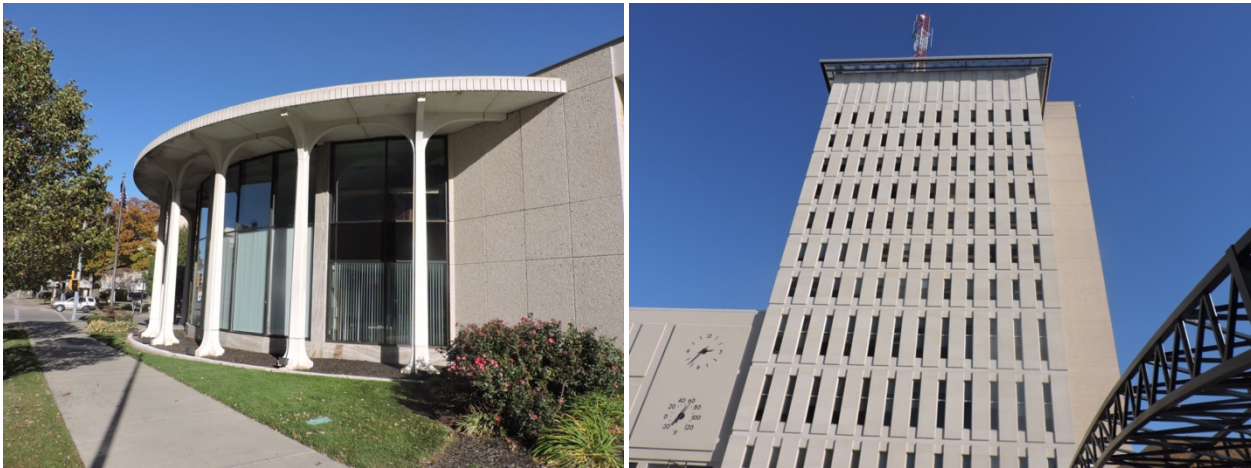
Concrete is featured in most of Downtown Topeka's Mid-century Modern buildings.

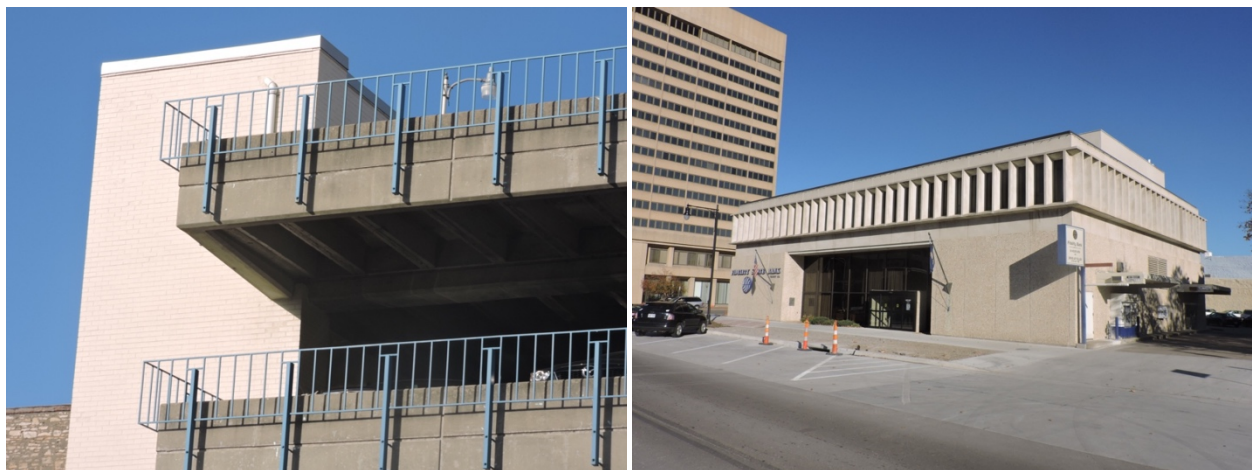
Cast-in-place concrete was used for the floor structure of the parking deck at left; precast concrete panels were used for the exterior of the bank at right.

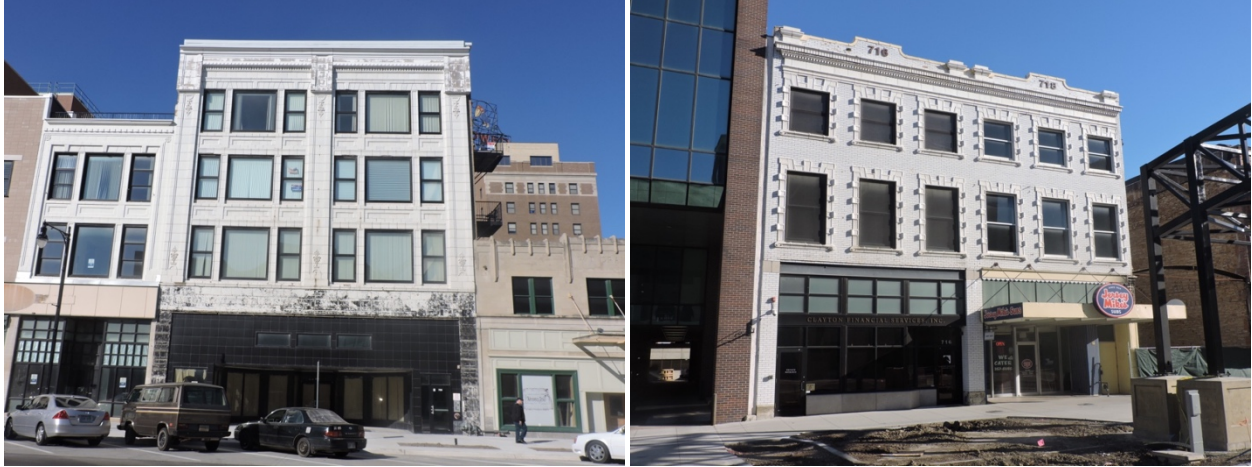
Three early twentieth century buildings with glazed brick and terra cotta facades.

Terra cotta is a common material used in exterior walls during the early twentieth century in Downtown Topeka. Terra cotta is usually used as a decorative material for special features placed in exterior brick walls. However, there are several prominent and high-quality buildings that use glazed brick and terra cotta for their entire facades. Several of these facades are having serious problems with spalling and delamination. Terra cotta is addressed further in Chapter 6, Storefronts, Doors and Windows.

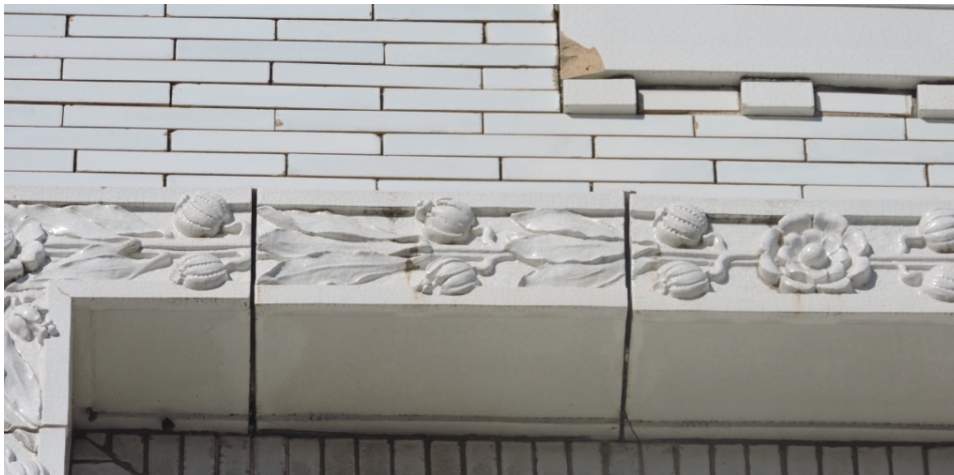
Open joints, chipping, and movement in terra cotta and glazed brick detailing.

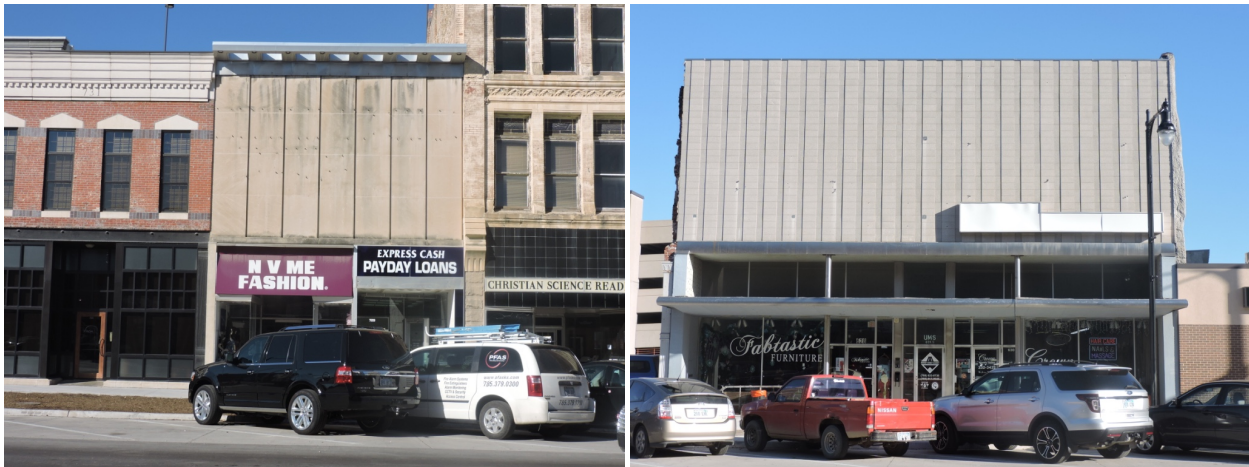
Precast concrete applied facades installed in the 1960s; each façade had large sign lettering similar to that on Briman's Leading Jewelers, pictured earlier in this chapter.

Precast Concrete –As applied facades, pre-cast concrete often served as a background for large sign letters that turned the entire two-story height of the building into a contemporary sign. Today, these sign letters are no longer present.

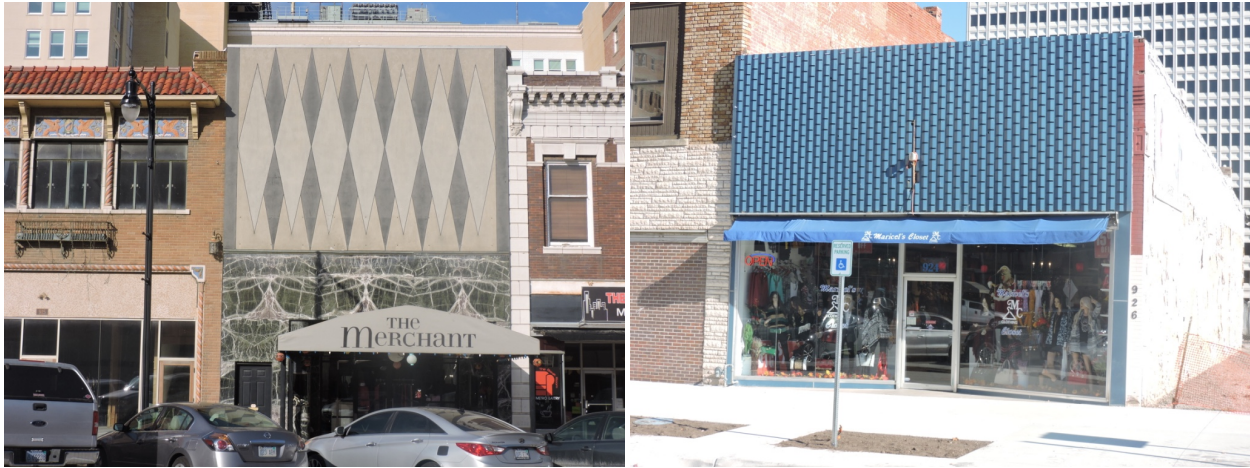
Stucco/stone and metal applied facades on South Kansas Avenue.

Metal – Two buildings within the historic district have metal applied facades. A one-story building at 924 South Kansas Avenue has a screen of sheet metal. This small building is in good condition but may be lost to the redevelopment and adaptive reuse of the 900 block. 106-108 East 8th Avenue has a facade of metal panels with what appears to be a baked enamel finish set within an aluminum framework. The blue finish of the metal panels is badly faded. The historic building behind the facade is reported to be in poor condition.

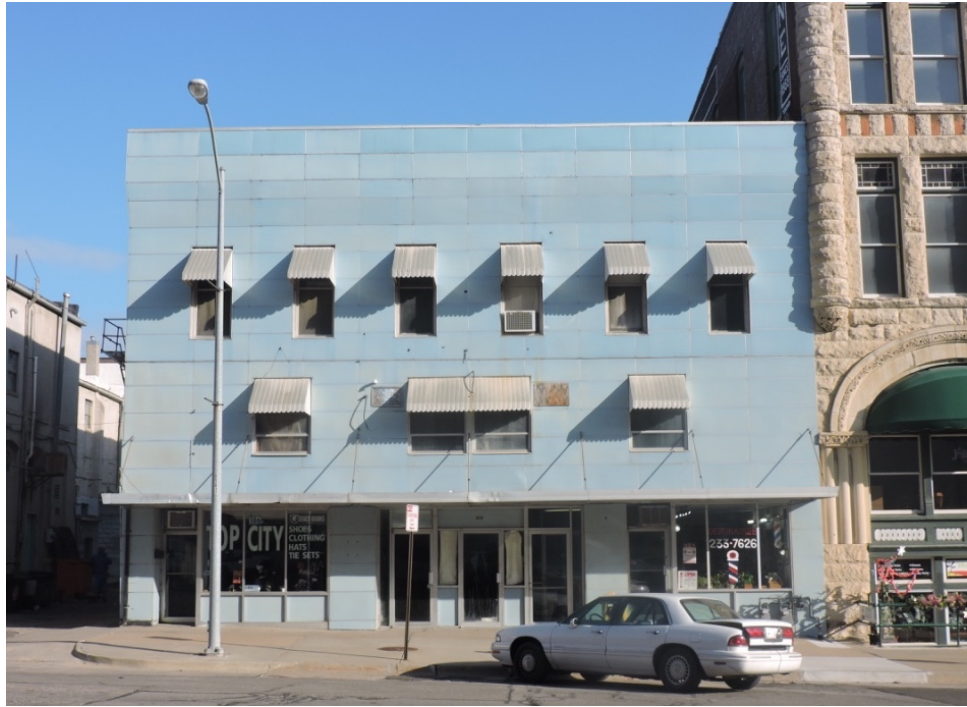
This applied metal façade is in not in good condition. Unlike others, it retained the window openings of the nineteenth century building beneath. The condition of that building and its original facade needs to be investigated.

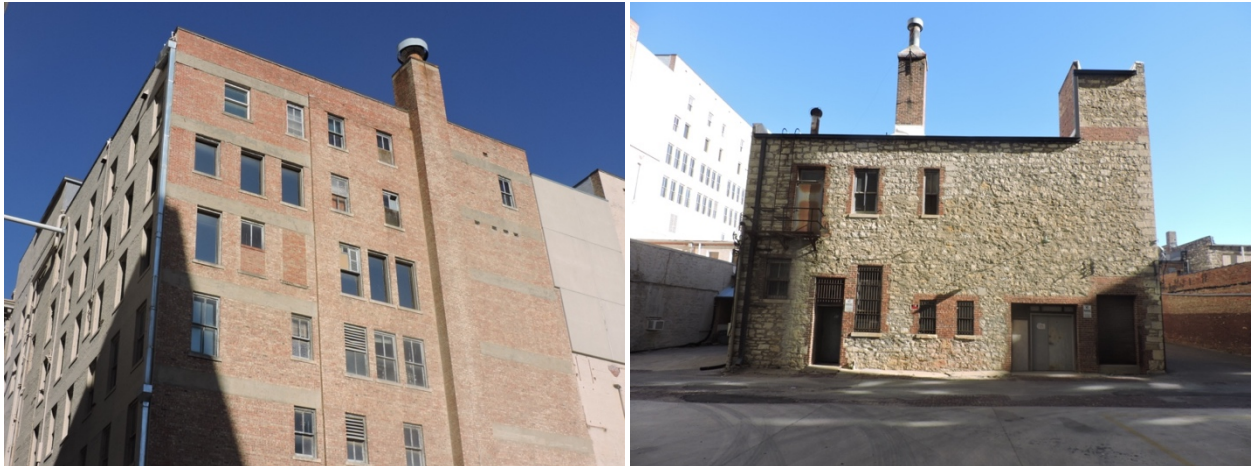
Chimneys are not prominent features and occur primarily on side and rear facades in Downtown Topeka's commercial buildings.

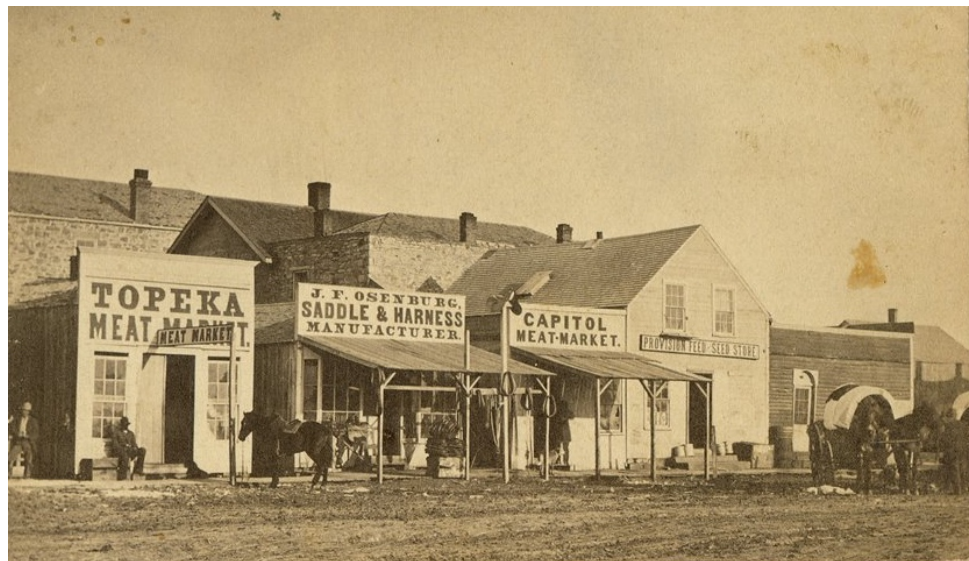
Photograph of the east side of South Kansas Avenue near the corner of 6th Avenue in 1863-65. The two meat markets have large wood doublehung windows. The saddle and harness shop in the center has large projecting display windows with divided lights. (KHS Kansas Memory)

Early photographs of South Kansas Avenue show a number of small, one-story wood buildings that may represent the earliest type of commercial buildings constructed downtown. Several of these small buildings have large wood doublehung windows that take up a considerable portion of the available facade and, though residential in type, function much like later storefronts. None of these buildings remains today.

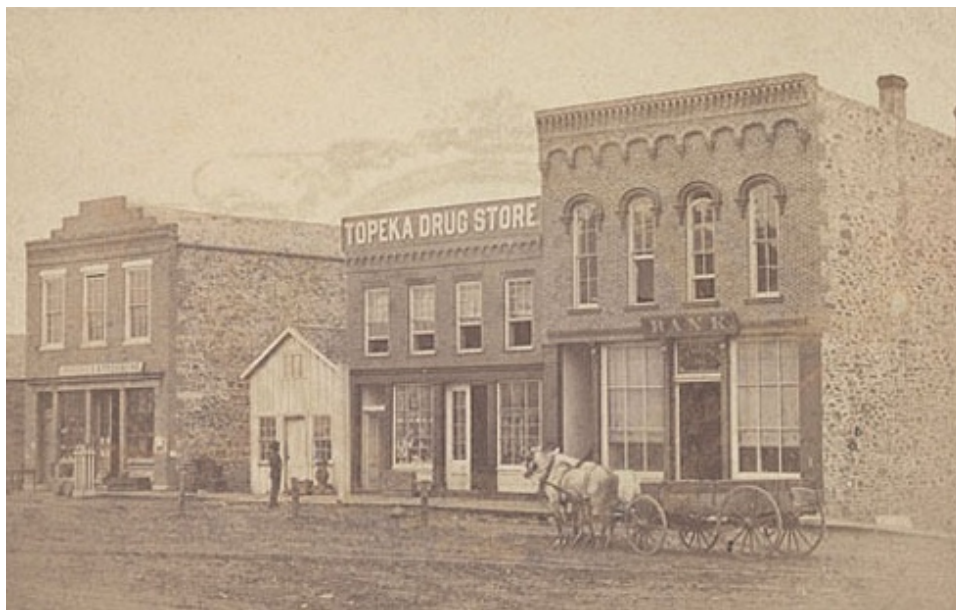
The west side of South Kansas Avenue at the corner of 6th Avenue, 1858-63. All three masonry buildings have complete storefronts with central entrances and large display windows to the sides. An independent doorway to the left side of each building provides access to the second floor level. (KHS Kansas Memory)

By the 1860s, however, more sophisticated commercial buildings using brick and stone were being constructed in Downtown Topeka. These new commercial buildings had complete storefronts in which large display windows take up the entire area of the available facade to allow light into the store. The display windows have large panes of glass with wood divided lights, maximizing the glass manufacturing technology of the time.

Doorways with wood double doors with glass lights are located at the center of the storefront. Cast iron beams span the masonry wall supported on cast iron posts flanking the entrances. Separate entrances from the sidewalk are located to the side of the storefronts to provide separate access to the second floors of the buildings.

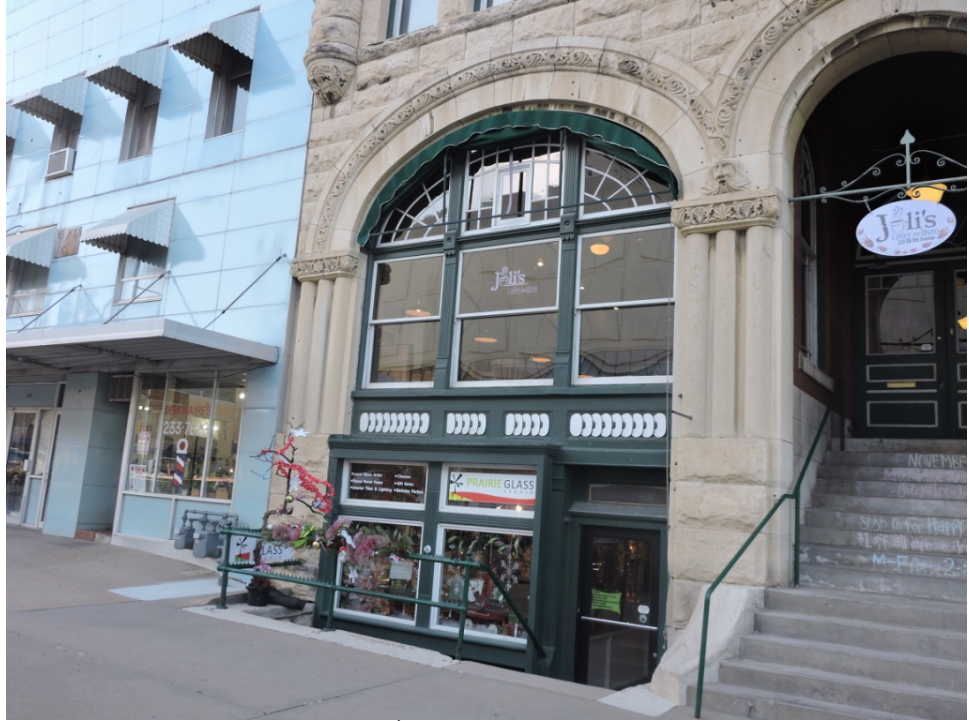
The 1888 Thacher Building on SE 8th Avenue uses elaborately designed stone masonry arches and piers to form its openings. The building's wood windows and storefronts may be the only surviving nineteenth century storefronts in Downtown Topeka.

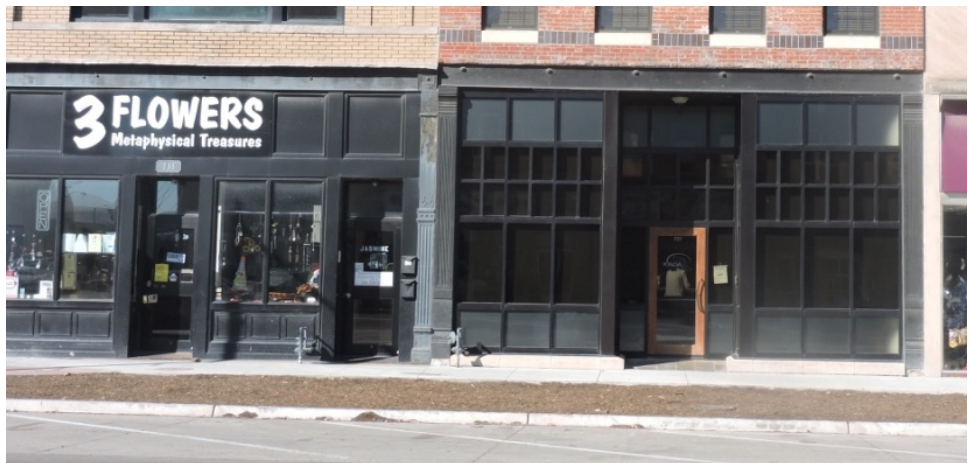
733 (left) and 731 (right) South Kansas Avenue both have cast iron beams and columns remaining. Both buildings were restored after having had their facades covered (see Chapter 2). The storefront of 733 is metal covered but recreates the spirit of its original storefront. It is possible that original wood remains beneath.

In recent years, increased recognition of the unique styles and features of Downtown Topeka's commercial buildings has led to their rehabilitation and renovation. Historic preservation tax credits have been used for building rehabilitation. Owners have removed false facades and restored windows to their original appearance and use, such as at 731 and 733 South Kansas Avenue,

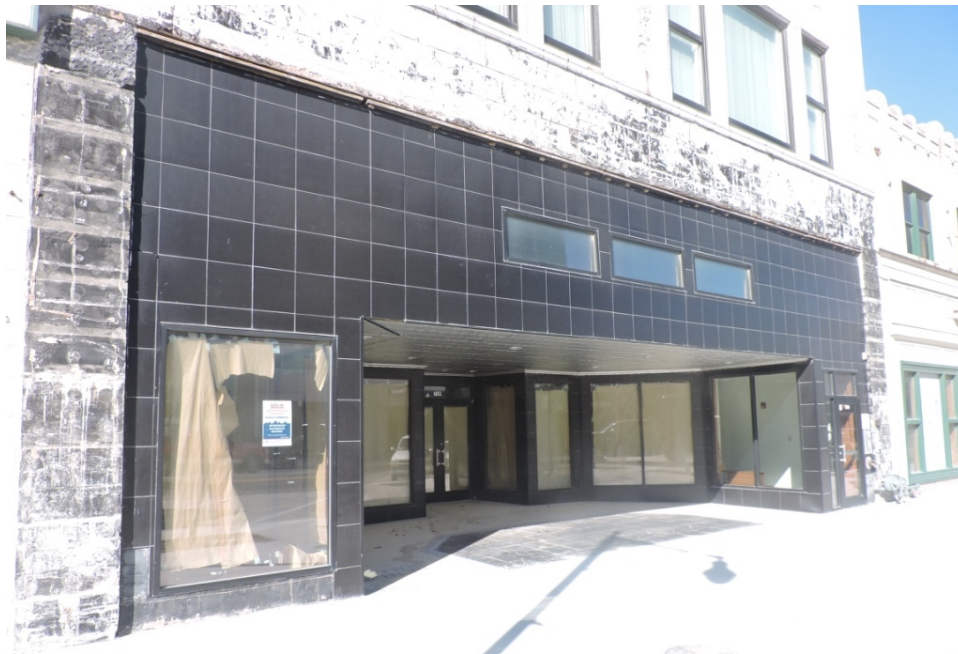
The Palace Building at 709-711 South Kansas Avenue was constructed in 1908 and altered in 1915. The black glazed tile is a still later alteration. The original building had a center display island, the footprint of which remains visible, that was removed when the tile renovations were made.

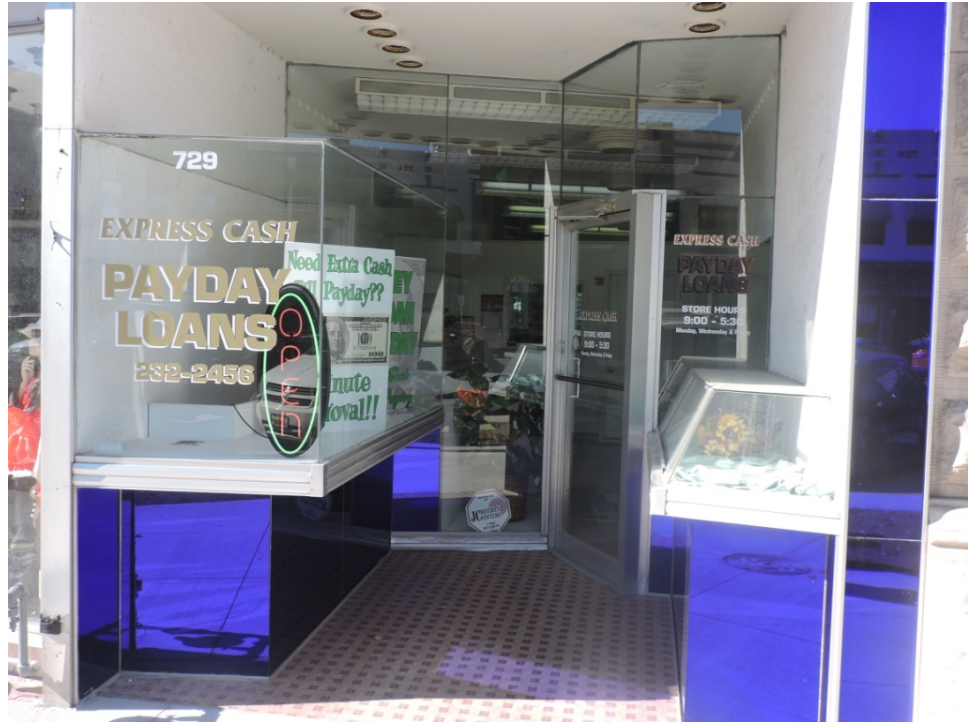
The colorful storefront of 729 South Kansas Avenue dating to the mid-1960s. The design uses reflective structural glass, aluminum, and clear display glass with sealant joints.

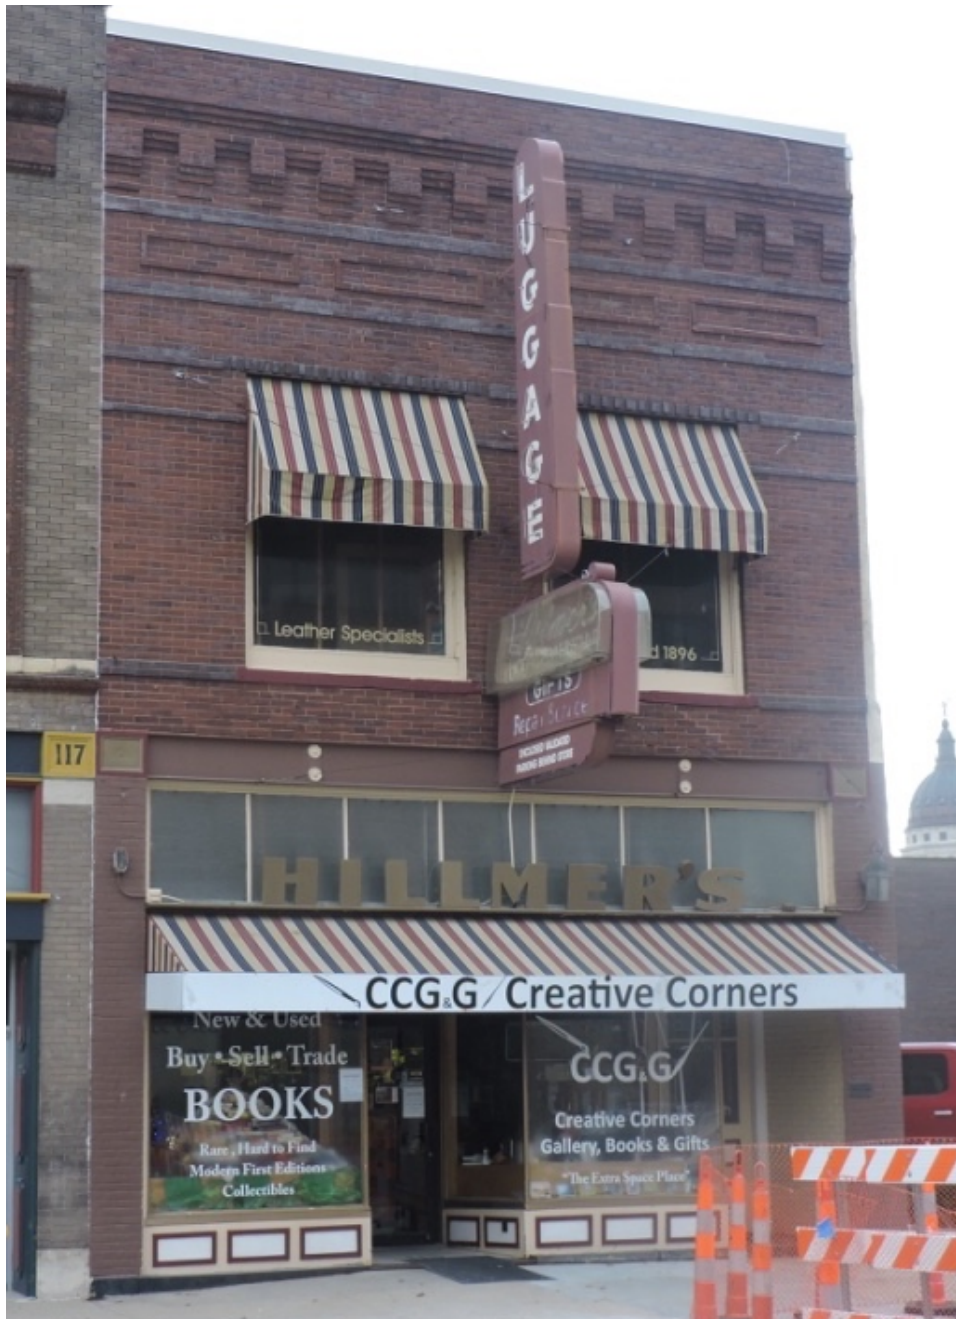
The facade of Hillmer's Leather Shop, one of Topeka's most intact early twentieth century storefronts

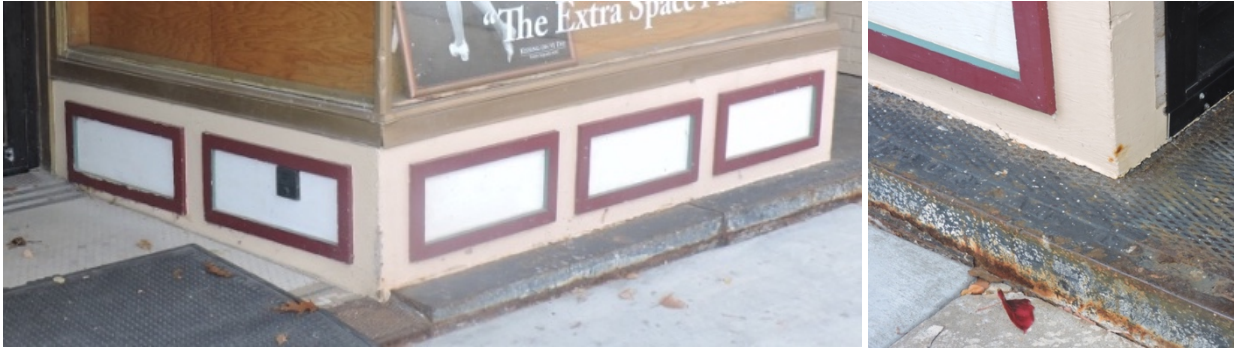
Hillmer's bulkhead is solid wood with applied panels. It is set slightly above the sidewalk on a cast iron step.

Bulkheads – Bulkheads are the portion of the storefront that is located below the display windows. They act as a raised base for the display area above the sidewalk and prevent the glass of the windows from being damaged. Nineteenth and early twentieth century bulkheads are often made of wood and decorated with raised wooden panels. Bulkheads from the 1920s through the 1960s may be of a variety of different materials. Bulkheads take a great deal of wear and abuse from splashing, shoveling, kicking, and impacts related to sidewalk activity.

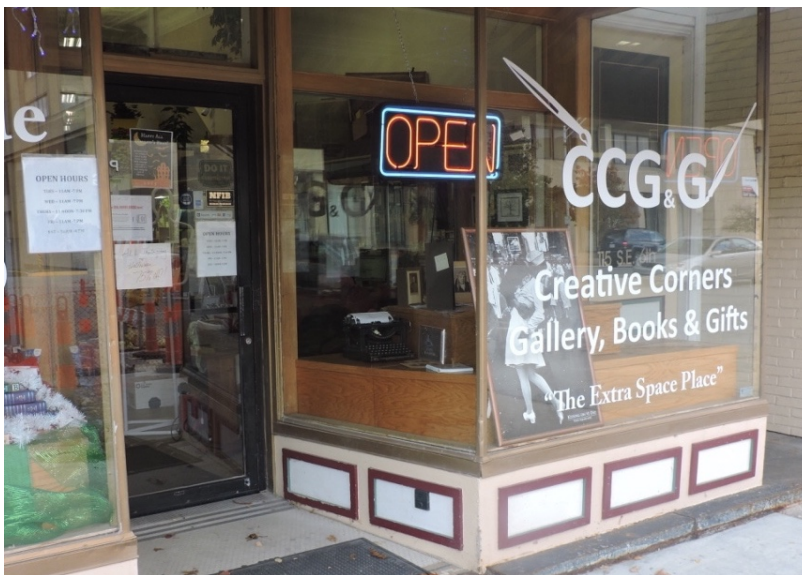
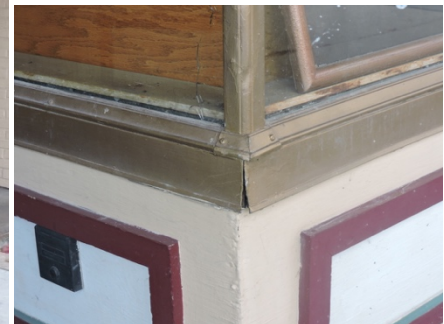
The display window at Hillmer's is comprised of large glass panels set in a thin copper frame. The painted signage on the glass enabled the current retail tenant, Creative Corners, to preserve the building's historic signage.

Display Windows – Display windows usually comprise the largest portion of the area of the storefront. Their purposes are to attract attention, display goods, provide visibility to the interior of the store, and maximize the amount of natural light to the interior. Display windows usually flank both sides of the store's entrance, including the recessed area in front of the entrance door.

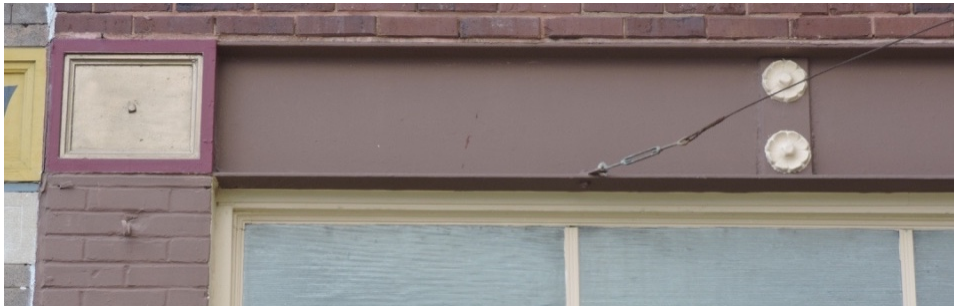
The cast iron or steel beam spanning Hillmer's storefront resting on its masonry column/end wall

With the technical development of steel and its widespread use in the early twentieth century, beams became capable of spanning the entire width of a facade, such as at Hillmer's. Many earlier storefronts were renovated in the 1920s and later with the installation of steel beams to allow storefronts to be more open. While in earlier periods beams were exposed as design features, in later installations they usually are not.
