DOWNTOWN TOPEKA

HISTORIC DISTRICT

DESIGN GUIDELINES

City of Topeka, Kansas

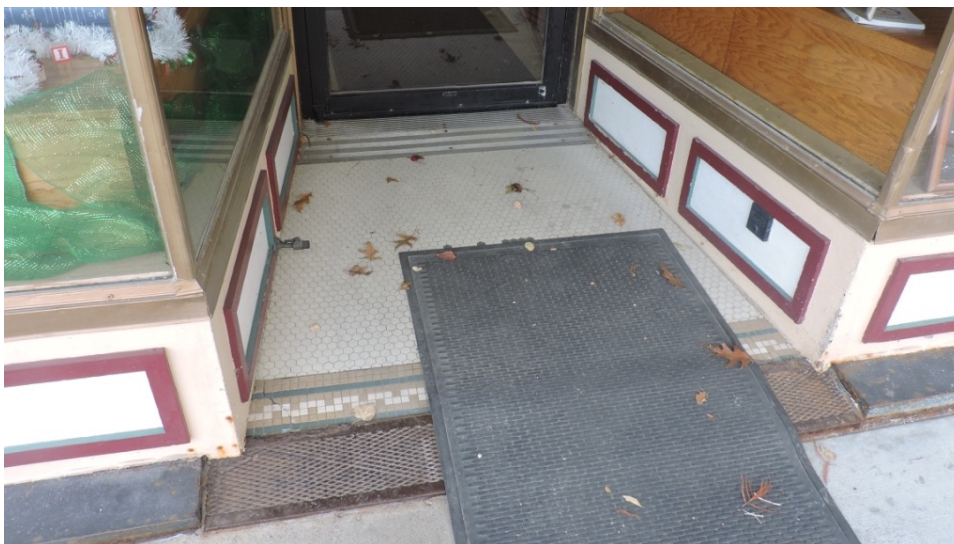
Recessed entrance vestibule of Hillmer's storefront with its decorative ceramic tile floor; the gray exterior carpet is temporary.

Aside from the treatment of the bulkhead and display windows, which wrap into the recessed entrance, components of entrances include flooring and ceilings. Tile and terrazzo have been used as the flooring of many entrances from the early twentieth century to the present. Flooring is often decorative and sometimes includes the name of the original store. Ceiling materials may vary.

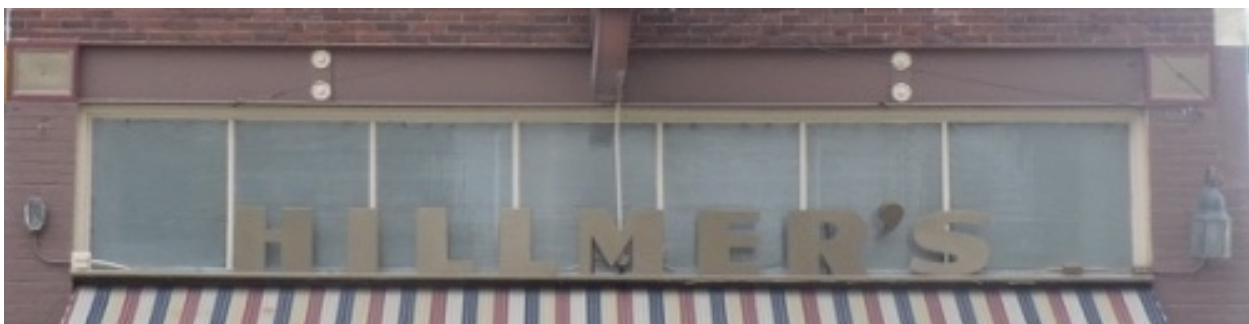
Transom with textured glass and signage across the top of the Hillmer’s storefront

Since transom windows were not meant to provide a view into or out of the building, they were fitted with decorative glass that was stained, leaded, or textured. Some types of glass were specifically designed to diffuse the light.

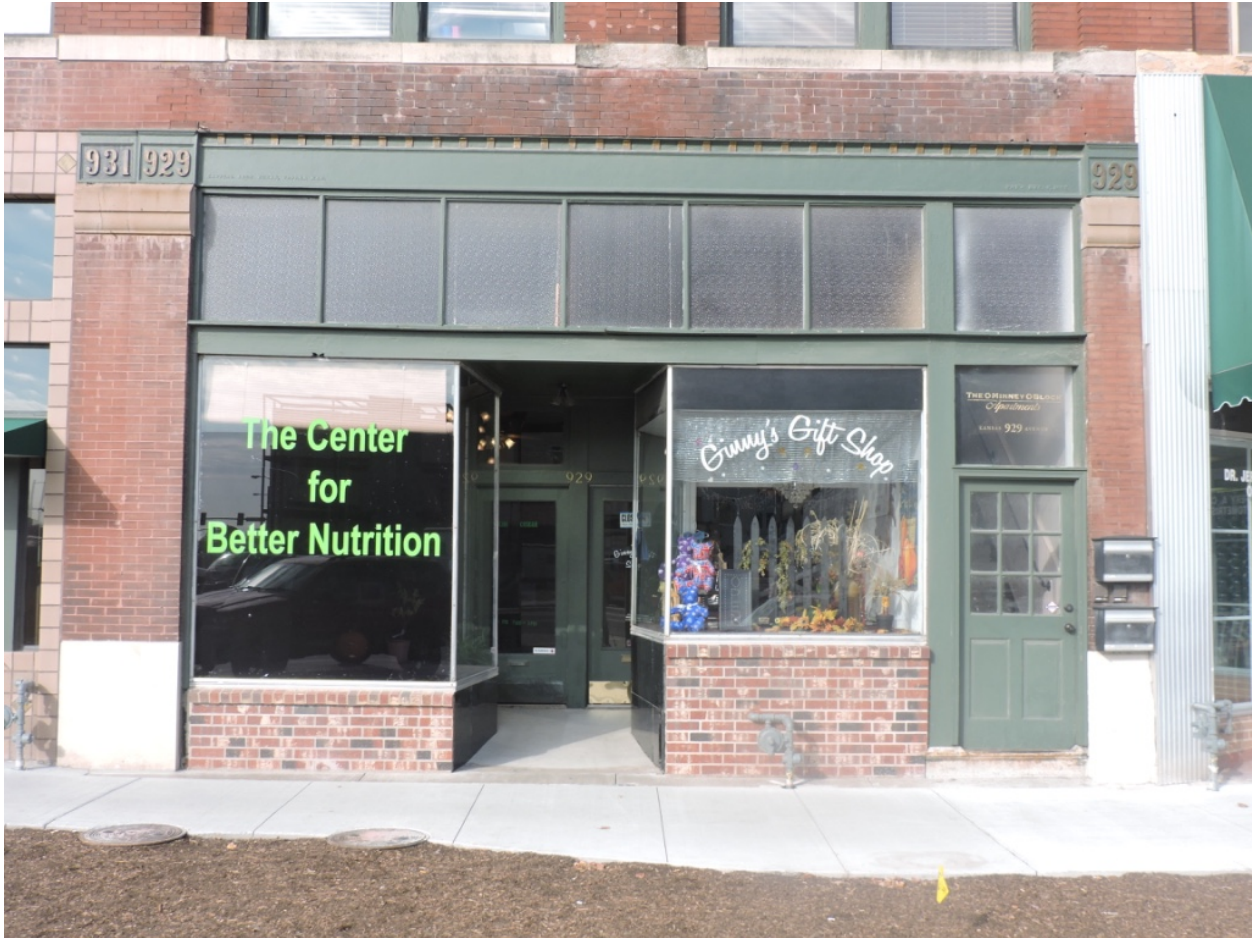
929 South Kansas Avenue was constructed in 1888 and is one of a few buildings downtown that appears to retain a significant amount of its original storefront, including the entrance doors within the vestibule, the full transom above, and the door to the upper floor on the right side. These elements should be preserved and appropriately treated as a high priority. The bulkhead and display windows appear to date from the 1950s or 1960s with thin aluminum frames (two different heights for two retail spaces inside) and black structural glass on the bulkhead (visible within the vestibule). Facing the sidewalk, the black glass has been replaced with rustic brick. The 1950s storefront components should be preserved. The brick on the bulkhead should be removed and replaced with a material similar to the black glass.

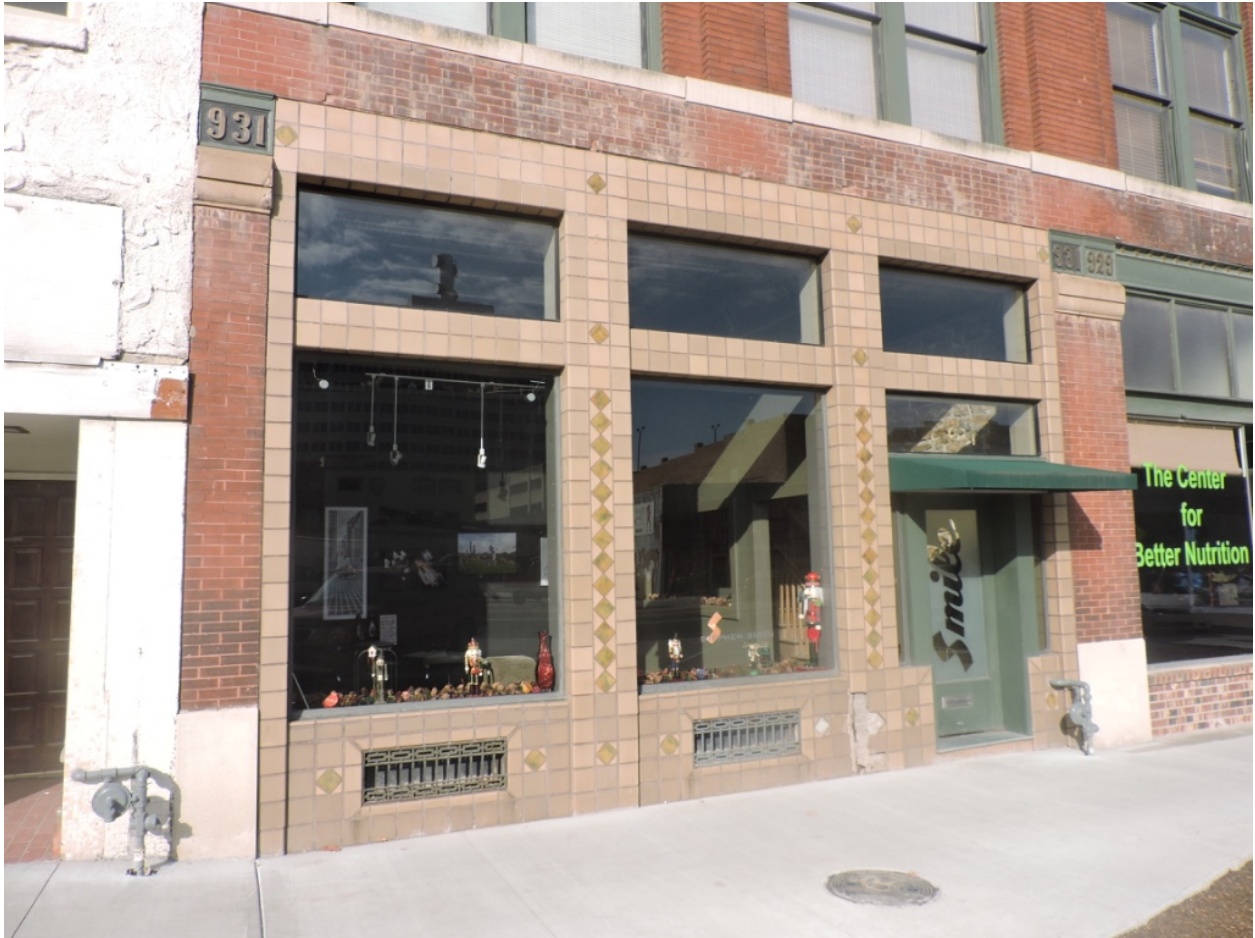
The original 1888 storefront at 931 South Kansas Avenue was entirely replaced with one composed of tile probably in the 1920s. This storefront is nicely designed. Its upper windows reflect the transom next door. The tan tile works well with the nineteenth century brick masonry. The decorative tiles and metal grills add a restrained, high quality decorative flair. A small awning provides shelter at the entrance. This storefront should be preserved in its entirety.

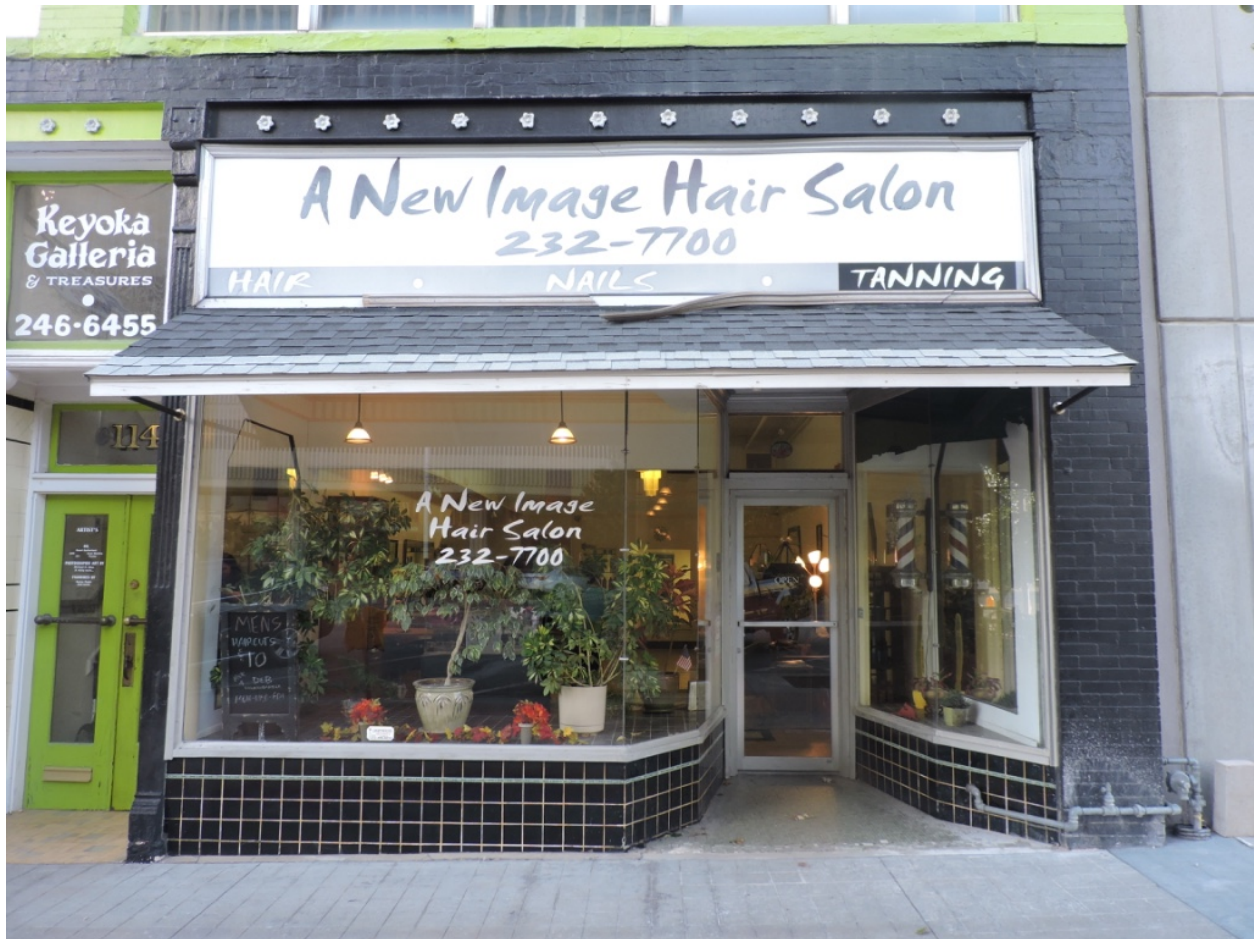
The storefront at 114 SW 8th Avenue, constructed about 1900, has storefronts with components from multiple periods. The overall storefront opening, steel beam at the top with decorative floral medallions, cast iron column on the left side, and masonry pier on the right date from the original construction. The original transom may be presents behind the sign panel and could be exposed. The entrance and display windows date from the 1950s or 1960s and include large glass panels with sealant joints at the entrance vestibule and an aluminum frame elsewhere. The bulkhead is covered with black glazed tile. Both original and 1950s/60s storefront components should be preserved. The transom could be opened. The solid awning with asphalt shingles should be replaced with a canvas awning.

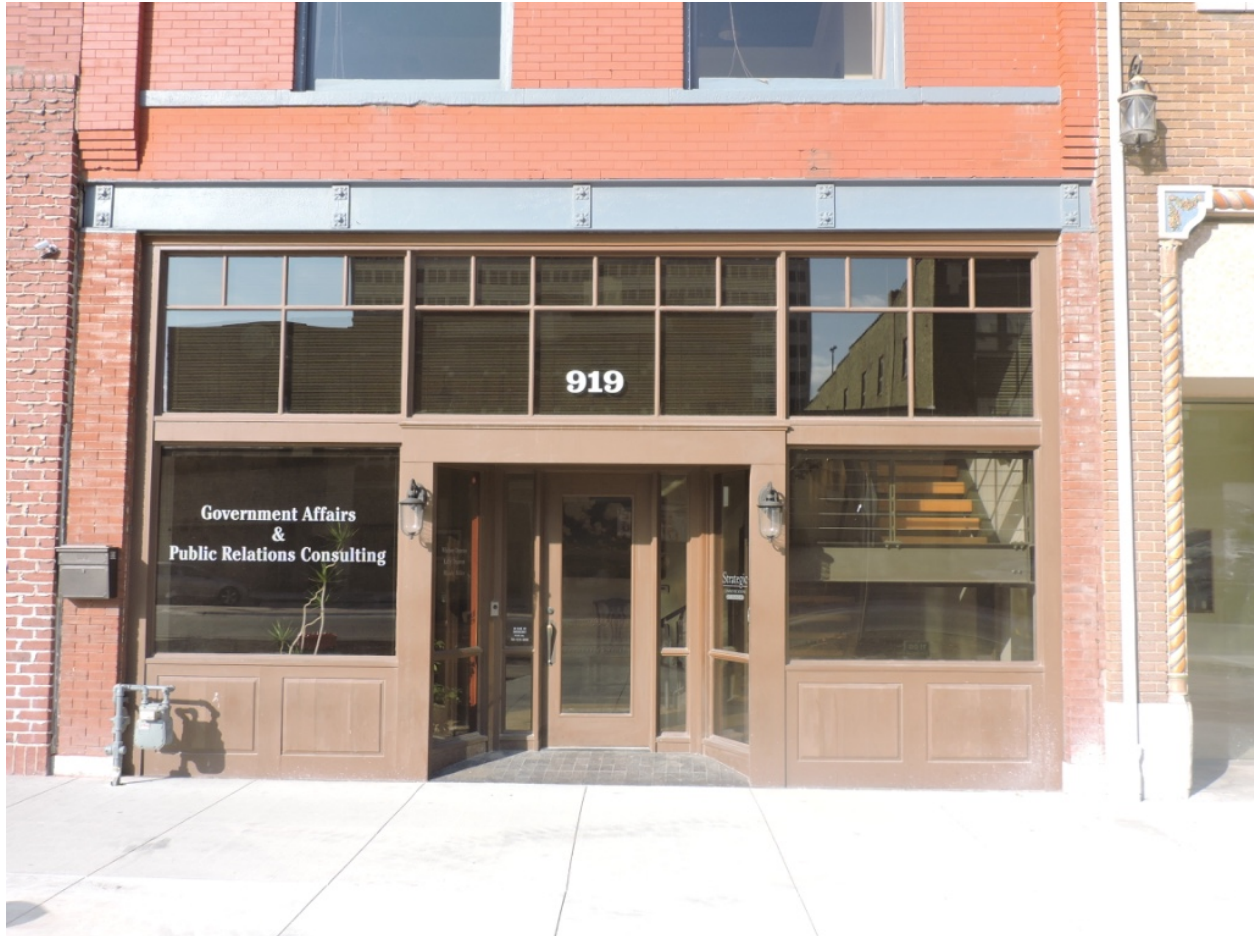
This new wood storefront at 919 South Kansas Avenue reflects historic precedents in its transom windows, display windows, and entrance vestibule. Original historic components including the steel beam above and side masonry piers have been preserved. The storefront is a high quality design and installation.

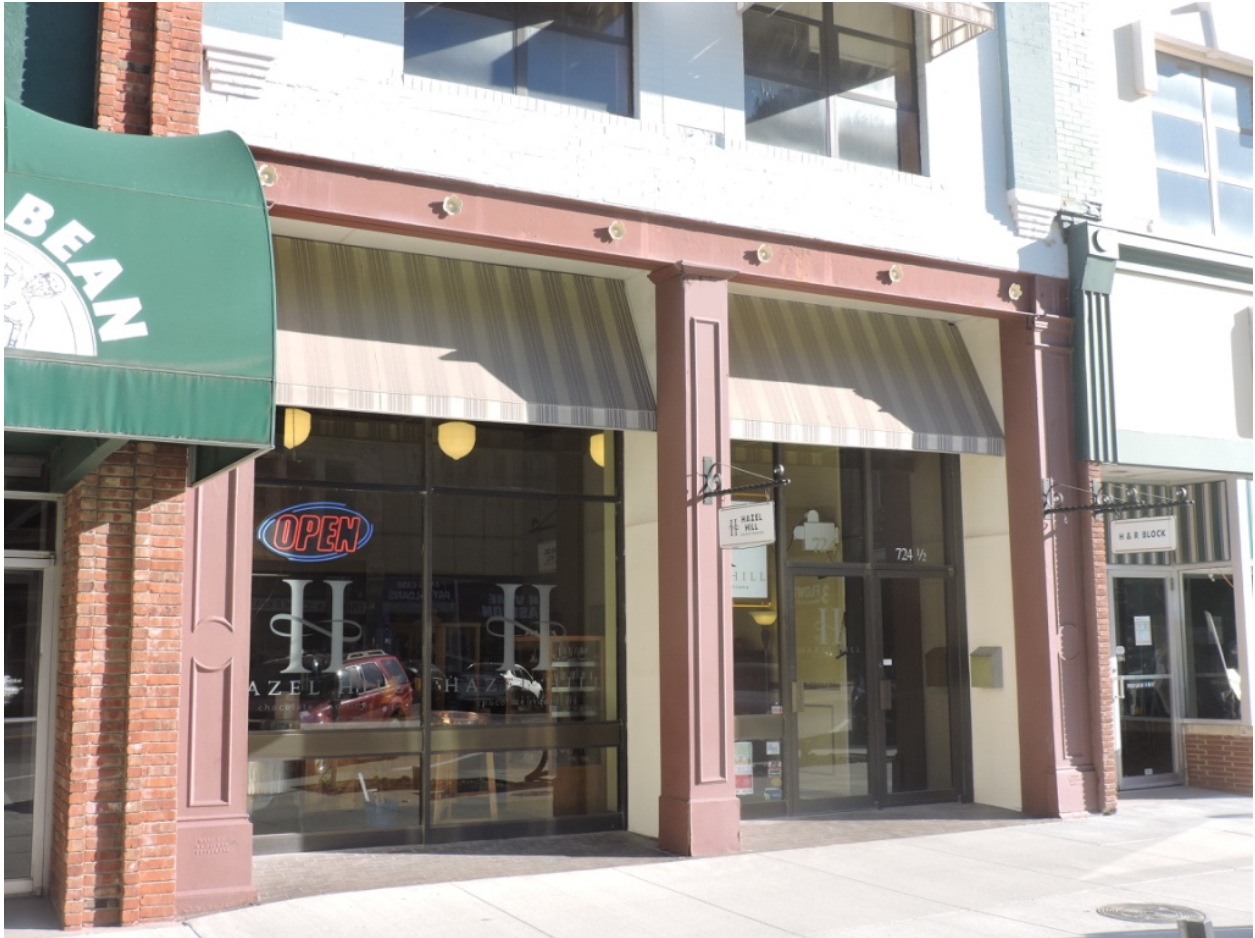
A storefront entrance and display windows of current design have been installed set back from the plane of the original building at 724 South Kansas Avenue, constructed about 1905. The steel beam at the top is original as appear to be the two cast iron columns at the two ends. The center column does not appear in historic photographs. A canvas awning covers the location of the former transom window. This is an appropriate current treatment that preserves and features original historic fabric.

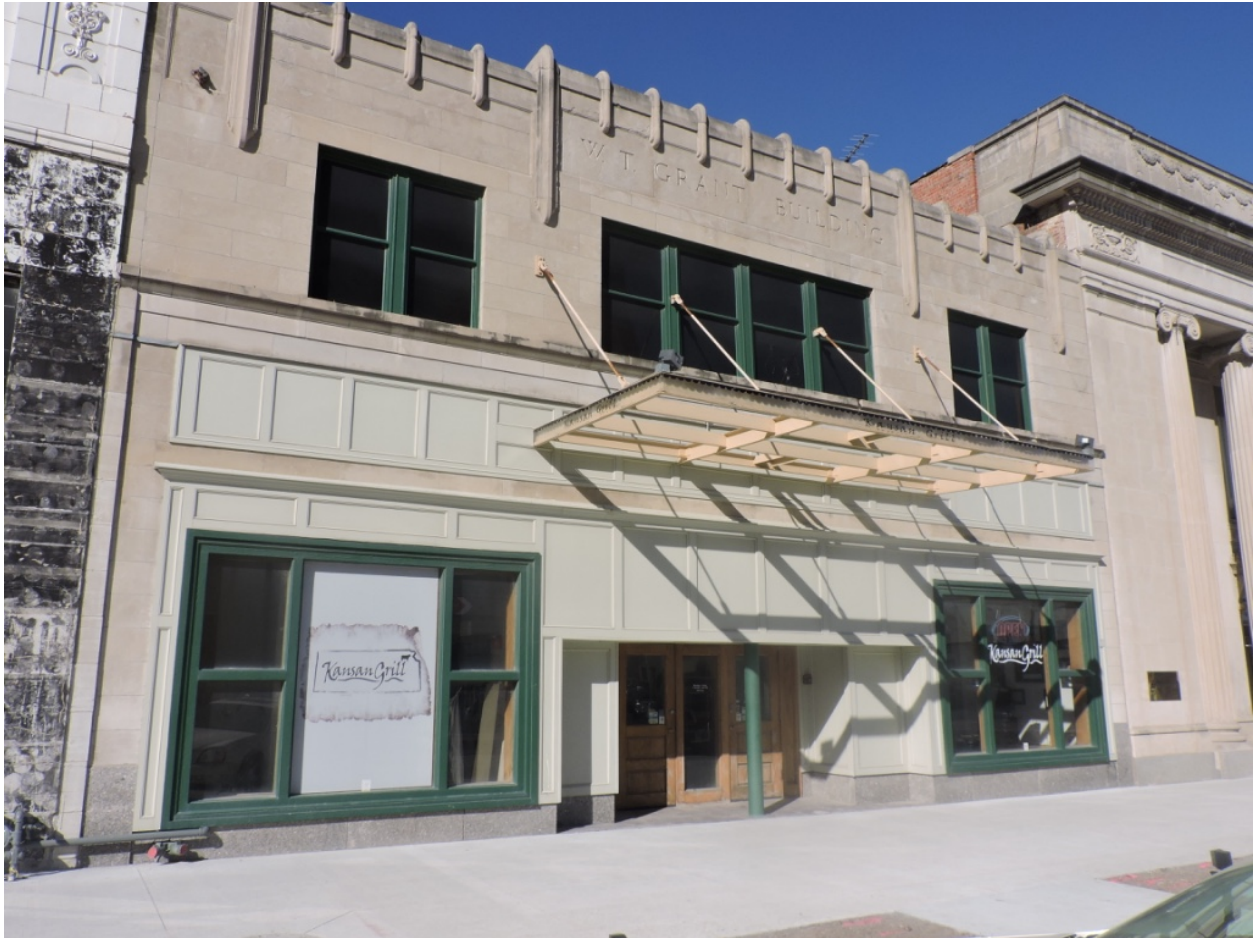
The W. T. Grant Building at 705 South Kansas Avenue was constructed in 1935 in the Art Deco style. The band at the transom level was a W. T. Grant sign and could remain a sign or be an artistic or decorative element. The contemporary wood panels at the sidewalk level should be removed and replaced with considerably full-sized glass. The steel canopy frame is not original, but is interesting and high quality should be preserved.

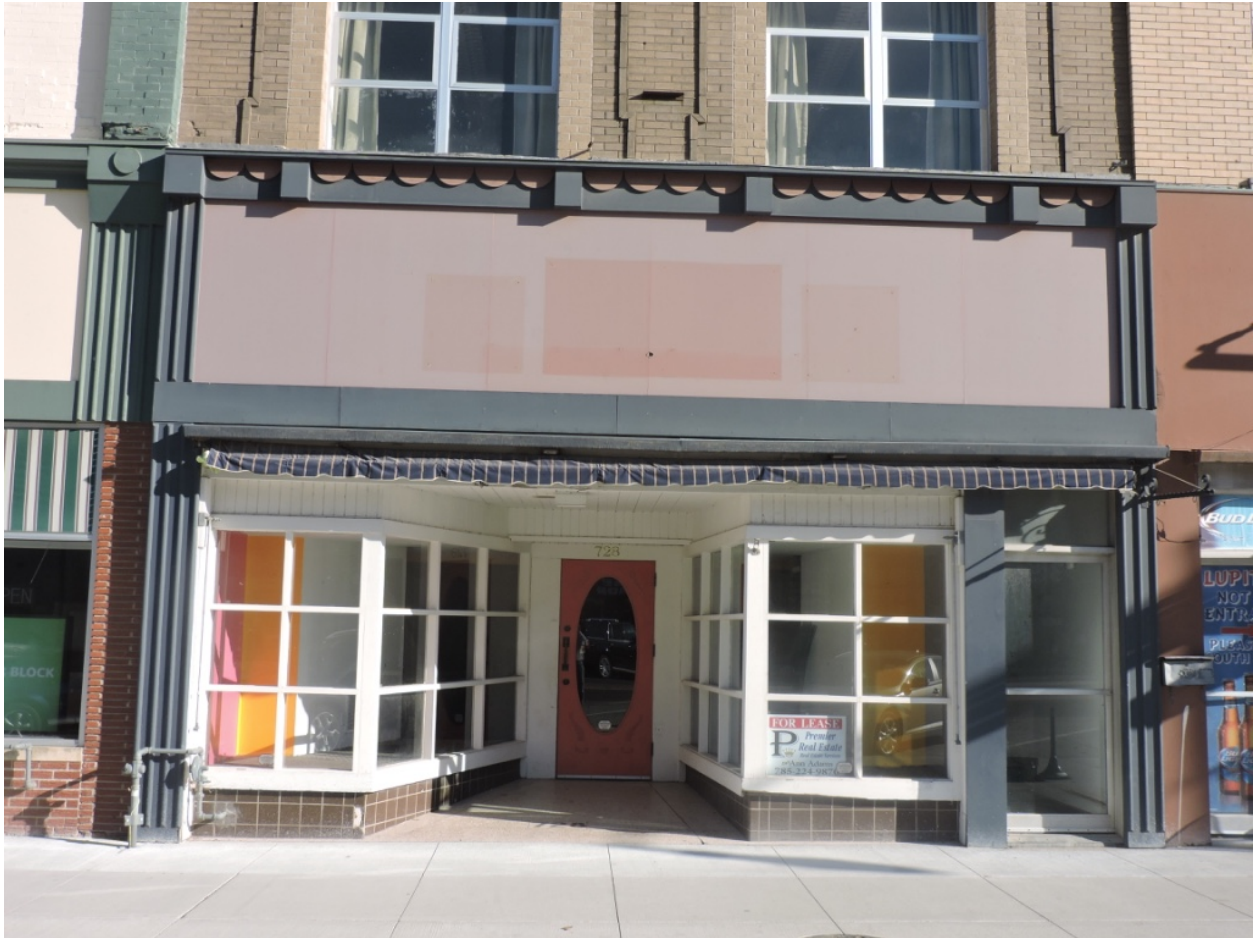
The storefront façade at 728 South Kansas Avenue has been entirely covered or replaced. A new wood transom cover has been installed at the top and down the two sides. The new cover is inappropriate. It would be preferable to retain and expose any remaining historic features. Assuming the original transom window has been removed, any new sign panel at the transom level should be the same size of the original transom and slightly recessed into it. The modern Colonial style storefront below with divided lights and a door with oval glass is inappropriate to the style of the building and not an appropriate contemporary expression.

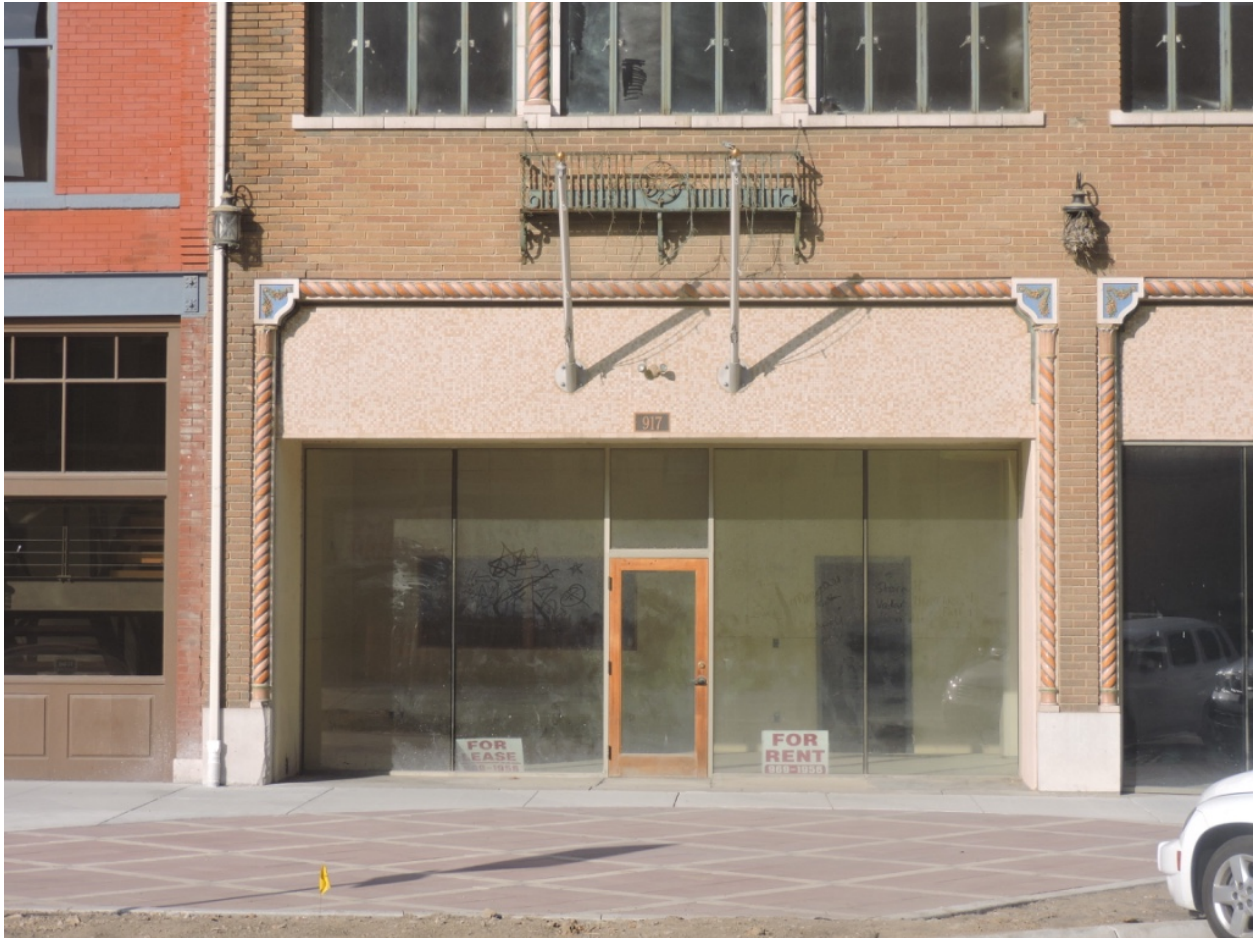
A storefront of current design has been installed within the Pennant Building at 915-917 South Kansas Avenue, constructed in 1927. The building has two storefronts, one of which is set back, which may not be consistent with the building's historic character. The storefront components are simple and straightforward. Centering the door was appropriate in this symmetrical facade. The colorful Spanish terra cotta surround was retained and featured. The design of the transom area could have picked up the color and motifs of the Spanish tile.

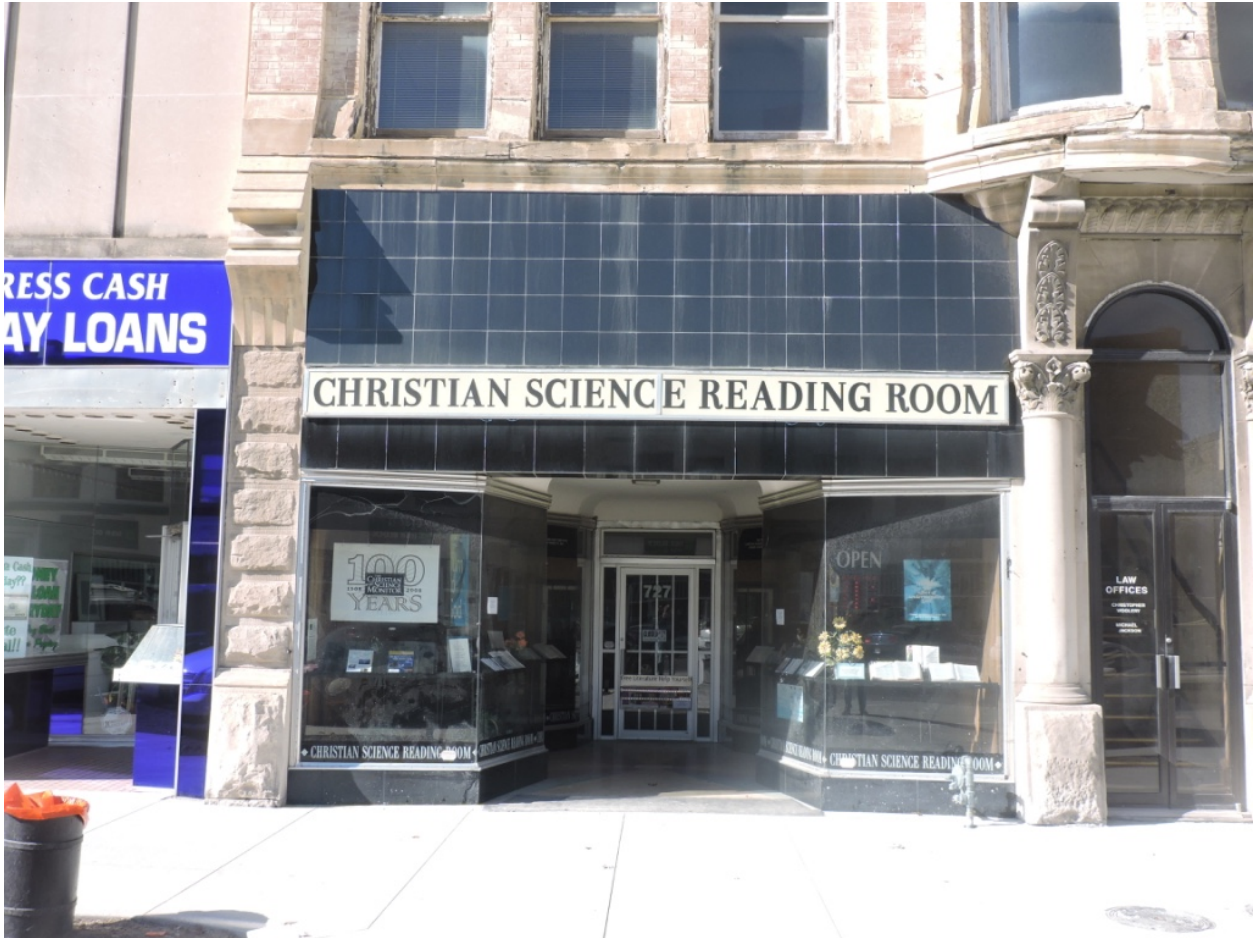
The storefront at the Davies Building at 727 South Kansas Avenue was renovated in the 1950s or 1960s. The display windows have large glass panels with sealant joints at the vestibule and an aluminum frame around. This design and use of materials represents a significant era of Post World War II architecture and contributes to the general character of the surrounding historic district.

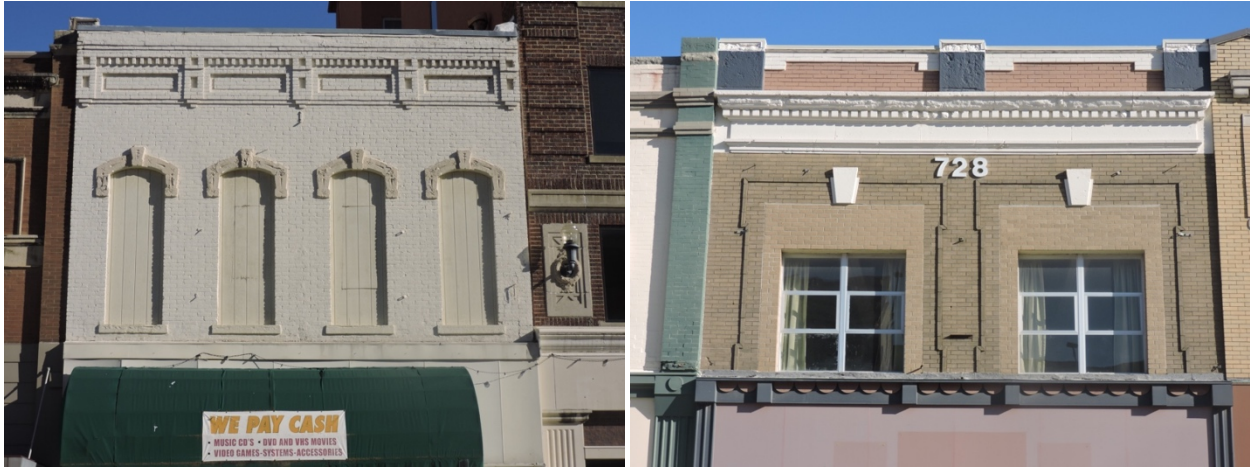
Windows that are blocked or covered (left) should be reopened. On the right, the original window opening was reduced in size using tan brick before new windows were installed. This installation should be reversed.

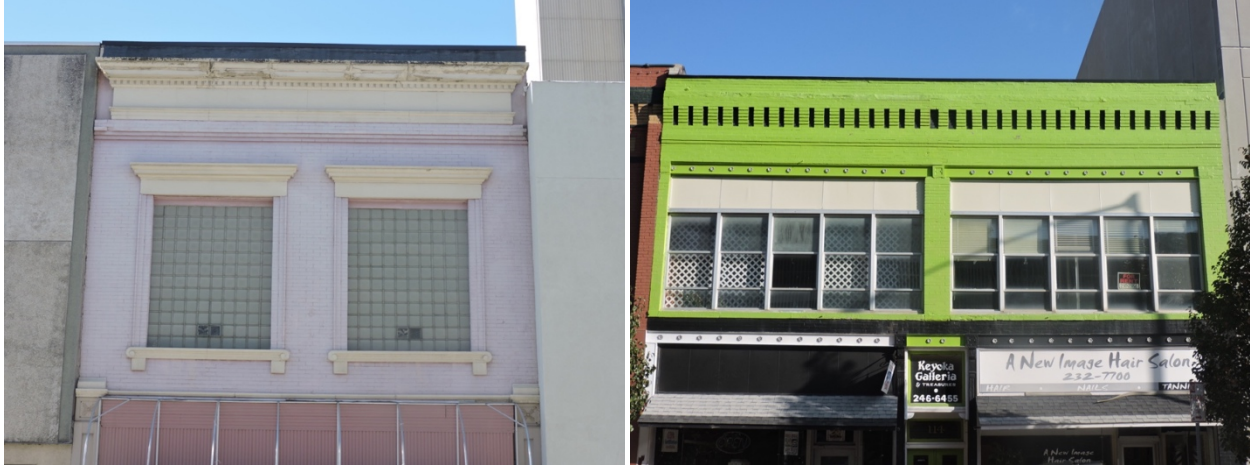
Replacement windows installed during the period of significance can be of significance themselves. Changes to both of these upper floor windows were probably made in conjunction with storefront renovations below. The glass block on the left is appropriate for its period, yet full use of the second floor will require its removal. The windows on the right are appropriate to the 1950s storefront below, yet it is unfortunate that the original window opening was reduced at the top.

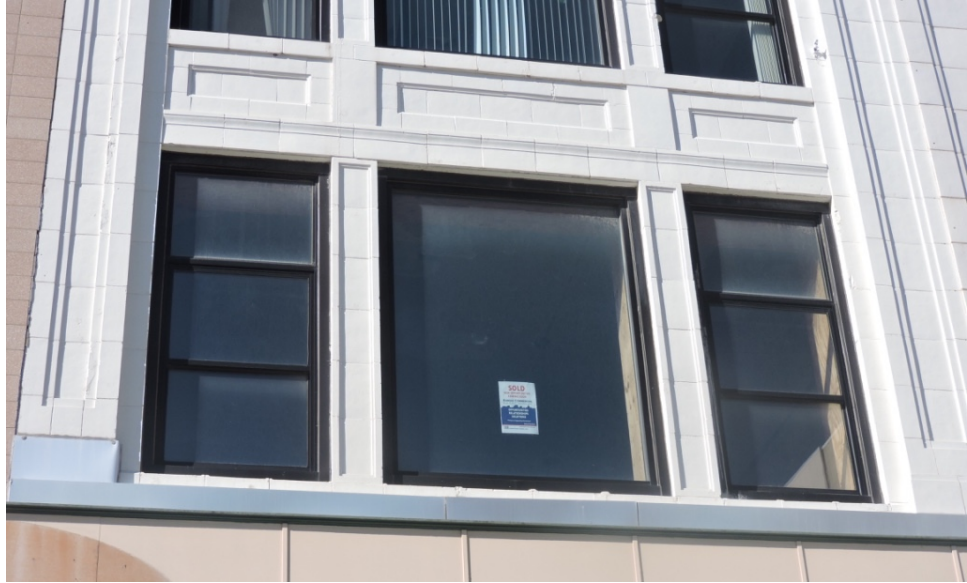
These modern replacement windows were well done, assuming that the original windows needed to be replaced due to deterioration that could not be repaired.

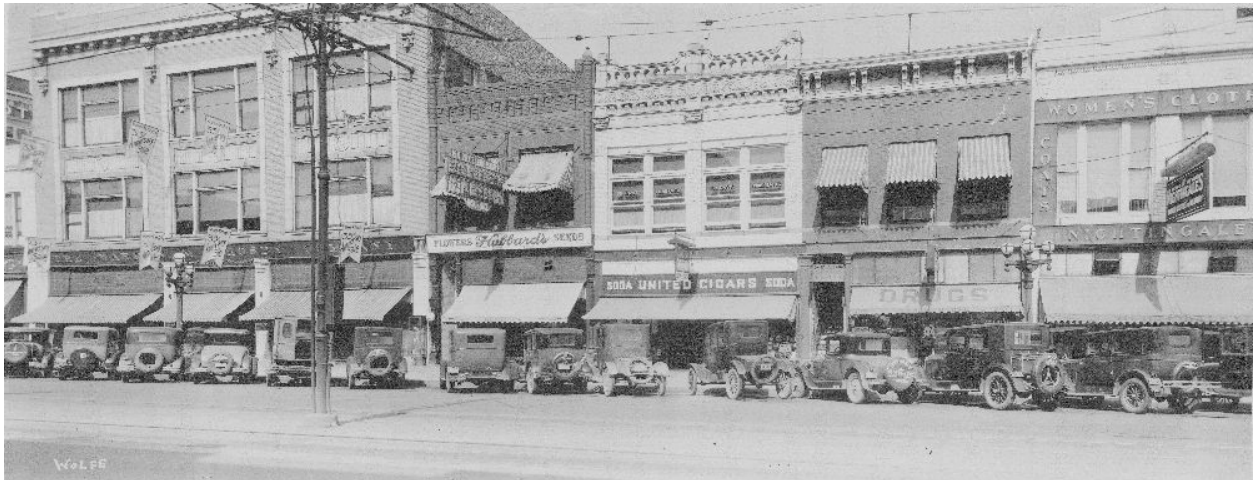
Awnings on the west side of the 600 block of South Kansas Avenue in the early 1930s (KHS Kansas Memory)

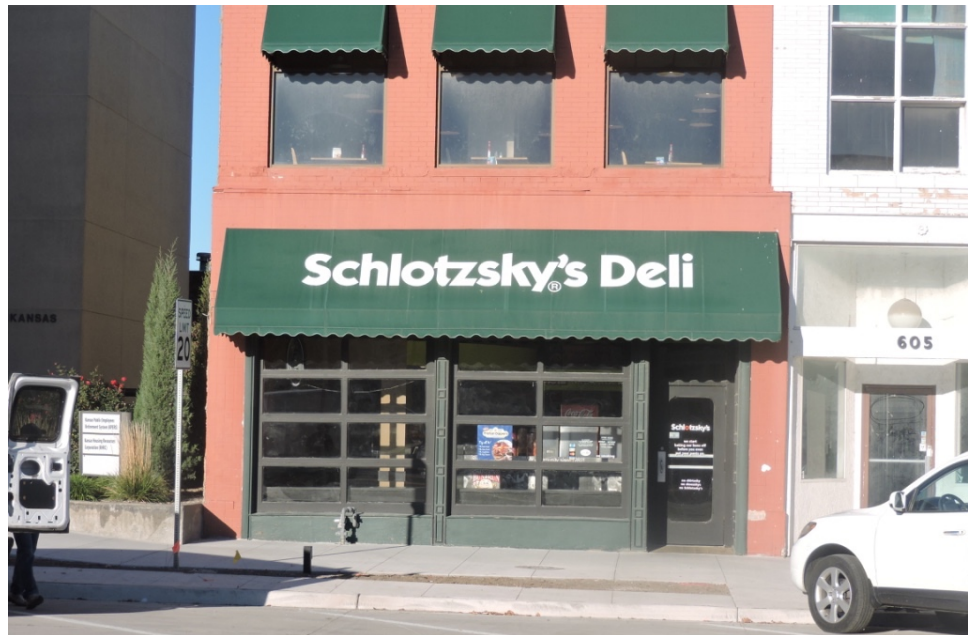
Contemporary awnings; the storefront has roll-up windows that can open the interior fully to the sidewalk. While not a historic treatment, such contemporary installations can enliven the streetscape so long as any remaining historic fabric was retained.

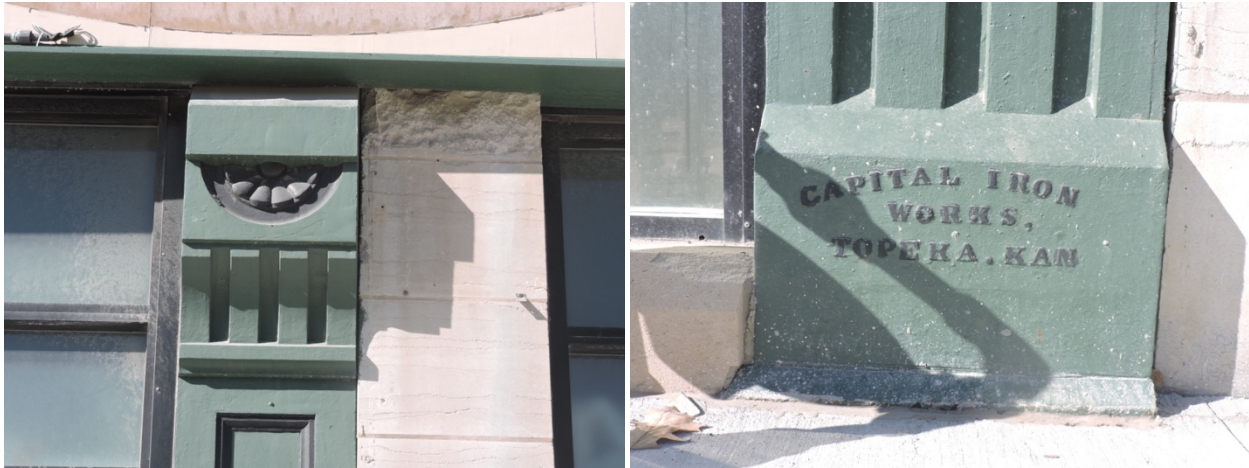
Details of cast iron column on one building; a number of cast iron columns and other elements remain.

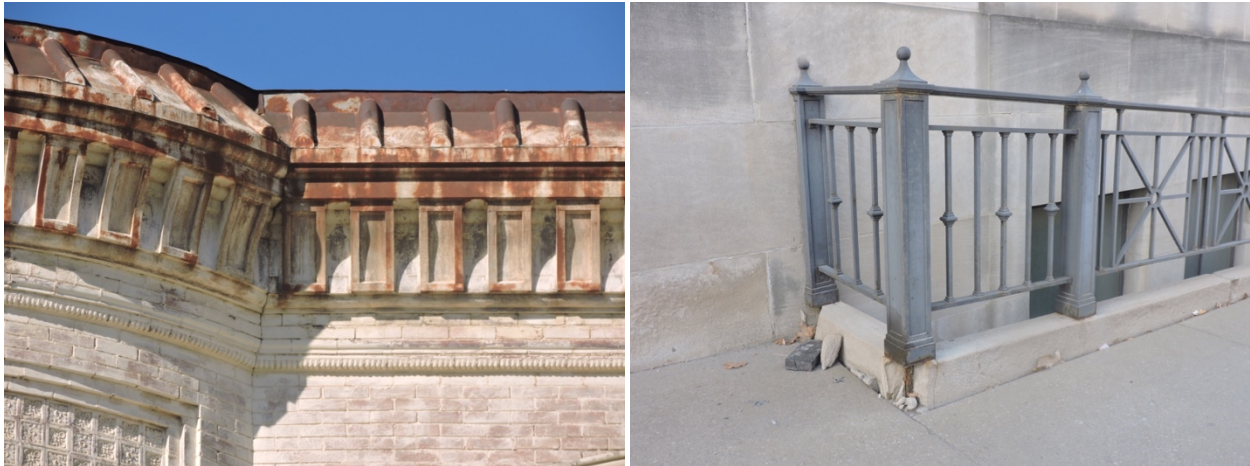
Sheet metal cornice needing maintenance at left; at right, the rusting of the base of a steel railing has expanded and fractured the concrete curb in which it is embedded.

- Regularly **inspect and maintain** historic metalwork. Look for signs of corrosion, tears, holes, or missing pieces. Rust and surface discoloration can provide evidence of internal deterioration and sources of water penetration elsewhere in the wall that must be addressed.
- Sanding, priming, and painting (where appropriate) can address **small patches** of deterioration, but more extensive damage may require limited replacement.
- Assess **patterns of use** that may affect historic metal features, and take measures necessary to ensure their long-term protection. Bronze doors features are especially prone to deterioration because they are often exposed to the salt used to melt snow and ice on sidewalks. A lacquer coating may help to protect metal features like these.

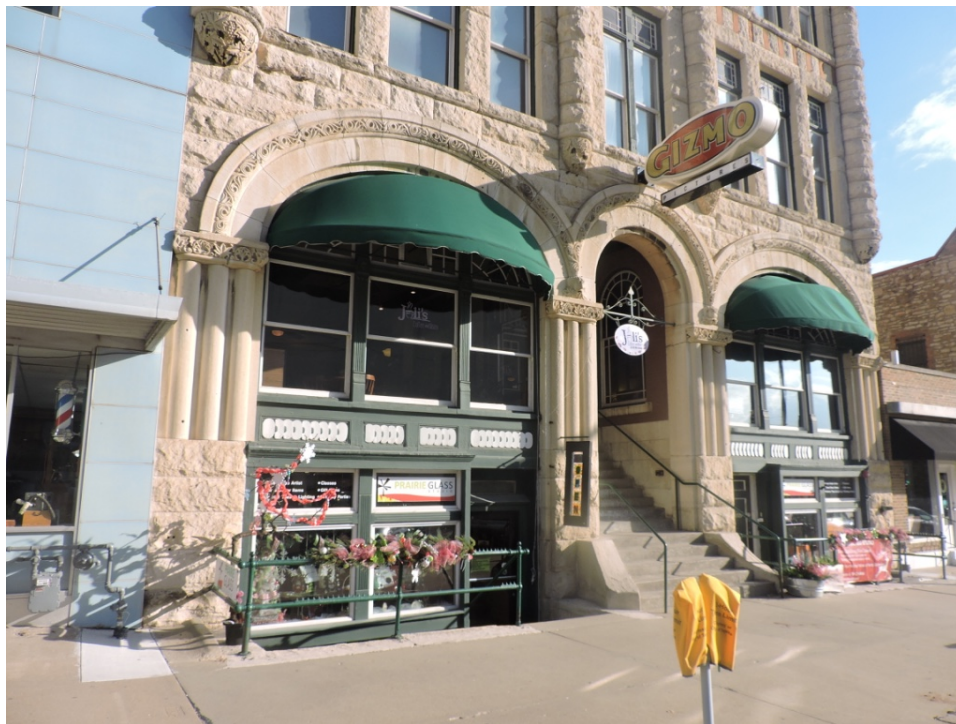
Authentic wood storefronts of the Thacher Building, dating to 1880

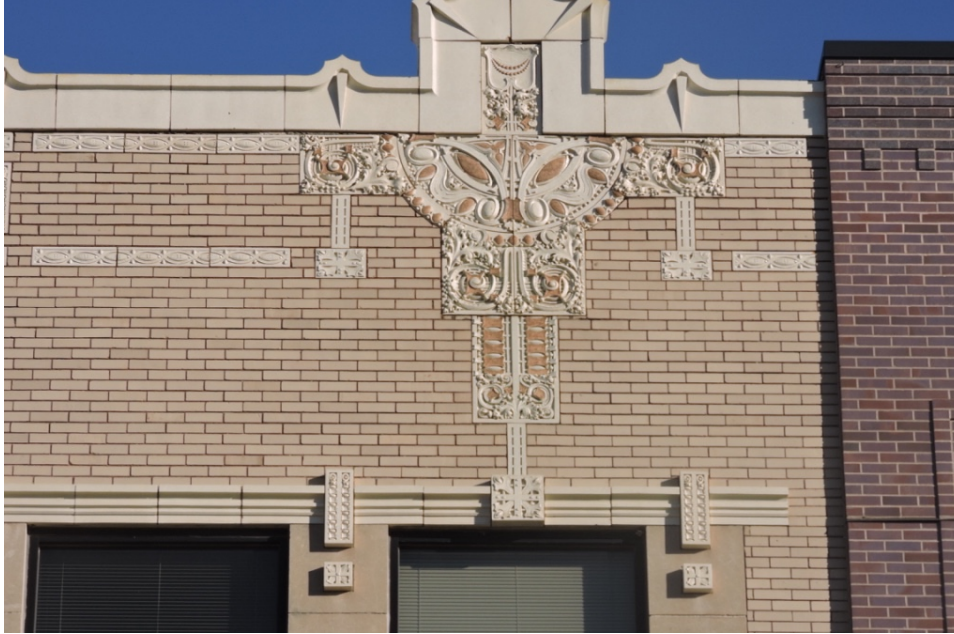
Fine terra cotta façade detailing that should be preserved and maintained.

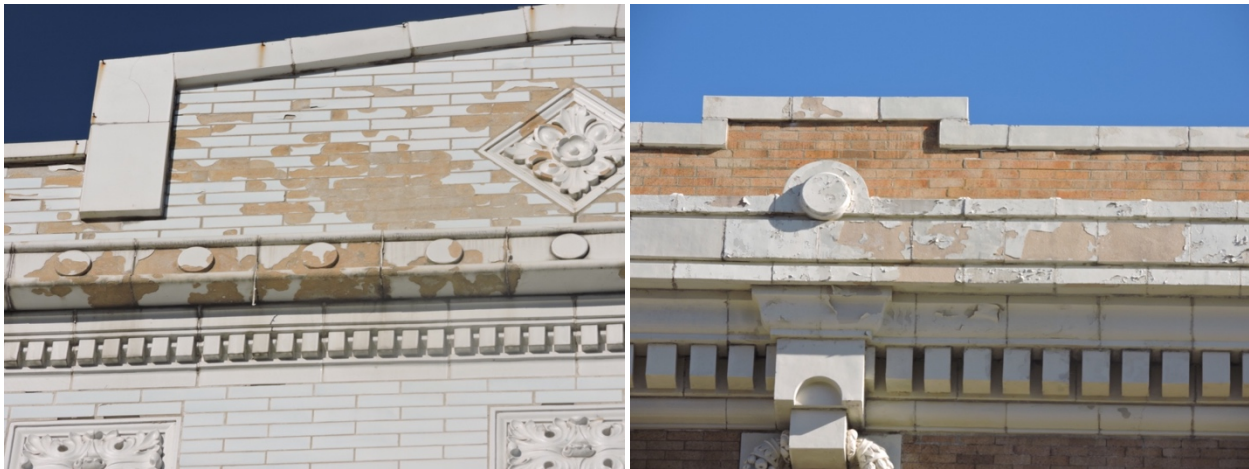
Surface delamination and spalling of terra cotta glazed surfaces probably caused by water penetration and absorption into the terra cotta behind the glaze. Parapets are particularly exposed and vulnerable.

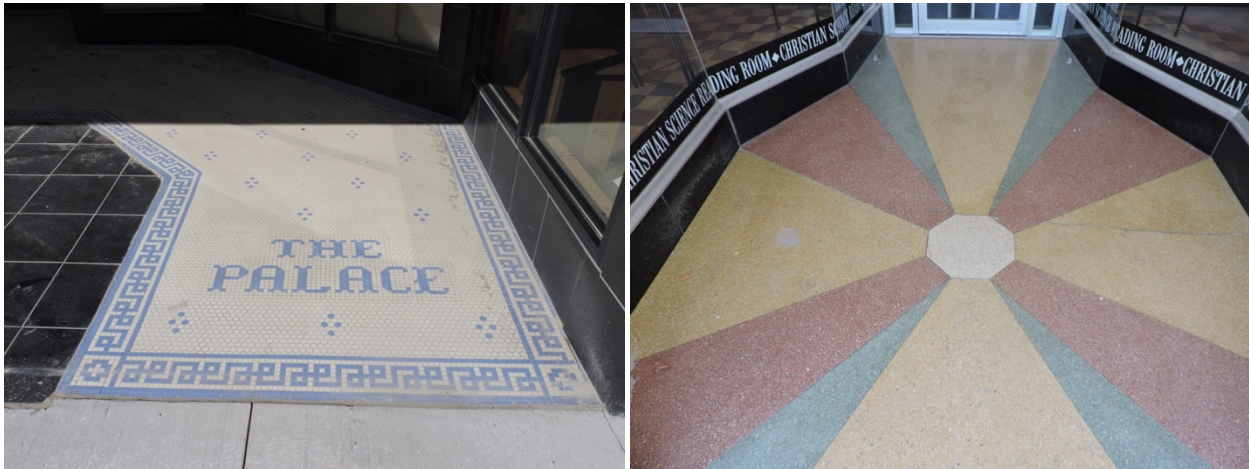
Tile storefront entrance vestibule from about 1908 on the left; terrazzo flooring in a storefront vestibule possibly from the 1950s on the right.

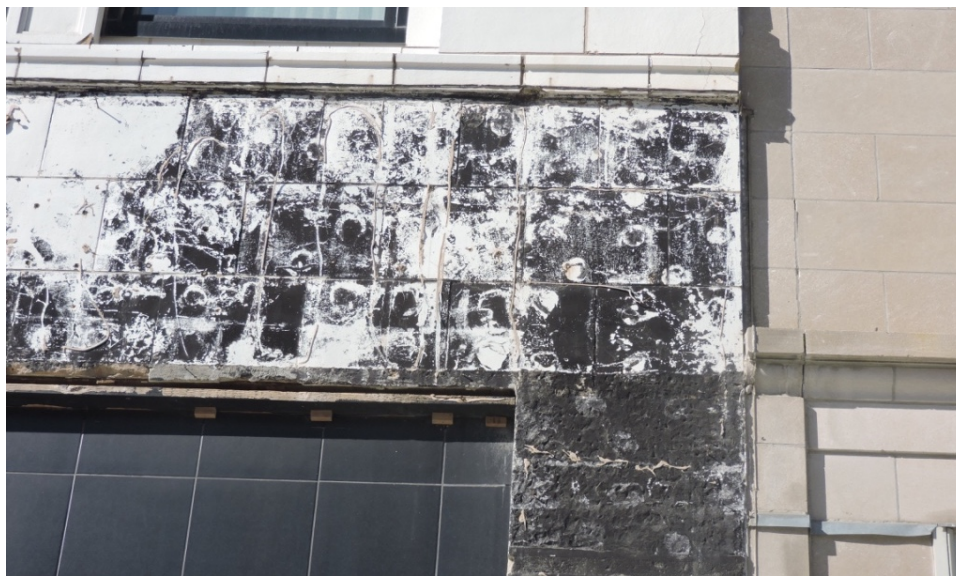
Remnant mastic from a terra cotta surface to which structural tile was applied and later removed; it is possible that the mastic could be softened and removed with solvent. If not, new structural glass or similar material could be applied.

The deterioration and failure of historic structural glass is caused by the deterioration of the joint cement, which hardens and cracks over time allowing water to enter the wall behind the glass; the deterioration of the mastic adhesive, which also hardens and loses its flexibility sometimes causing separation from the glass; and damage from physical impact.

- **Preserve** storefronts and other features that were designed using structural glass in Downtown Topeka.
- Regardless of the size of the installation, preserve the maximum amount of original historic fabric. **Repair** damaged areas unless the deterioration is too extensive and repair is not possible.
- When building **rehabilitation projects** are undertaken, make sure that appropriate techniques for the maintenance and repair of historic structural glass are undertaken.
- Where structural glass features remain but a new overall storefront design will be implemented, preserve and retain the structural glass materials and features and **incorporate** them into a compatible new design.

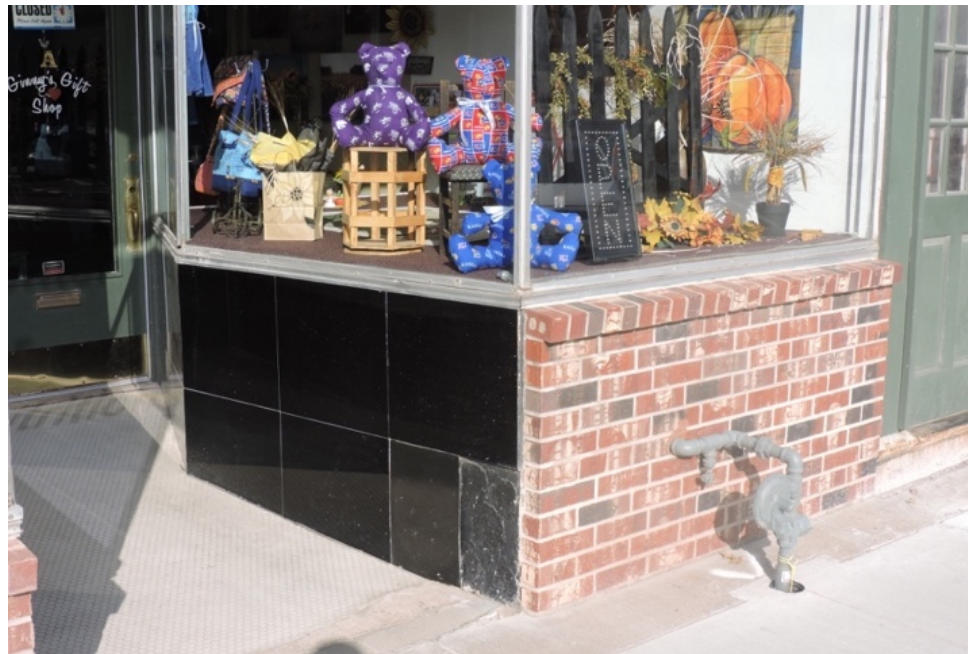
Remnant black structural glass in a storefront bulkhead that should be preserved at right.

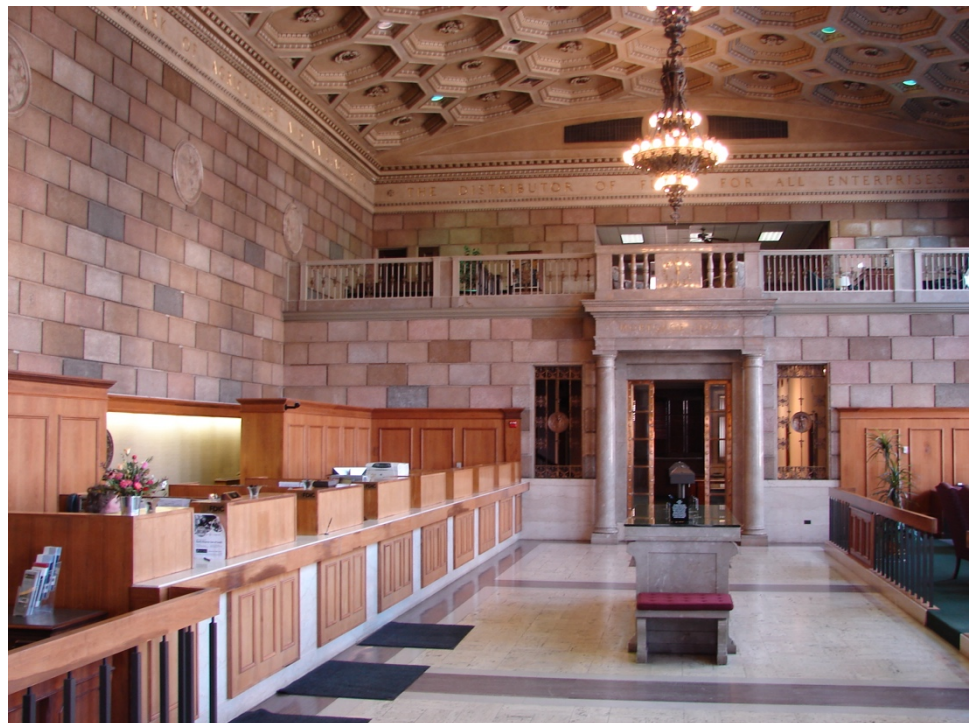
High quality interior of the 1927 Central National Bank building, now Equity Bank.
