DOWNTOWN TOPEKA

HISTORIC DISTRICT

DESIGN GUIDELINES

City of Topeka, Kansas

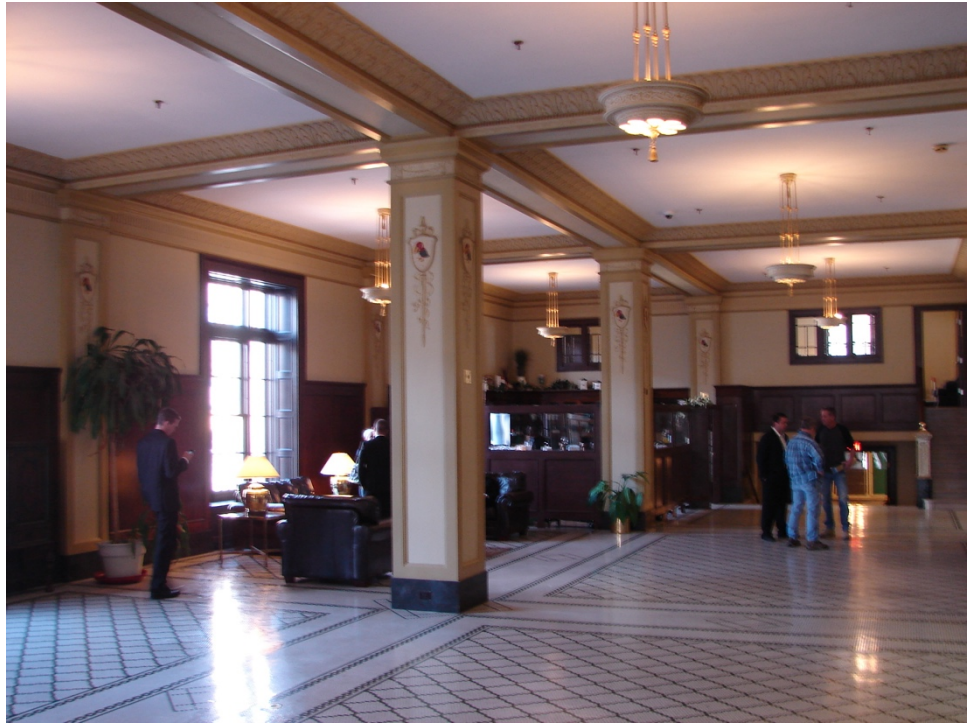
Prominent public interiors like the lobby of the Jayhawk Hotel are obvious examples of a Principal Space that should have a high priority for preservation.

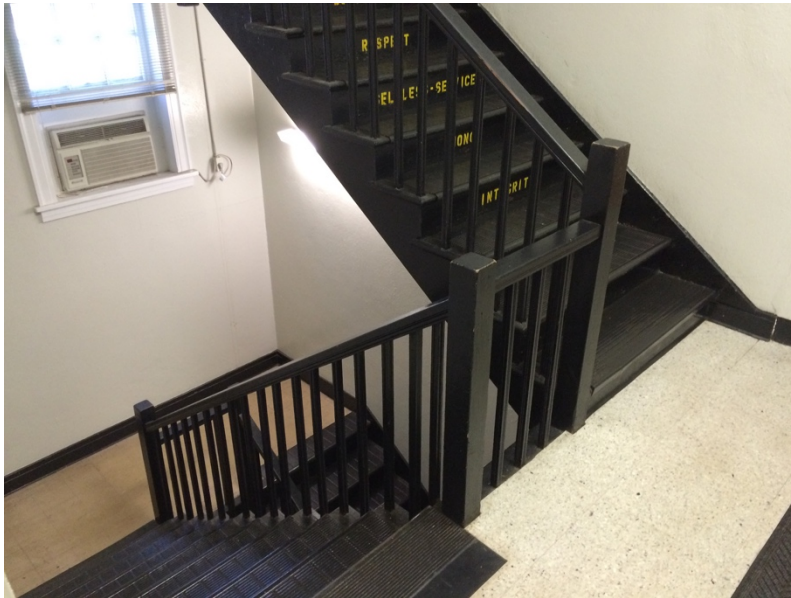
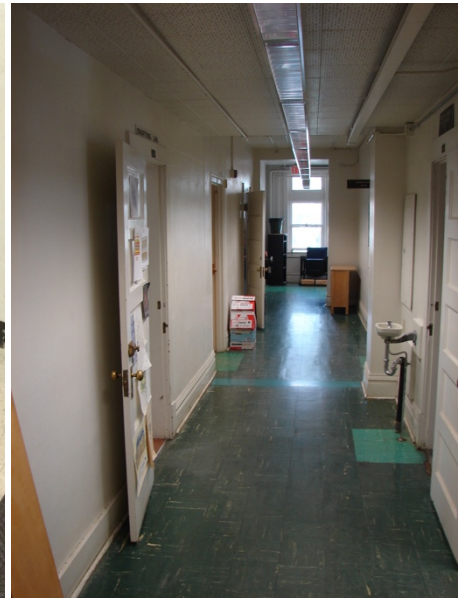
Less prominent public stairways and corridors are also considered Principal Spaces and often retain original historic features and fabric that should be preserved.

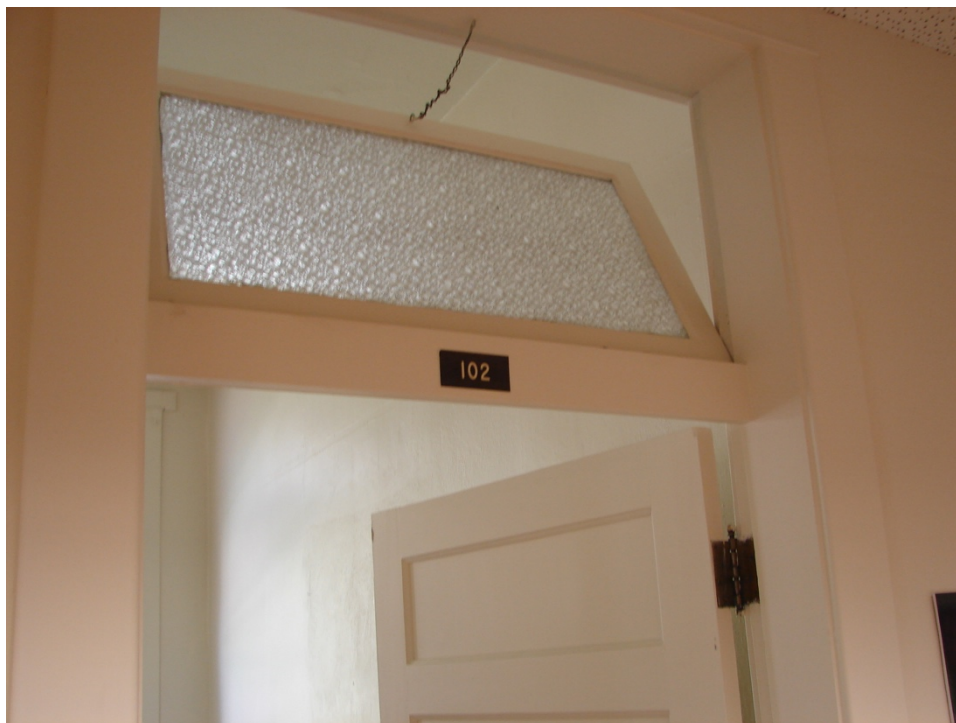
Many older historic commercial buildings retain features such as original doors and transoms, especially on upper floor levels.

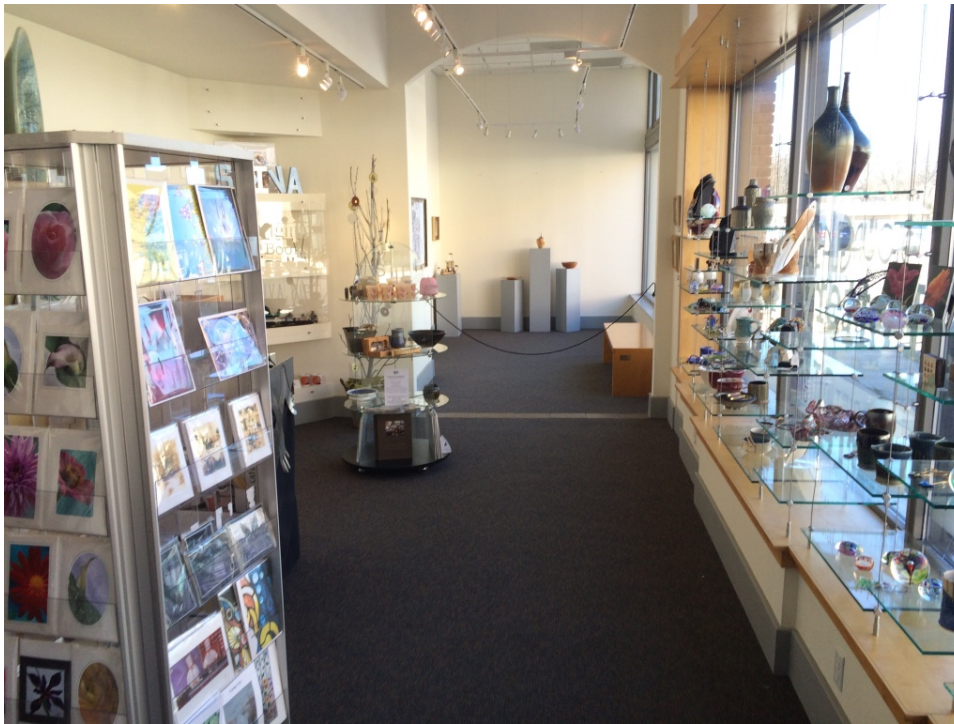
Retail space of current design and finishes set within a historic retail space in which little or no historic fabric was remaining.

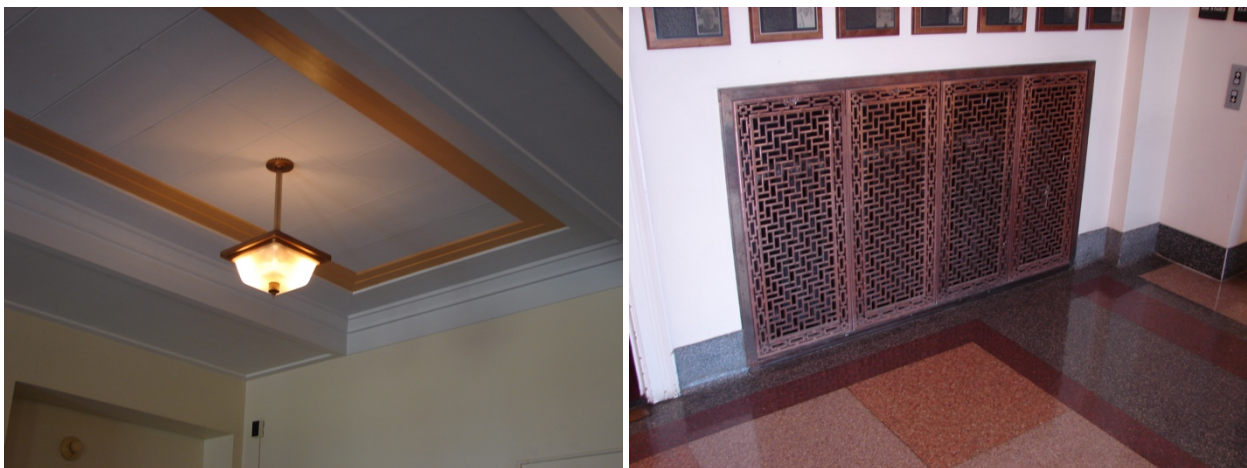
Remnant historic light fixture and heating grill that were retained in rehabilitation of public spaces.

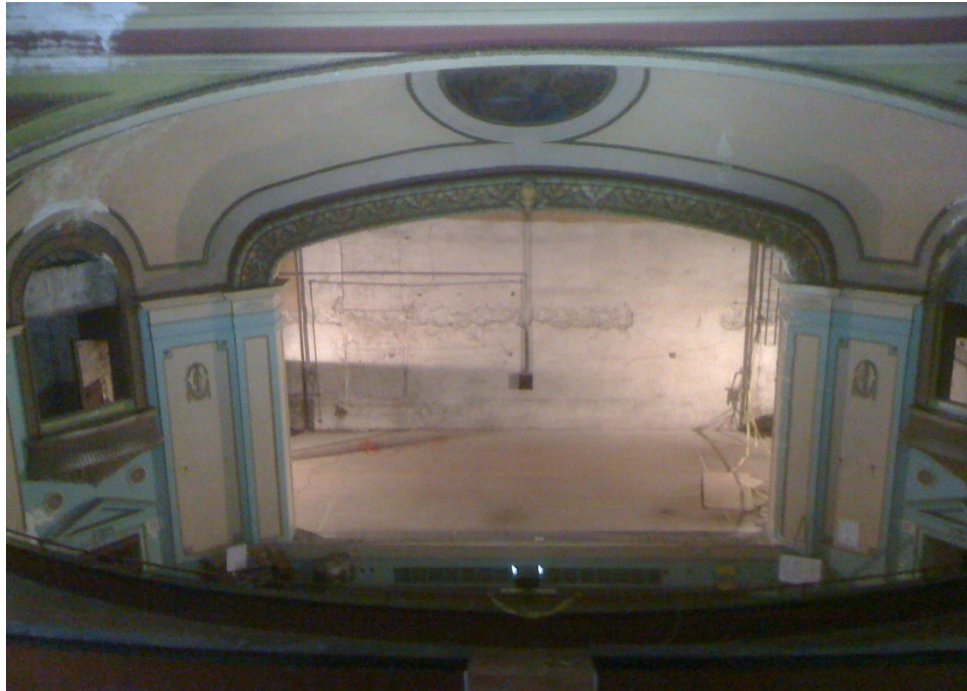
Interior plaster work of the Jayhawk Theater, which is under rehabilitation.

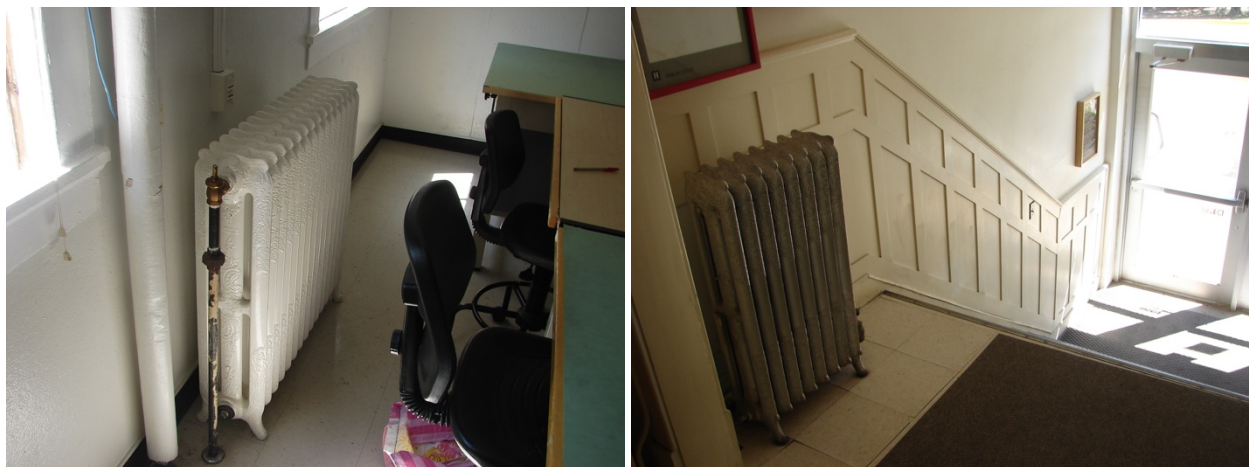
Historic radiators should be retained and can sometimes be incorporated into new heating systems.

If an existing system of steam heating pipes is present and can accommodate future heating needs in a rehabilitation project, it may be appropriate to install new wall-mounted or baseboard radiators in each room that can use the existing piping system. In such cases, air conditioning can be handled as a wholly separate system. New elements such as electric or water radiant heating can be surface mounted and should be carefully installed without altering historic woodwork, plaster, or other materials.

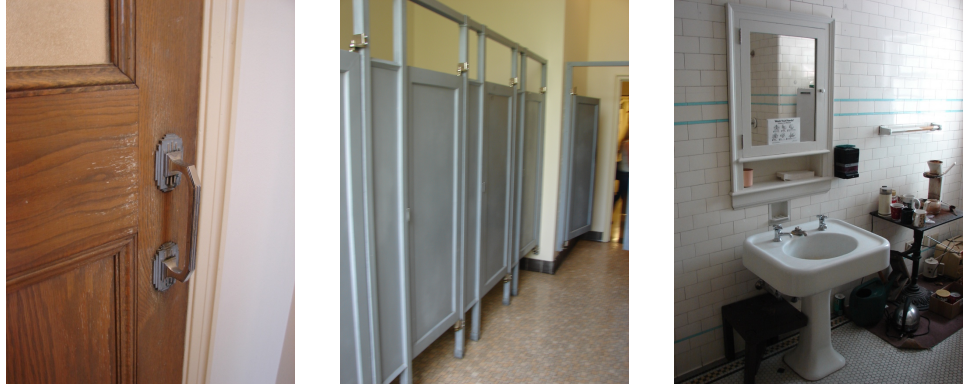
Historic hardware should be retained and refurbished whenever possible. The survival of historic bathrooms is rare and their preservation is highly desirable when they exist.

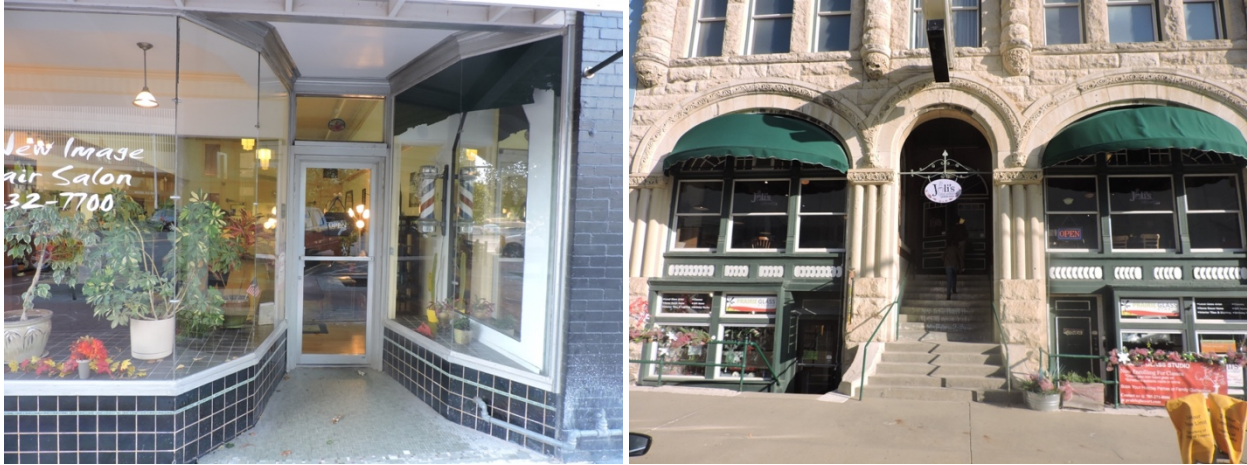
Most historic retail spaces are accessible, though they don't fully comply with ADA standards. The store entrance at the left does not meet standards for width. The building on the right has been modified through its ground-floor entrance on a side facade to comply with ADA requirements without destroying historic features.

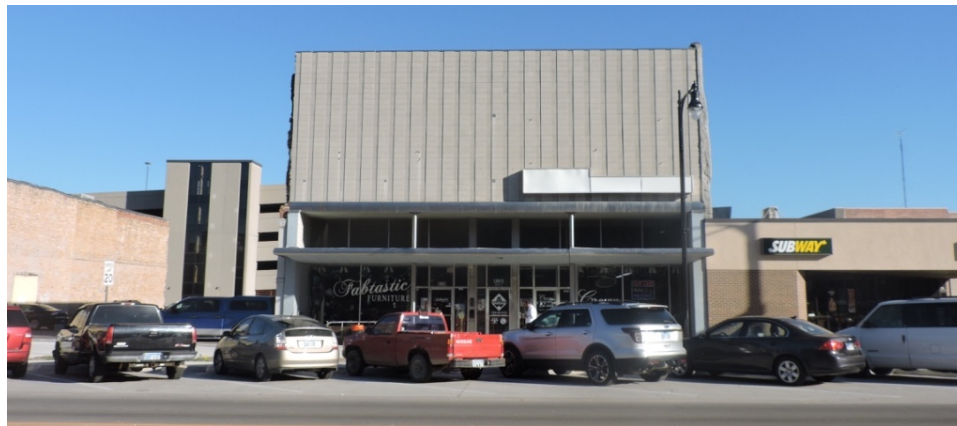
628-632 South Kansas Avenue (center) was constructed about 1925, was renovated about 1965, and is significant to the historic district. To its left is a vacant lot and to its right is a recent one-story building that is inappropriate to the district.

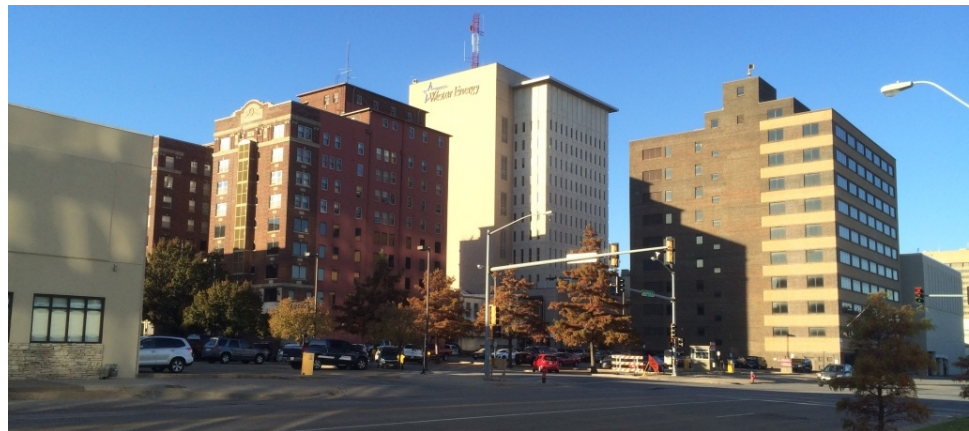
View of the two corners from across Quincy Avenue. The lots are adjacent to several taller buildings of varying periods and styles. The brick Hotel Kansan at center-left was constructed in 1924, and the office building at right was constructed in 1951.

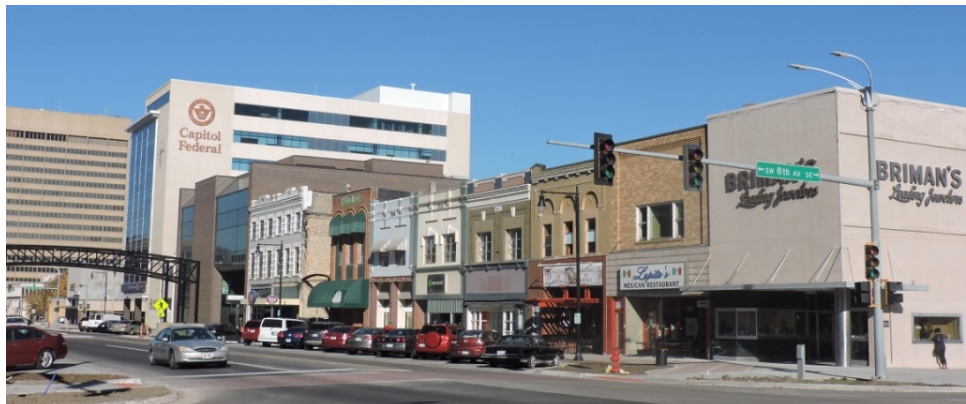
The historic district is characterized by a variety of building types and sizes. Early twentieth century commercial buildings are predominantly two and three stories. Taller, more massive buildings were constructed in the 1920s and 1960s.

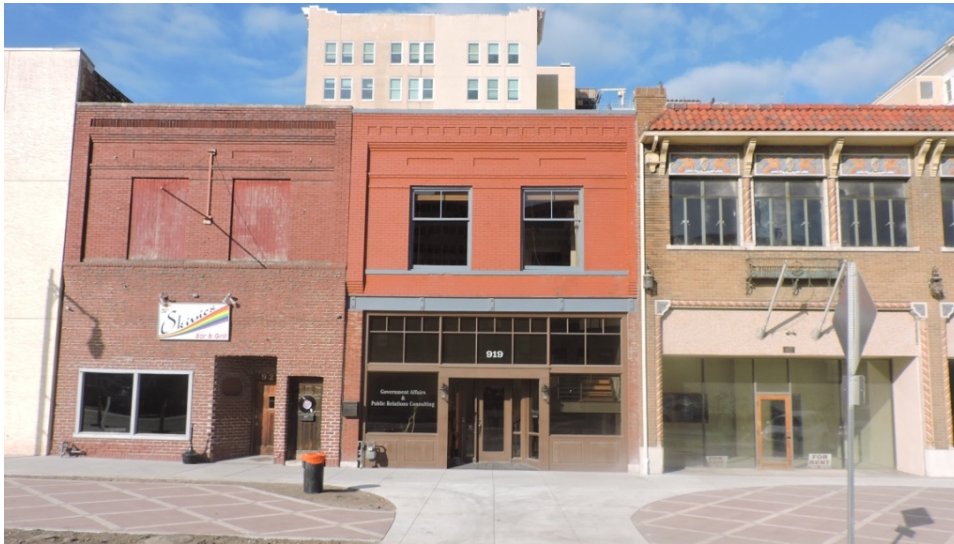
Most buildings throughout downtown are located immediately adjacent to the sidewalk, fill the full width of the lot, are oriented to the street, and create a continuous streetscape facade.

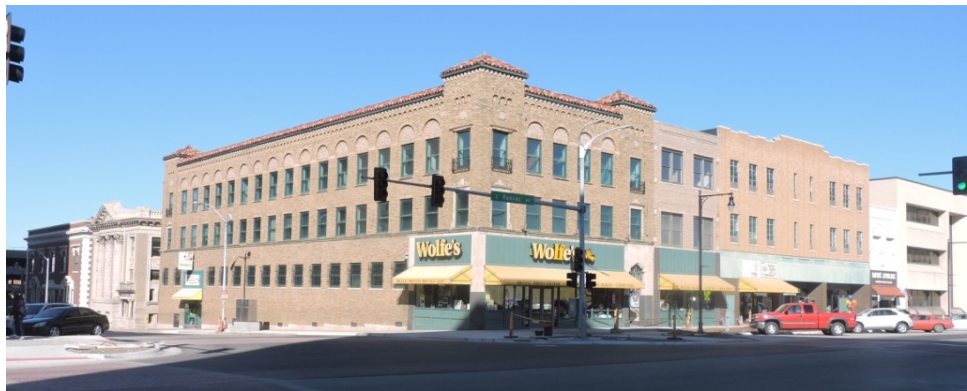
The Kresge Building at 635 South Kansas Avenue was constructed in 1926 and designed to respect and turn the corner.

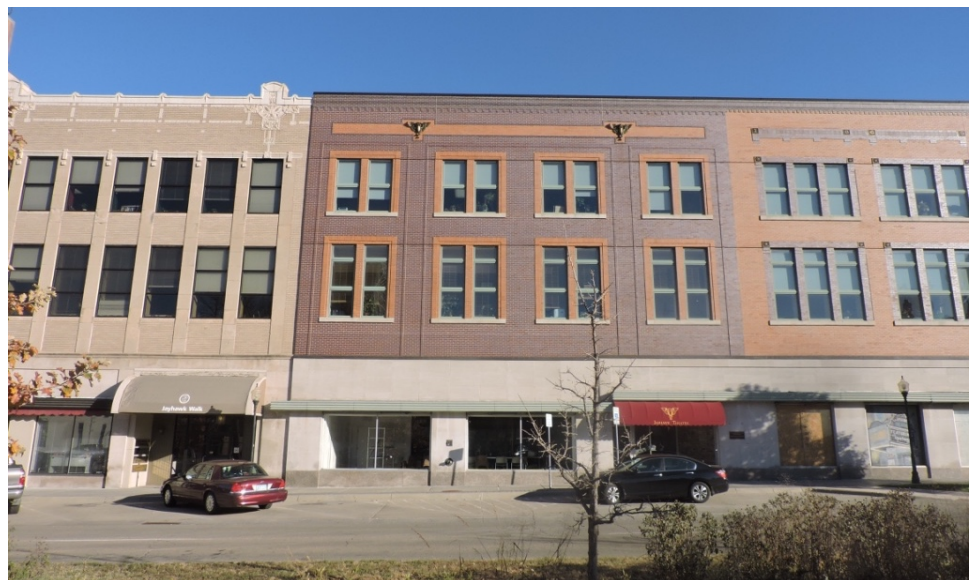
These three-story buildings along Jackson Street are very consistent in scale, form, and massing (proportion of solid to void). There is variation in the rhythm of the window openings, color, and detailing.

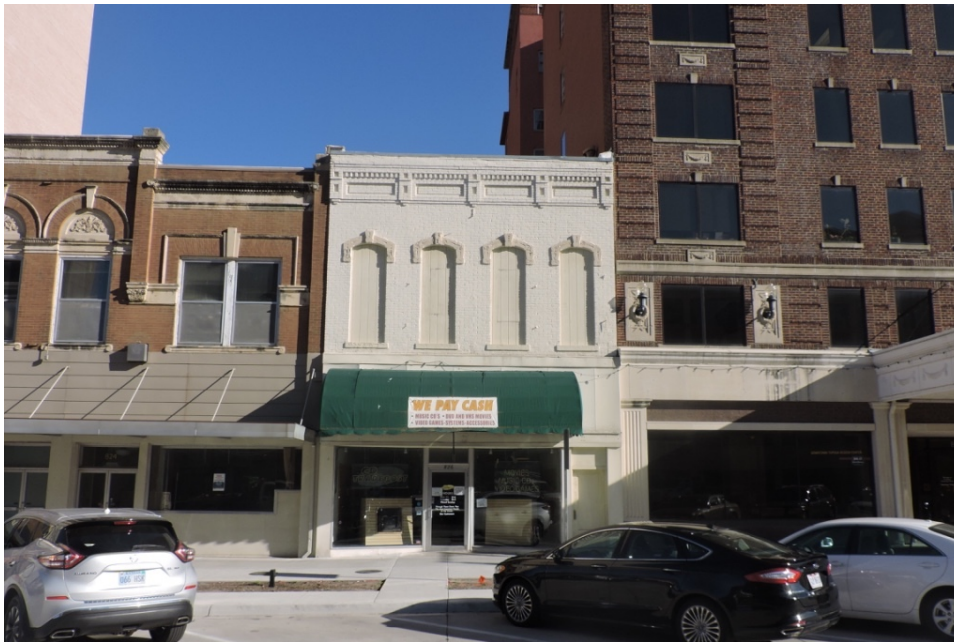
These adjacent buildings along South Kansas Avenue are varied in size, form, massing, and rhythm and date to different periods. They demonstrate the diversity of variety of the Downtown Topeka streetscape, which can be picked up in new construction while still being compatible.

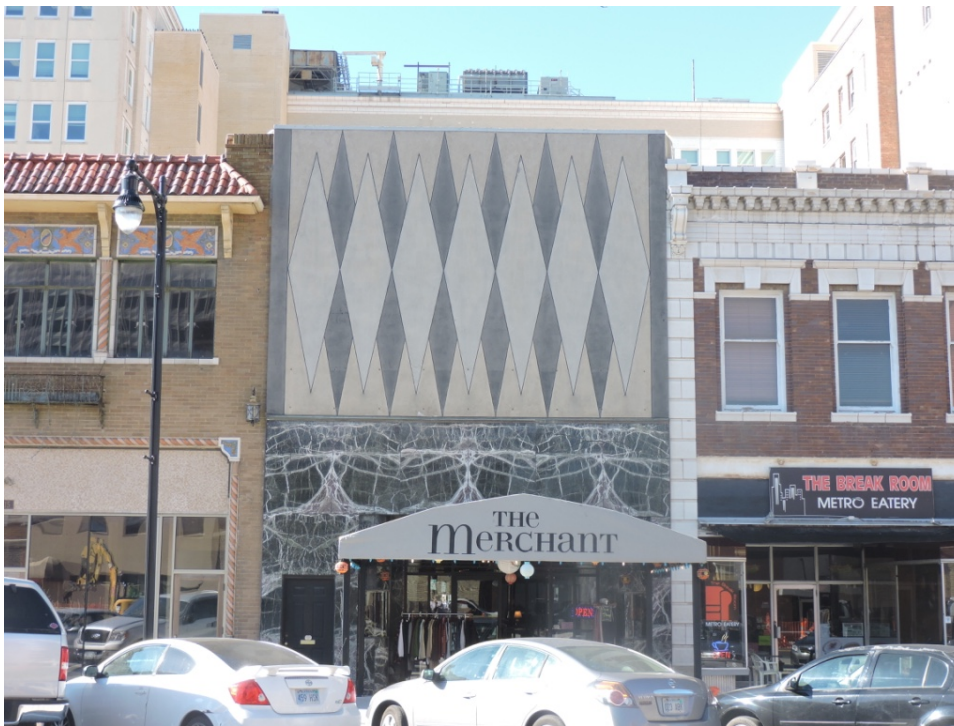
The Merchant at 913 South Kansas Avenue was constructed in 1910 and renovated about 1960. Its entrance and lower storefront are consistent with others on the street, but its renovated façade contrasts dramatically with the buildings on either side, another example of the streetscape's diversity.

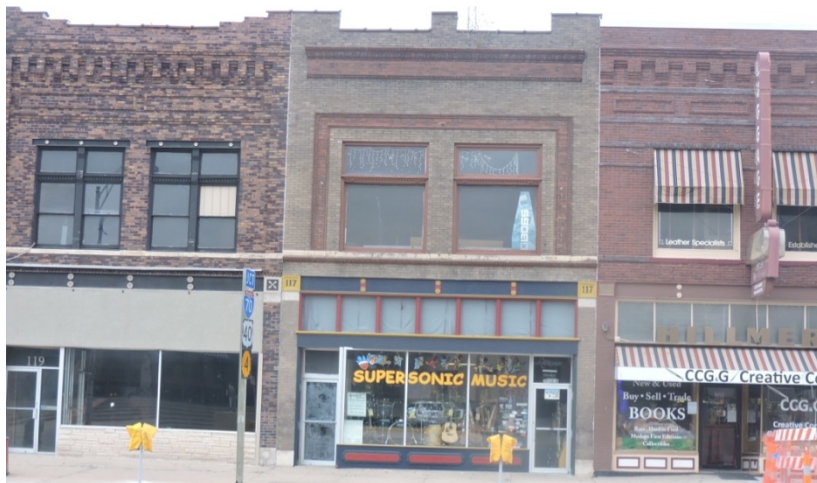
These three similar early twentieth century buildings have an interesting interplay of materials and color.

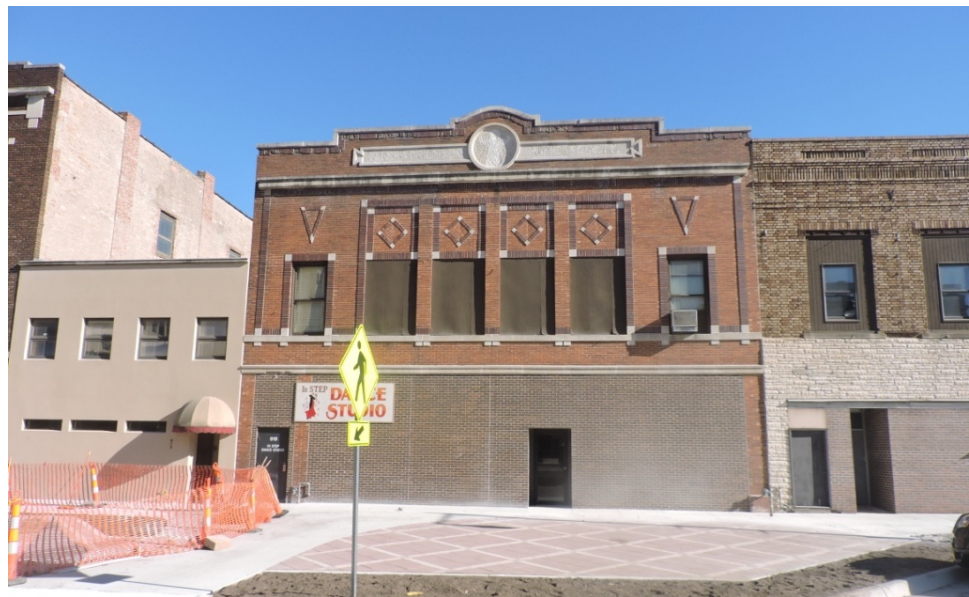
These buildings in the 900 block of South Kansas Avenue have been proposed for rehabilitation with new construction. Upper story facades would be restored. New storefronts would be similar to those that were present historically. New taller construction would be set back from the streetscape. The non-contributing building at left would be removed for a new entrance to the complex. The proposed design would relate to the broad architectural character of the district as a whole.

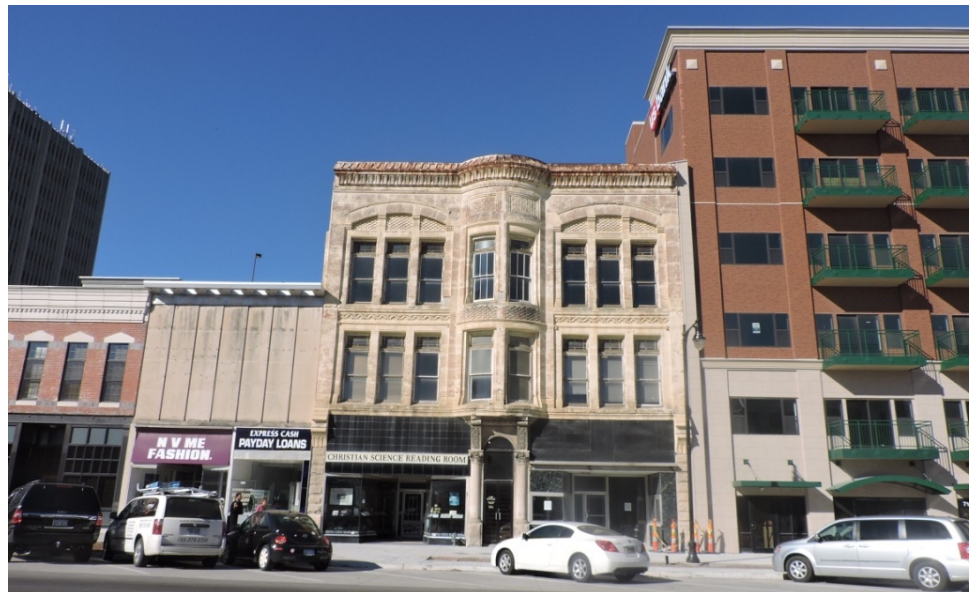
These adjacent buildings in the 700 of west South Kansas Avenue have different scales, sizes, forms, materials, and window treatments. The building at right would not be allowed under these guidelines because the floors do not align and the windows and balconies are completely different and inappropriate.

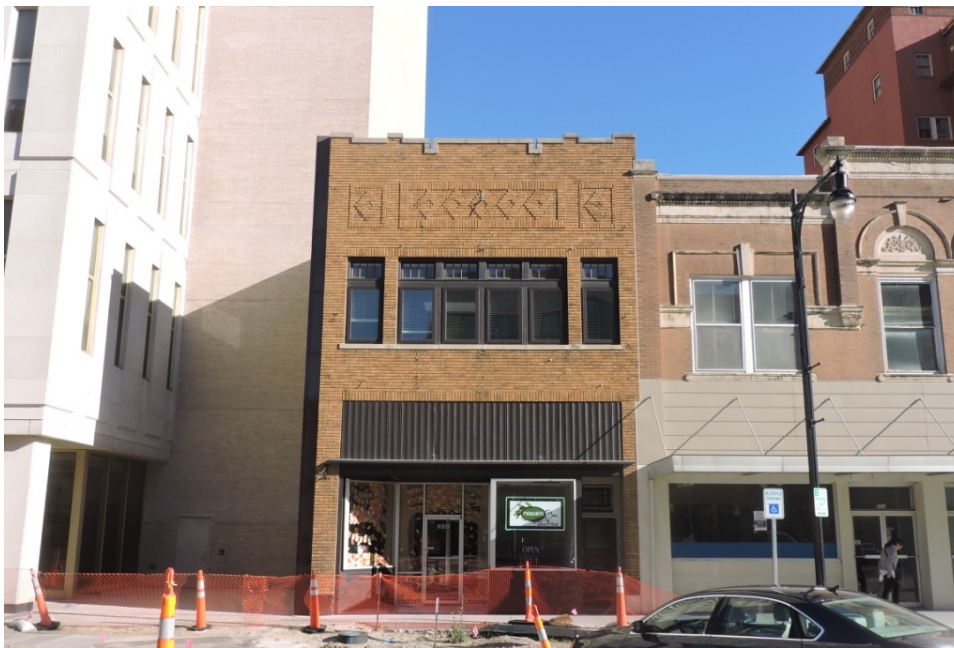
The twelve-story Kansas Power & Light Company Building (left, today known as the Westar Energy Building) steps back and creates a gap between the tower and its much smaller two-story neighbors.

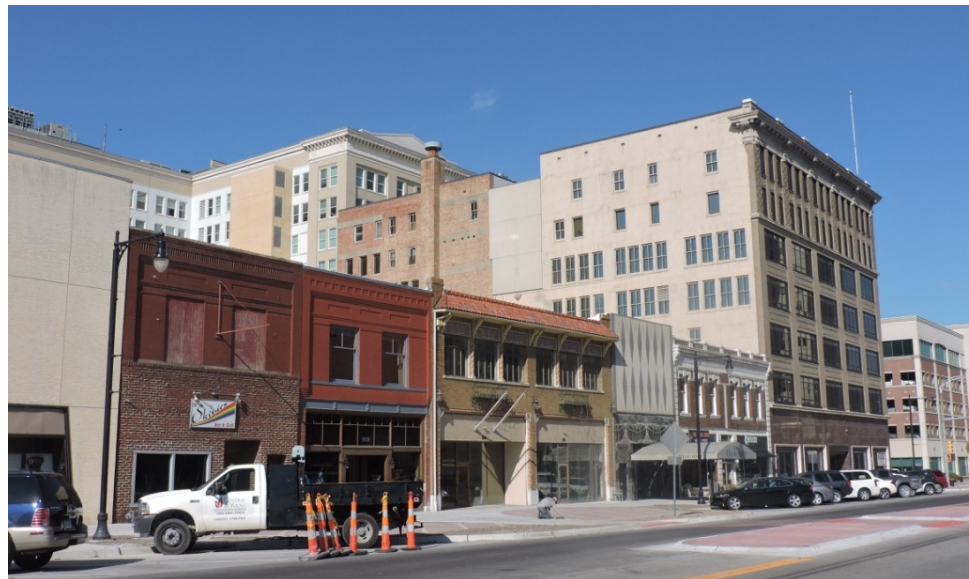
A row of two-story buildings in the 900 block of west South Kansas Avenue are juxtaposed against the seven-story office building on the corner that dates to 1912.

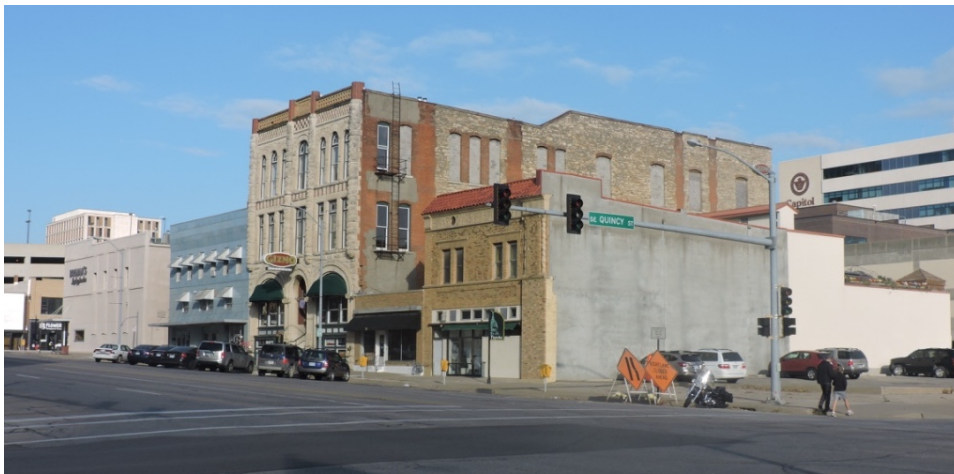
Buildings along SE 8th Avenue have variation in size, form, materials, and style, including one of the district's few small one-story contributing structures. The vacant lot on the corner at right may be a site for new construction.

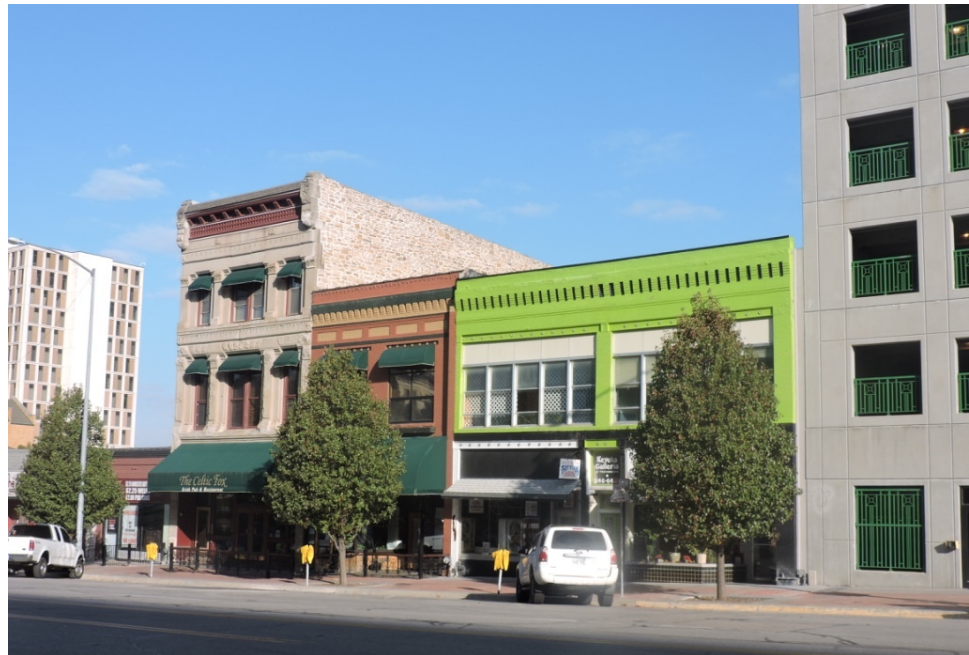
Though dramatic contrast may be related to the district's characteristic diversity and variety and is present downtown, in this case a contrast in color, it is not a desirable attribute for new construction going forward.

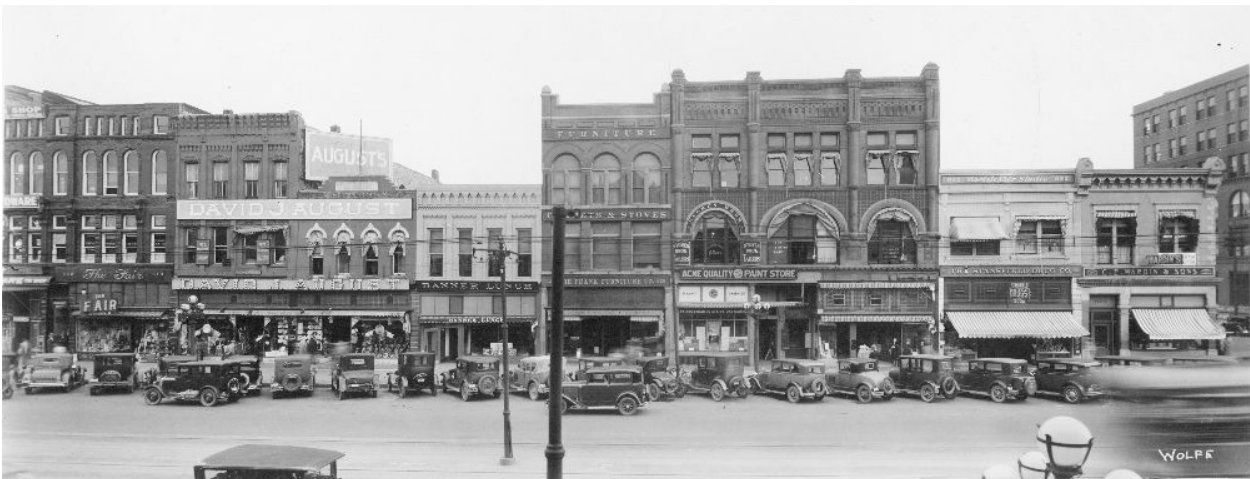
Above-transom signs are the most common in the late nineteenth and early twentieth centuries. This photo of the east side of the 600 block in the early 1930s (maybe the 1920s), also has a rooftop billboard sign, cornice level sign, second floor level sign, two-building cornice level sign, projecting signs, and awning signs. (KHS Kansas Memory)

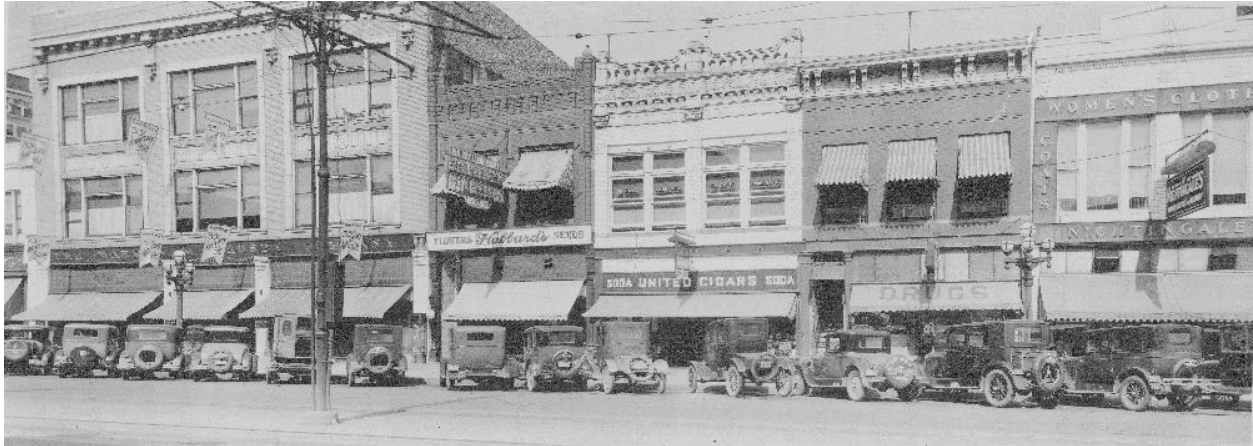
This photograph of the west side of the 600 block of South Kansas Avenue from about 1930 shows above-transom signs, an in-transom sign, a cornice level sign, two upper level projecting signs, two in-transom projecting signs, and awning signs. (KHS Kansas Memory)

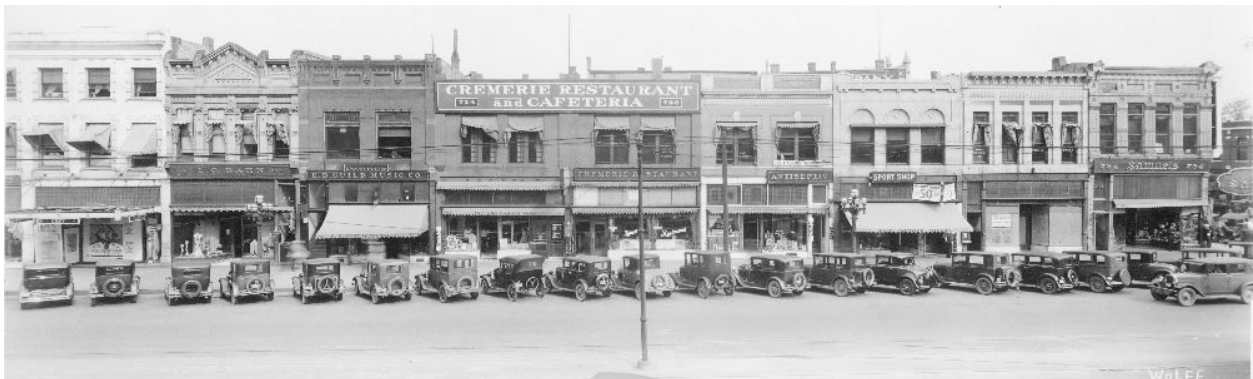
This photograph of the east 700 block of South Kansas Avenue includes a two-building cornice level sign that is out of scale with its context. (KHS Kansas Memory)

Some cornice level signs installed historically were too large for the buildings they were attached to—out of scale with the facade and obscuring architectural features and details. When cornice signs are installed in the future, they should be proportional to the space available.

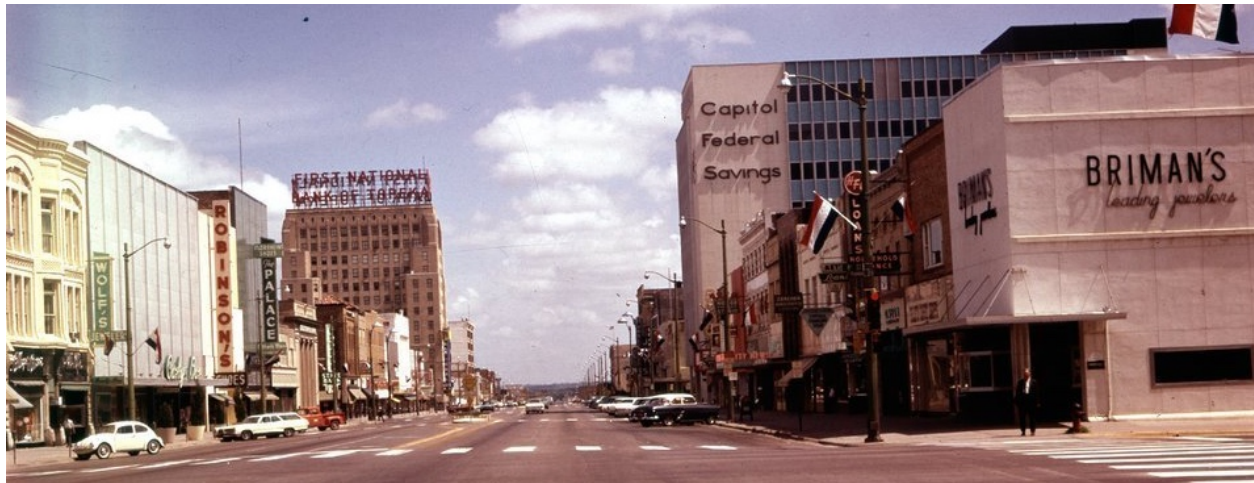
South Kansas Avenue looking north from 8th Avenue showing wall-mounted lettering in 1962 on Capitol Federal Savings and Briman's Leading Jewelers. On the left, a series of vertical projecting signs are shown. In the distance, the large roof-mounted sign on the First National Bank of Topeka is pictured. (KHS Kansas Memory)

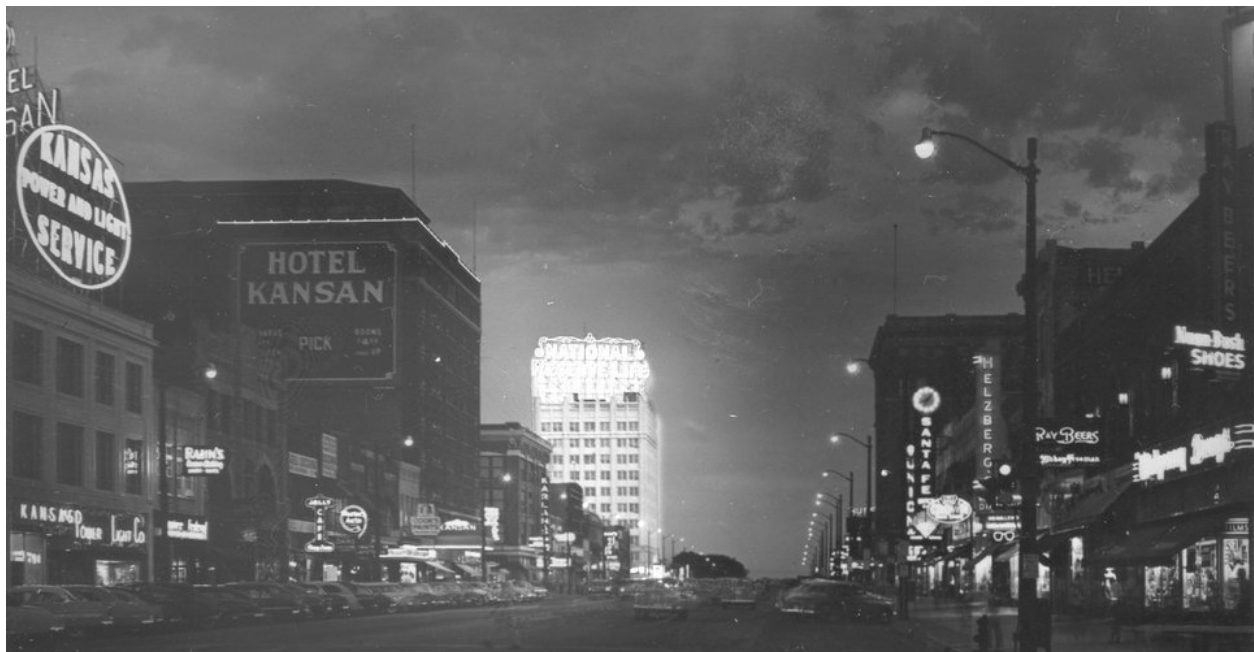
South Kansas Avenue looking south from 8th Avenue in 1954 showing multiple projecting signs, portions of three roof signs, lit surface mounted lettering, and a painted masonry sign. (KHS Kansas Memory)

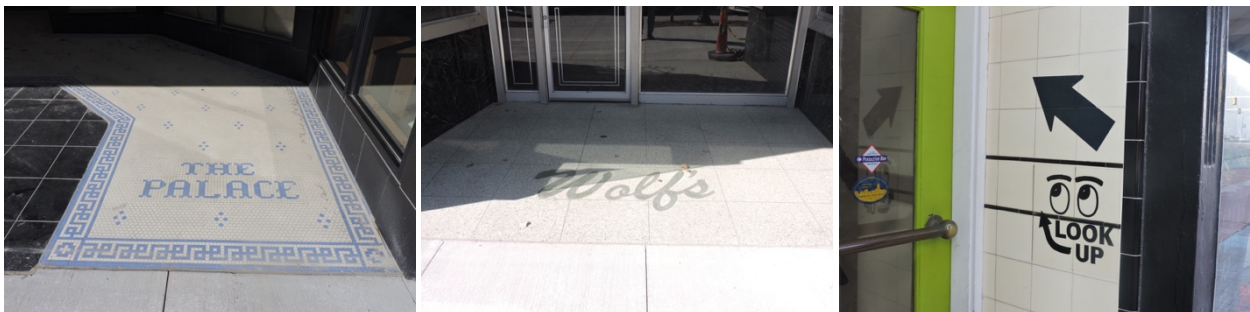
Existing entrance paving signs (center and left) and wall sign on tile (right).

Entrance Paving and Wall Signs – As discussed in Chapter 6 on storefronts, the names of stores were sometimes designed into outdoor tile entrance vestibules during the early twentieth century. Where such designs survive, they should be preserved. This format could be appropriate for new construction as well. Signage was designed into wall tile and other wall materials on occasion.

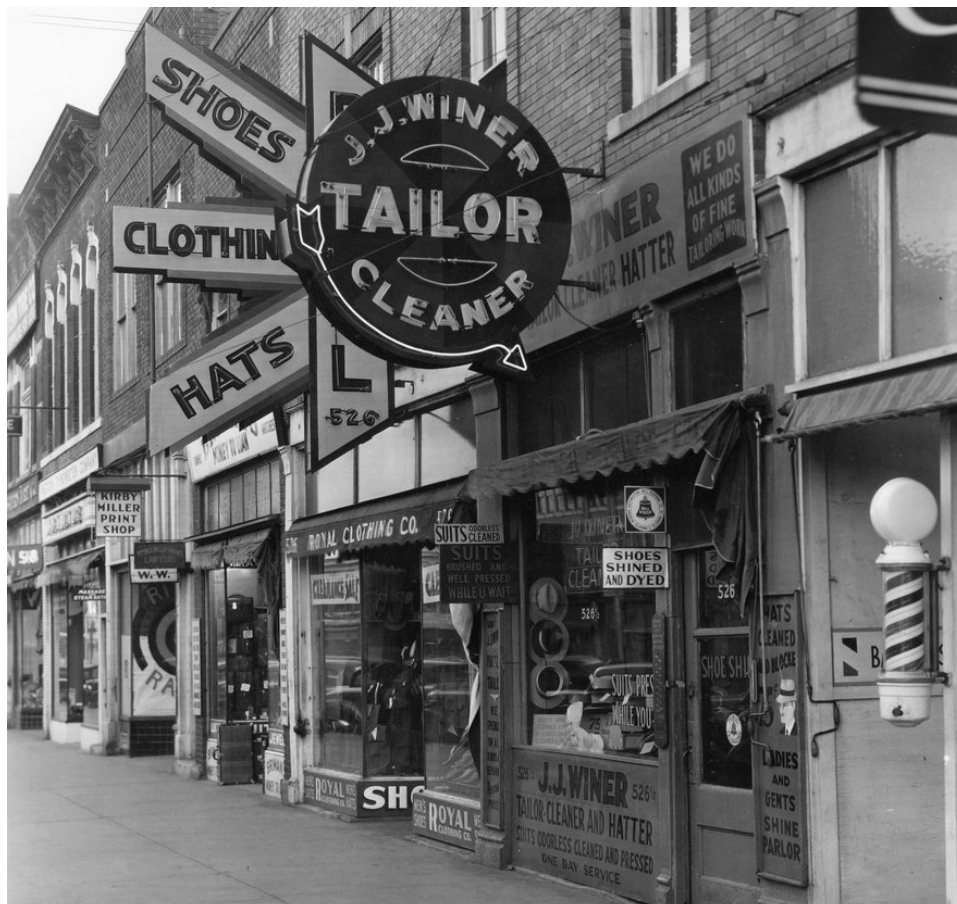
Profusion of signs at the storefront level on the east side of the 500 block of South Kansas Avenue between 1945 and 1949. While present historically, excessive signage is not considered desirable today. Unique designs like the large neon projecting sign would be desirable. (KHS Kansas Memory)

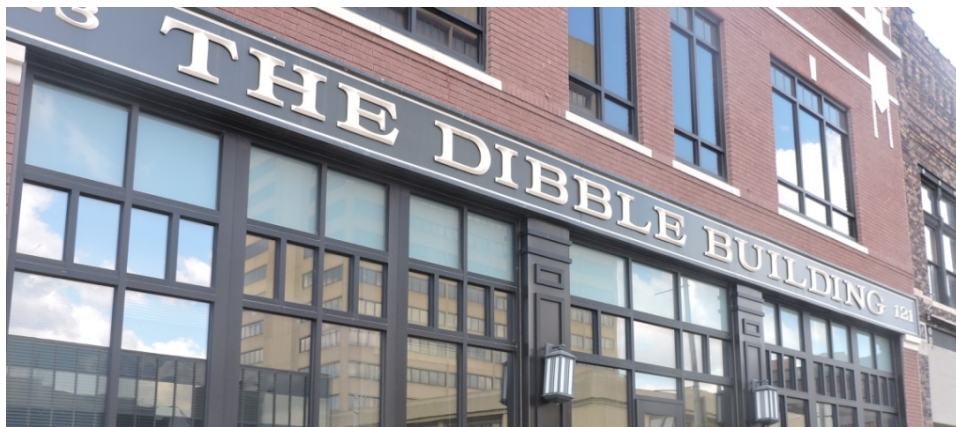
Traditional style above-transom sign over a contemporary storefront facade

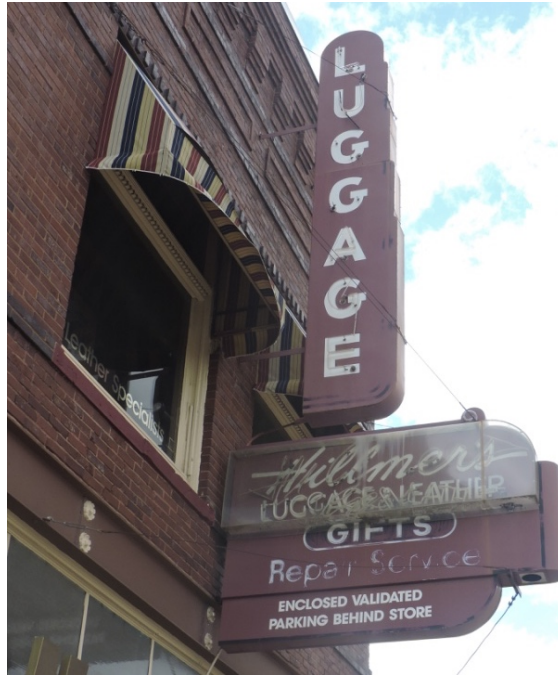
Historic projecting neon sign remaining on Hillmer's Leather Shop, East 6th Avenue

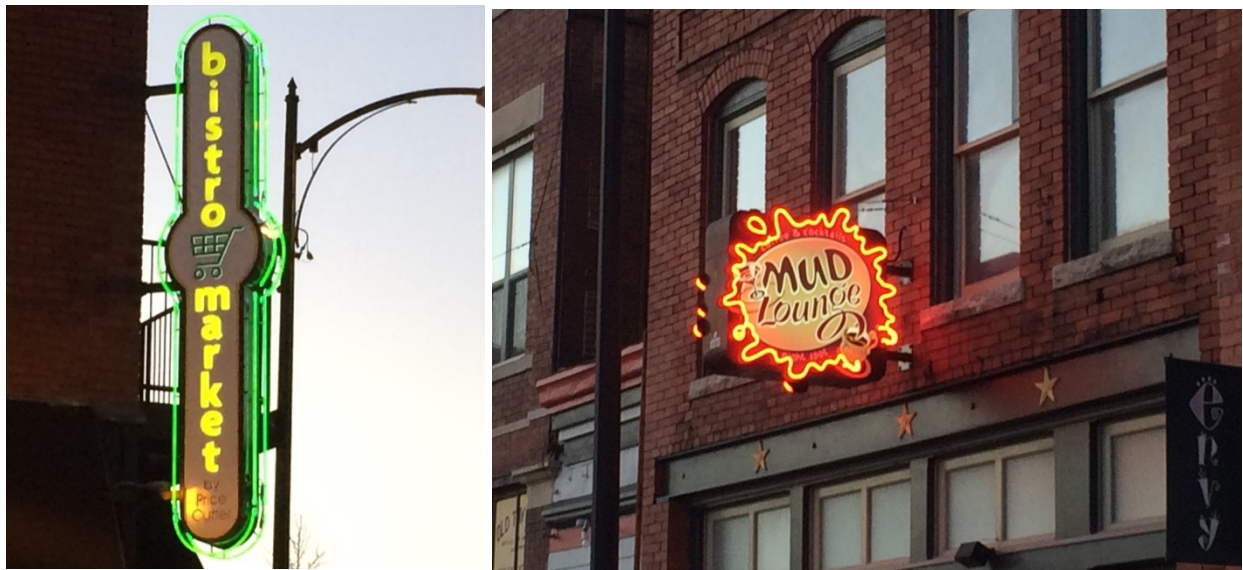
Colorful projecting neon signs from another city

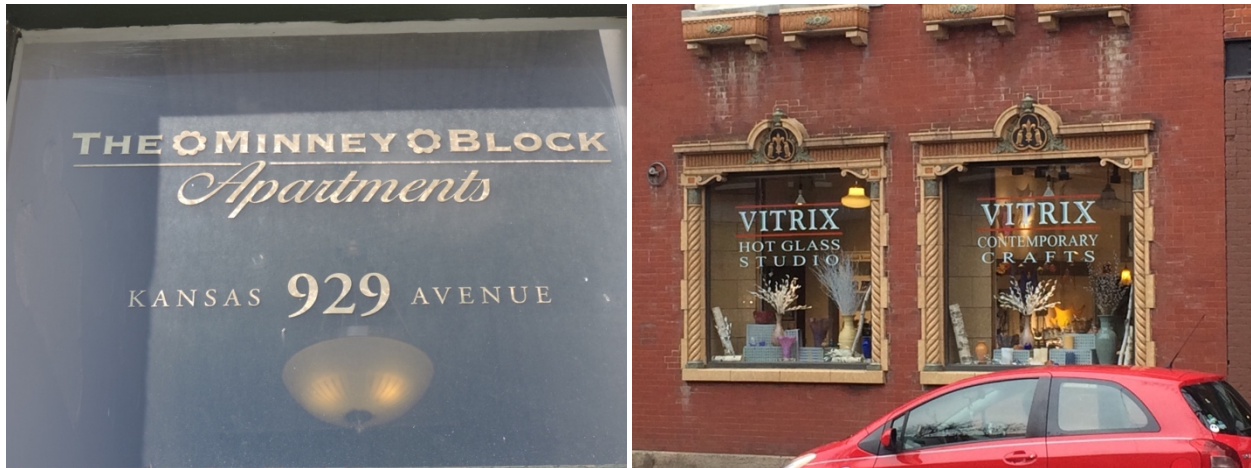
Painted glass signs on a door transom (left) and windows (right)

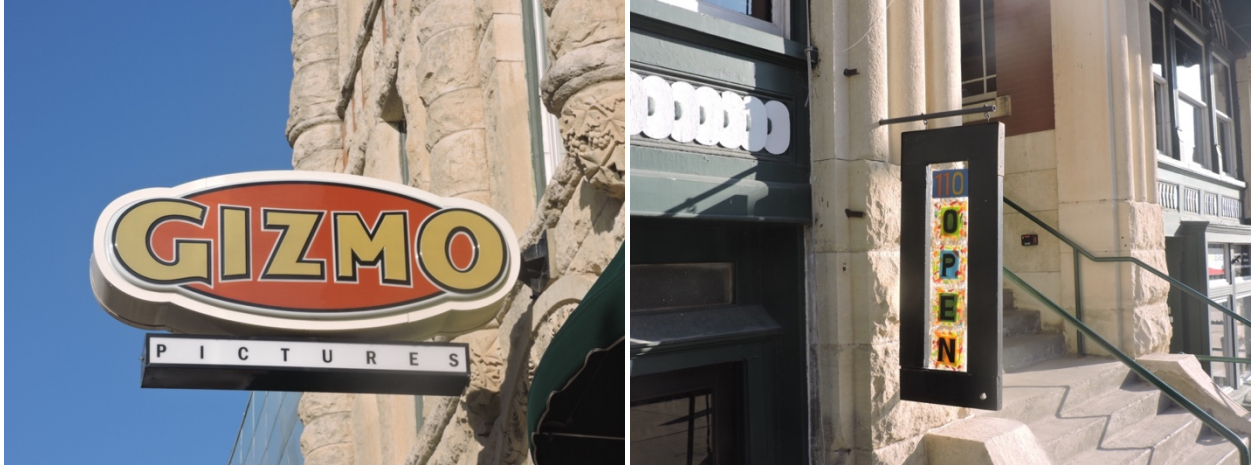
Artistically designed box sign and small non-lit projecting sign on the Thatcher Building
