DOWNTOWN TOPEKA

HISTORIC DISTRICT

DESIGN GUIDELINES

City of Topeka, Kansas

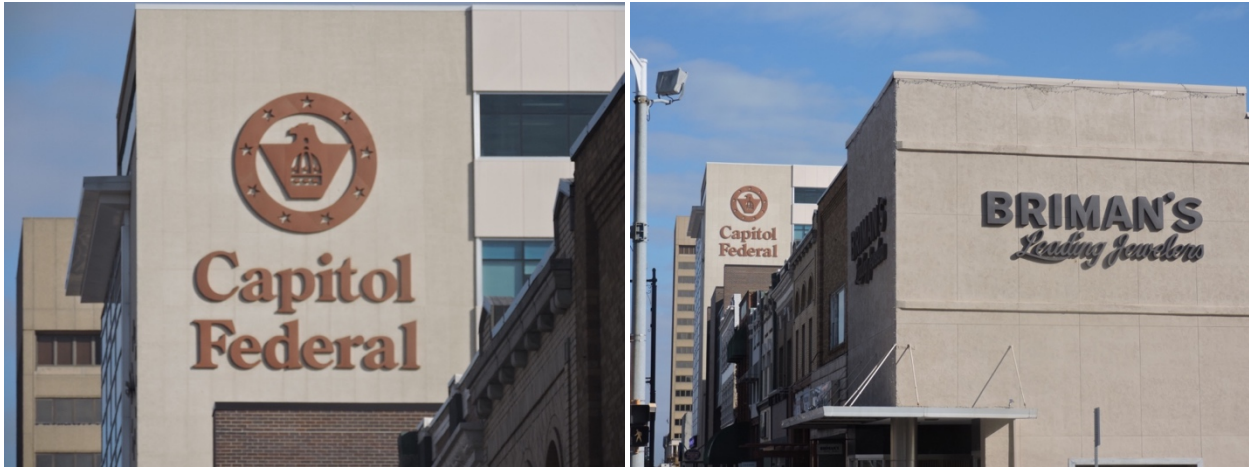
Large scale wall-mounted lettering characteristic of the 1960s

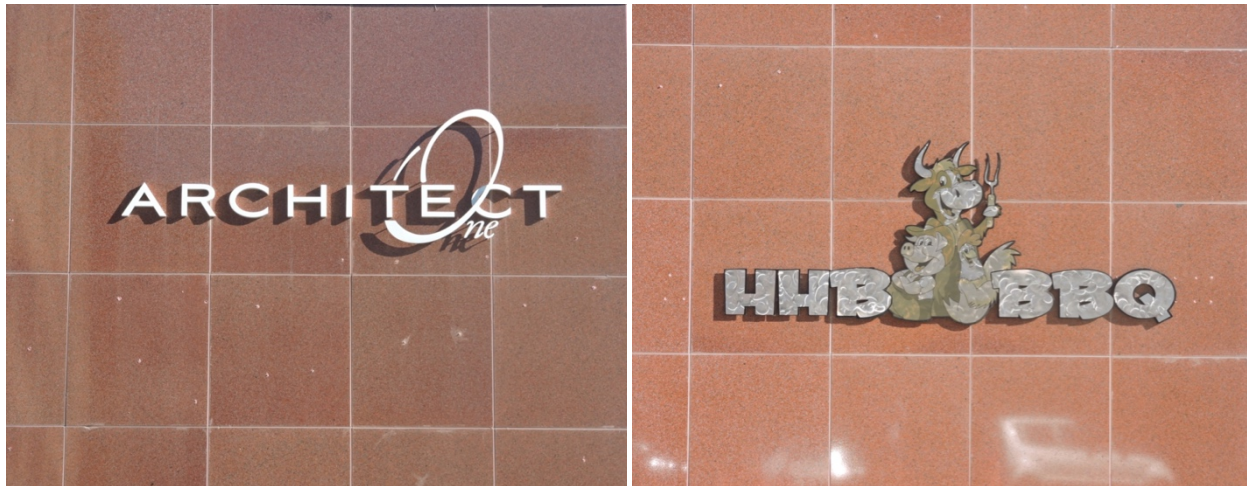
Smaller scale wall-mounting lettering of high quality, recently installed

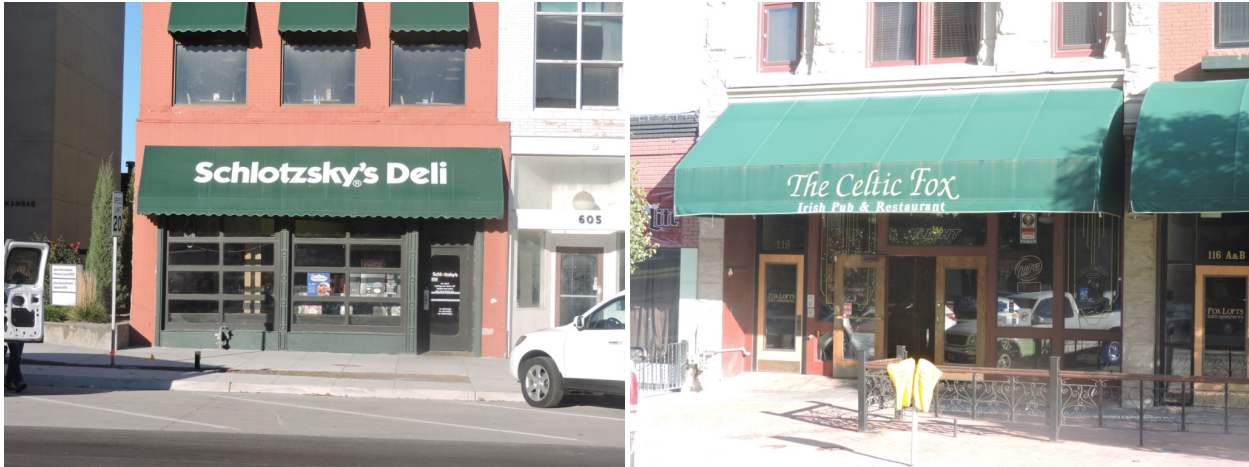
Awning signs on two buildings within the downtown district

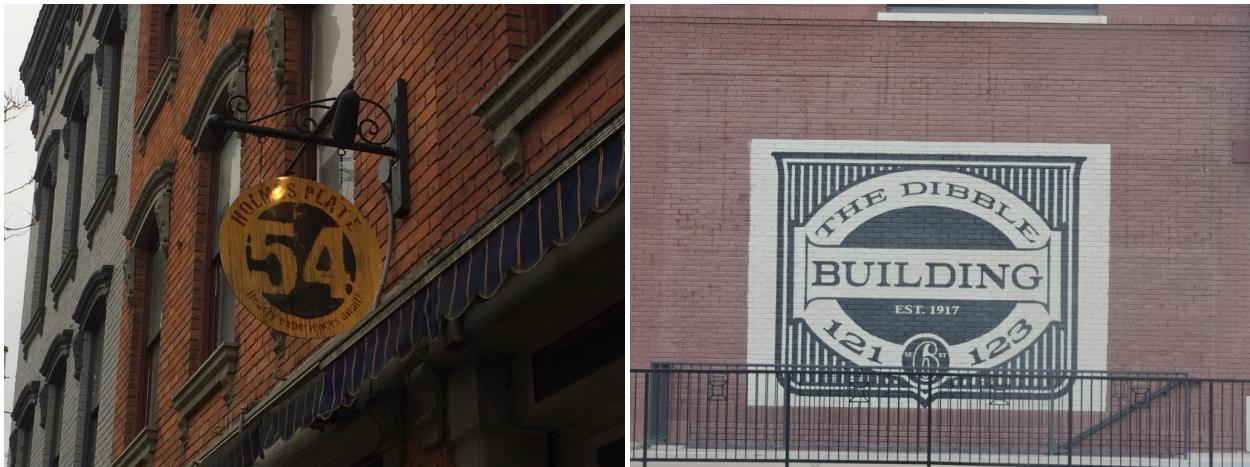
Non-lit projecting sign with indirect lighting (left) and recent painted masonry sign on a side wall (right)

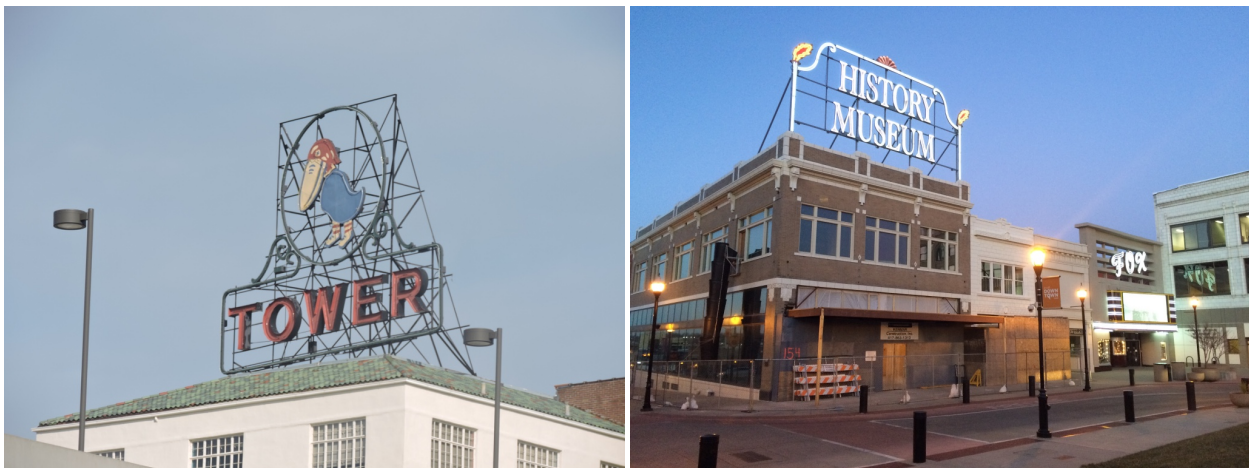
The historic Jayhawk Hotel/Tower roof sign (left) and a recent roof sign on a historic building in another city (right). The sign at right may be considered out of scale with the size of the low-two-story building.
